ENFIELD ARCHAEOLOGICAL SOCIETY ARCHIVE REPORT

EXCAVATIONS AT ELSYNG PALACE, FORTY HALL, ENFIELD, MAY AND JULY 2024

(SITE CODE FXW24)

by
MARTIN J. DEARNE

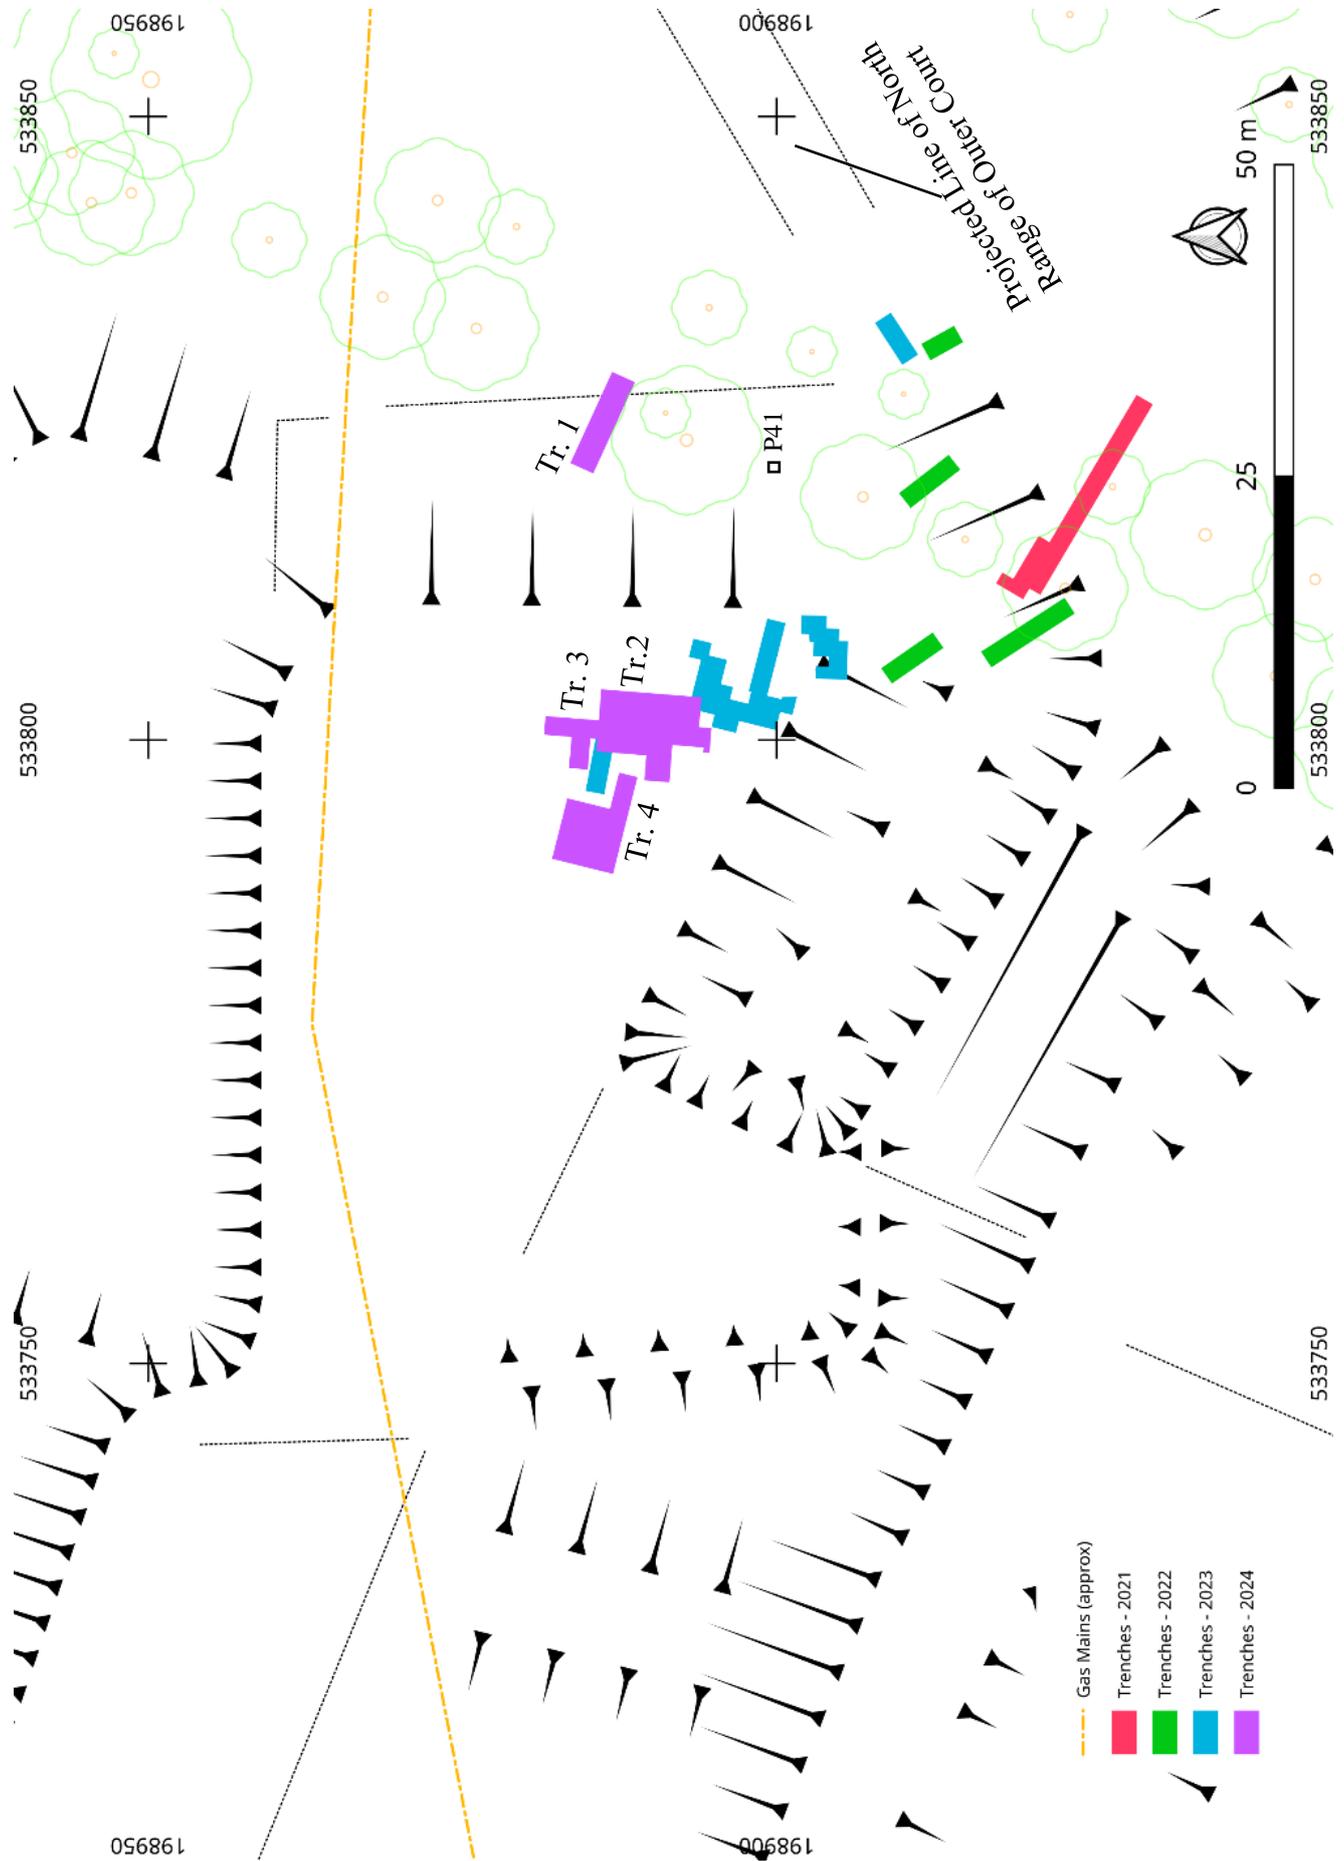
Fig. 1: FXW24 Trenches in Relation to Earlier Work and LiDAR Recorded Topography

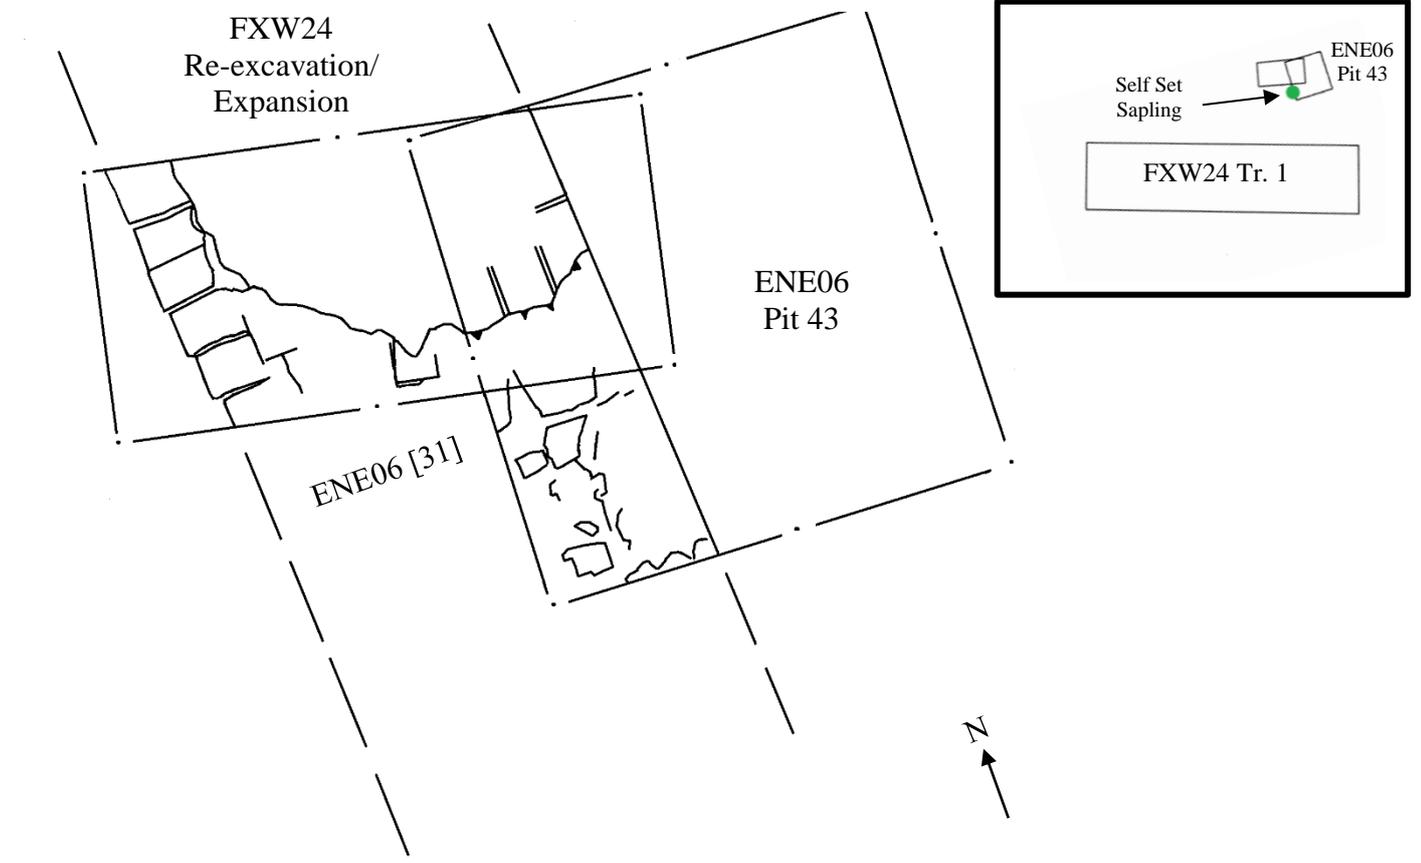
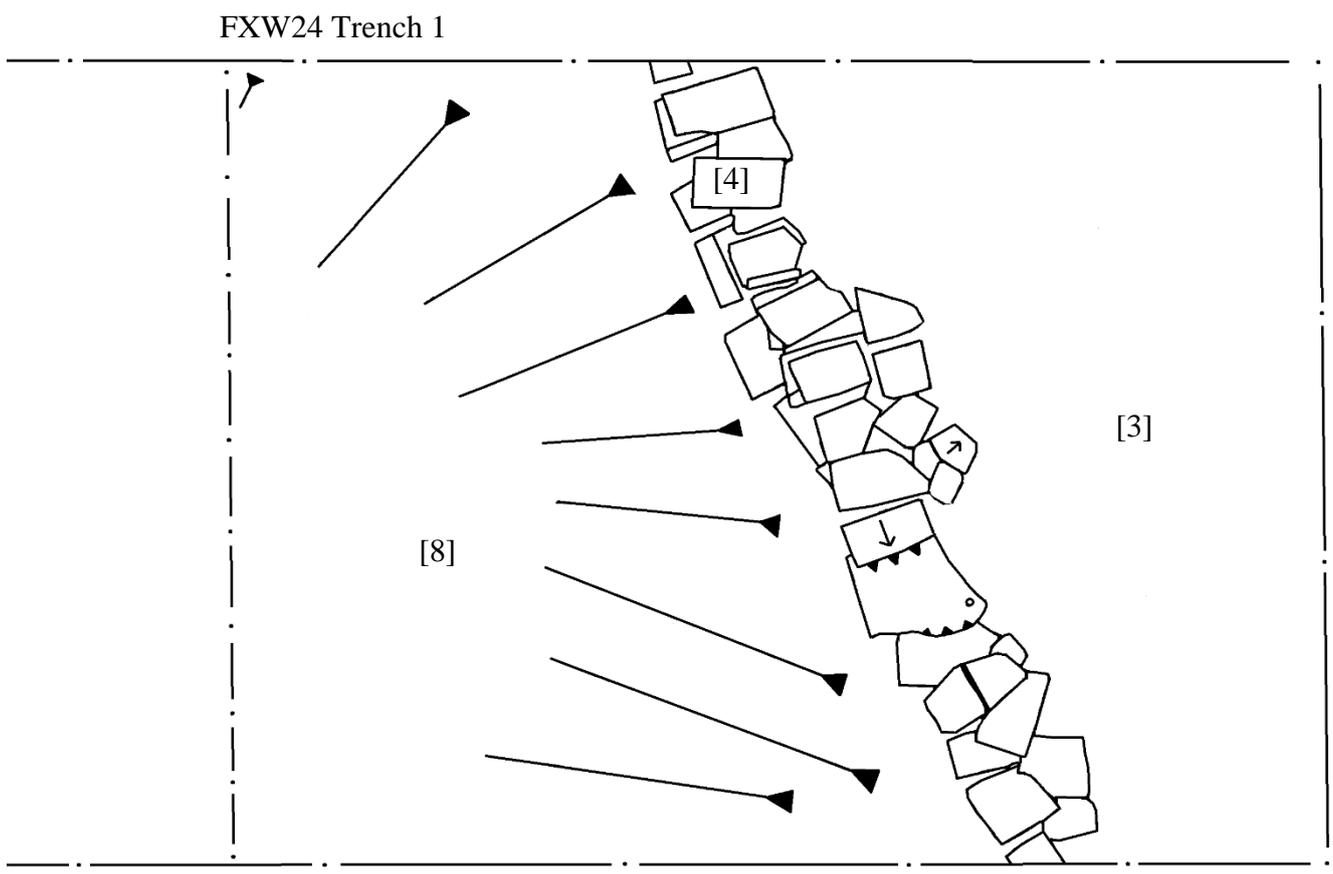
Fig. 2: East End of Trench 1 and ENE06 Pit 43 (1:20)

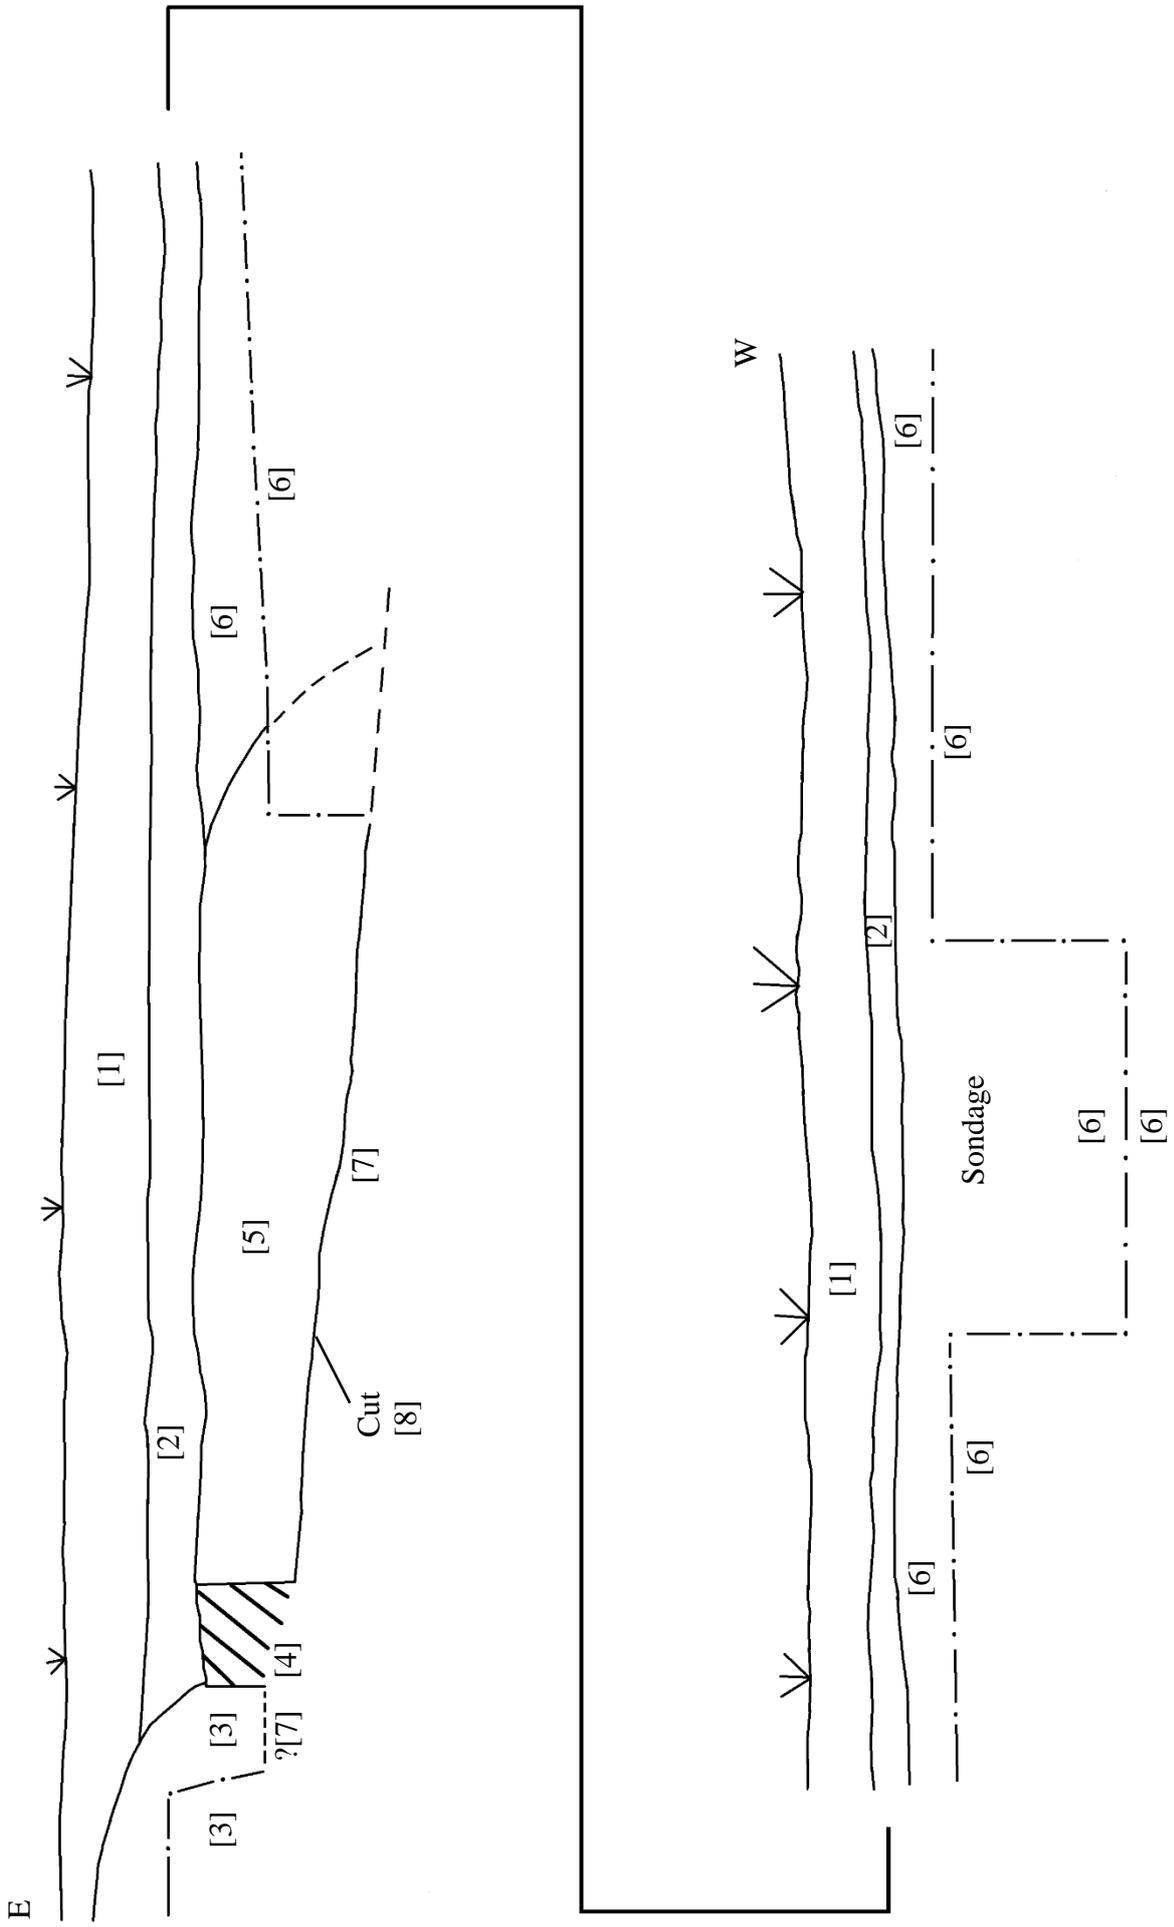
Fig. 3: Trench 1, South Section (1:20)

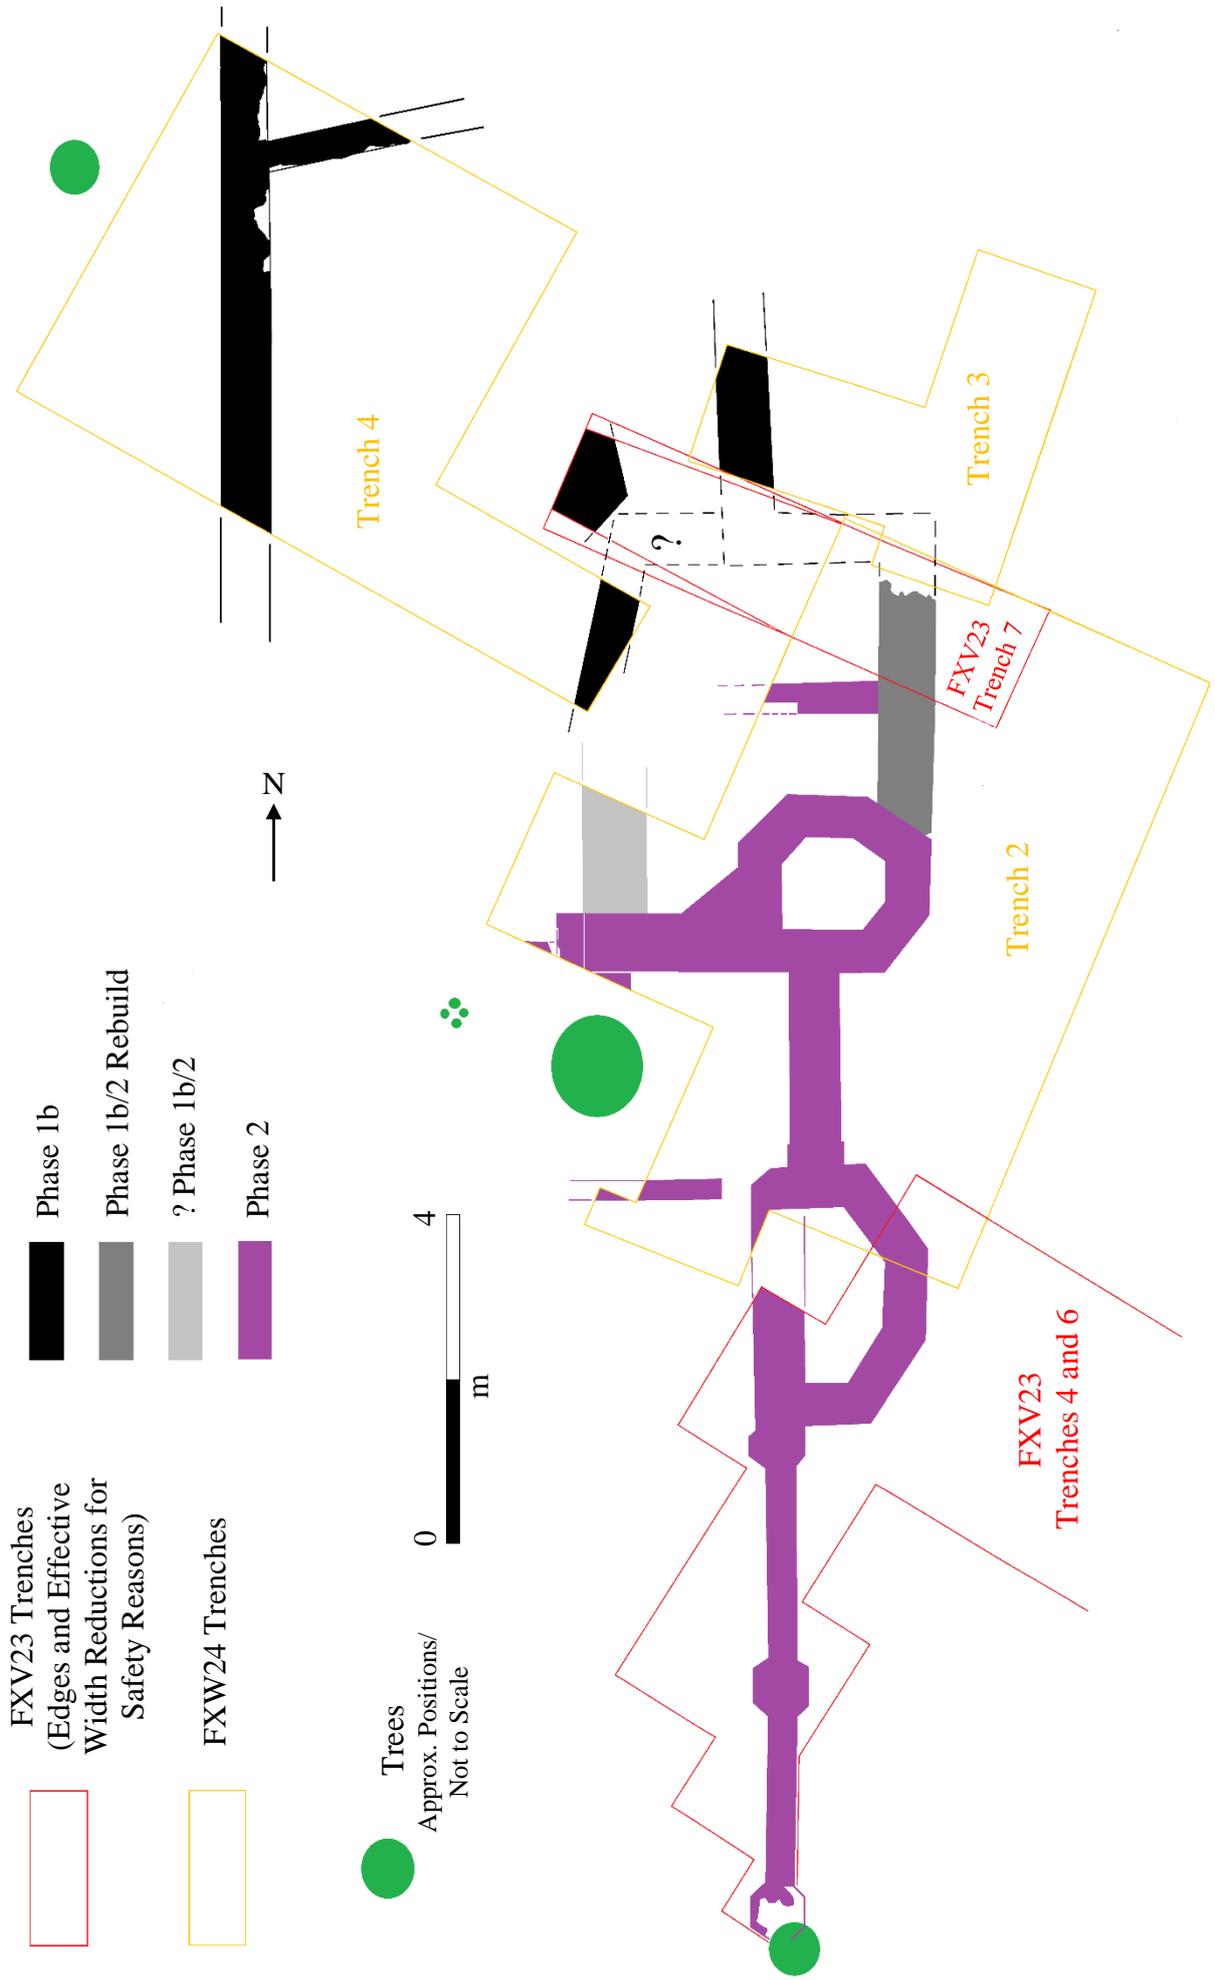
Fig. 4: The Raised Platform: 2023 and 2024 Trenches and Phased Structural Features

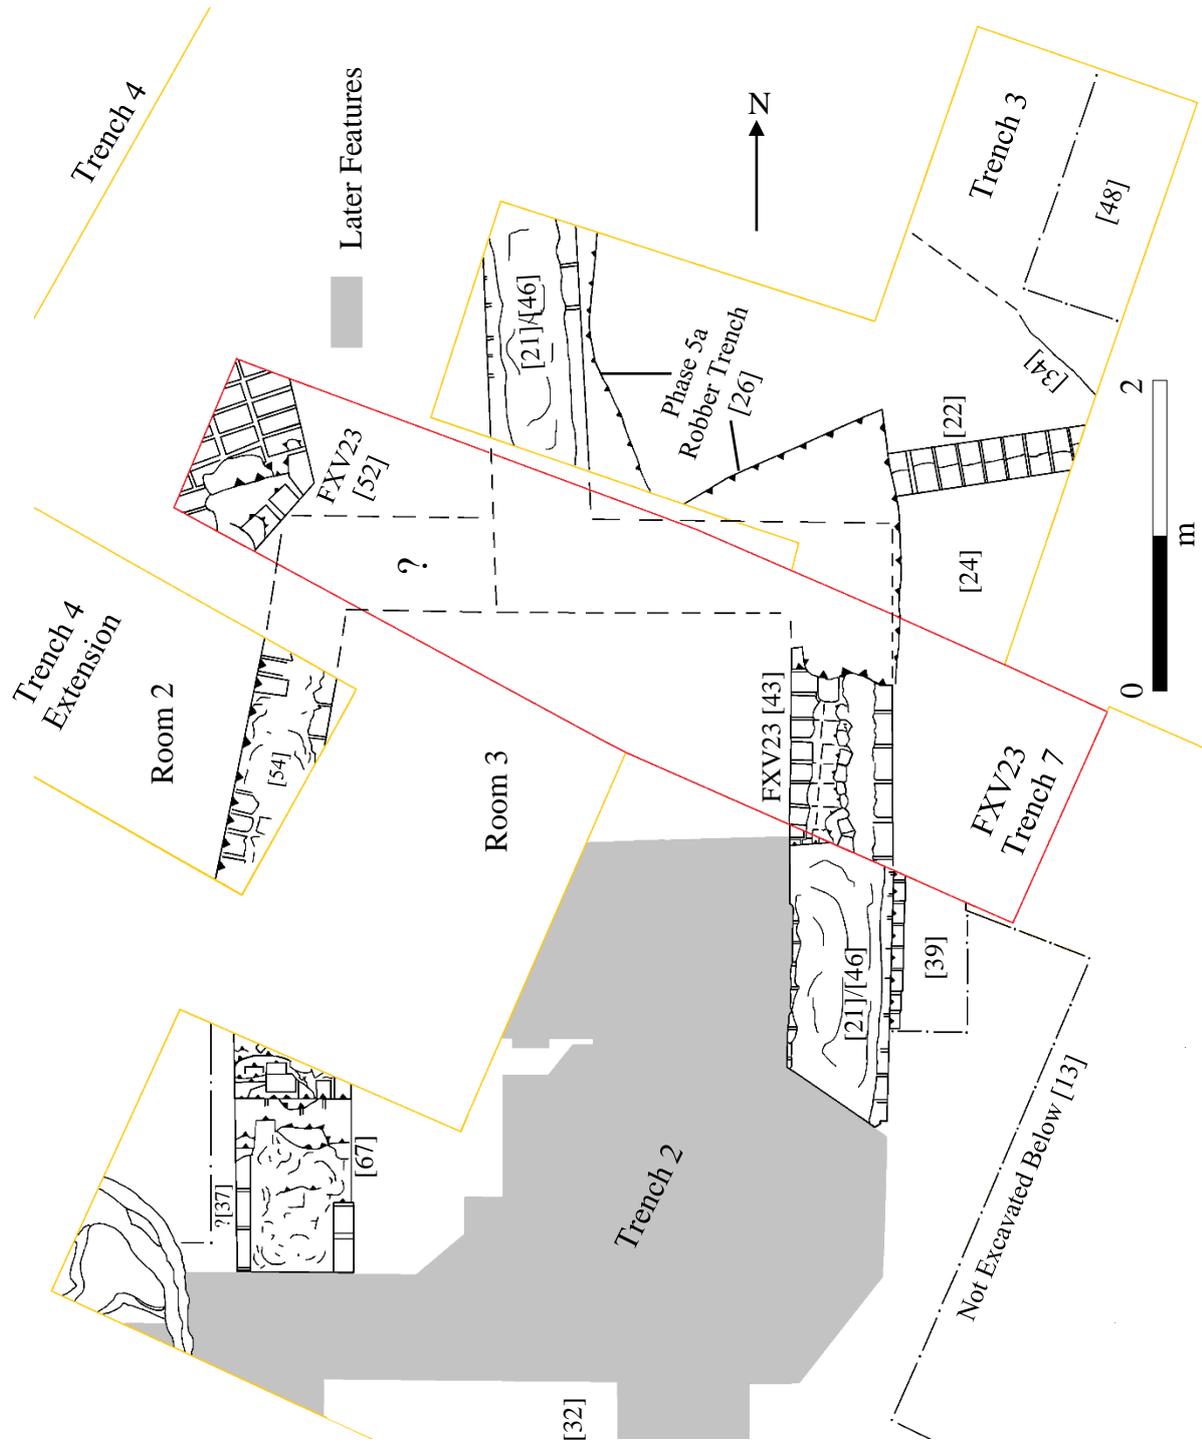
Fig. 6: Phase 1b and Phase 1b/2 Features in Trenches 2, 3, Trench 4 Extension and Fully Excavated Parts of FXV23 Trench 7

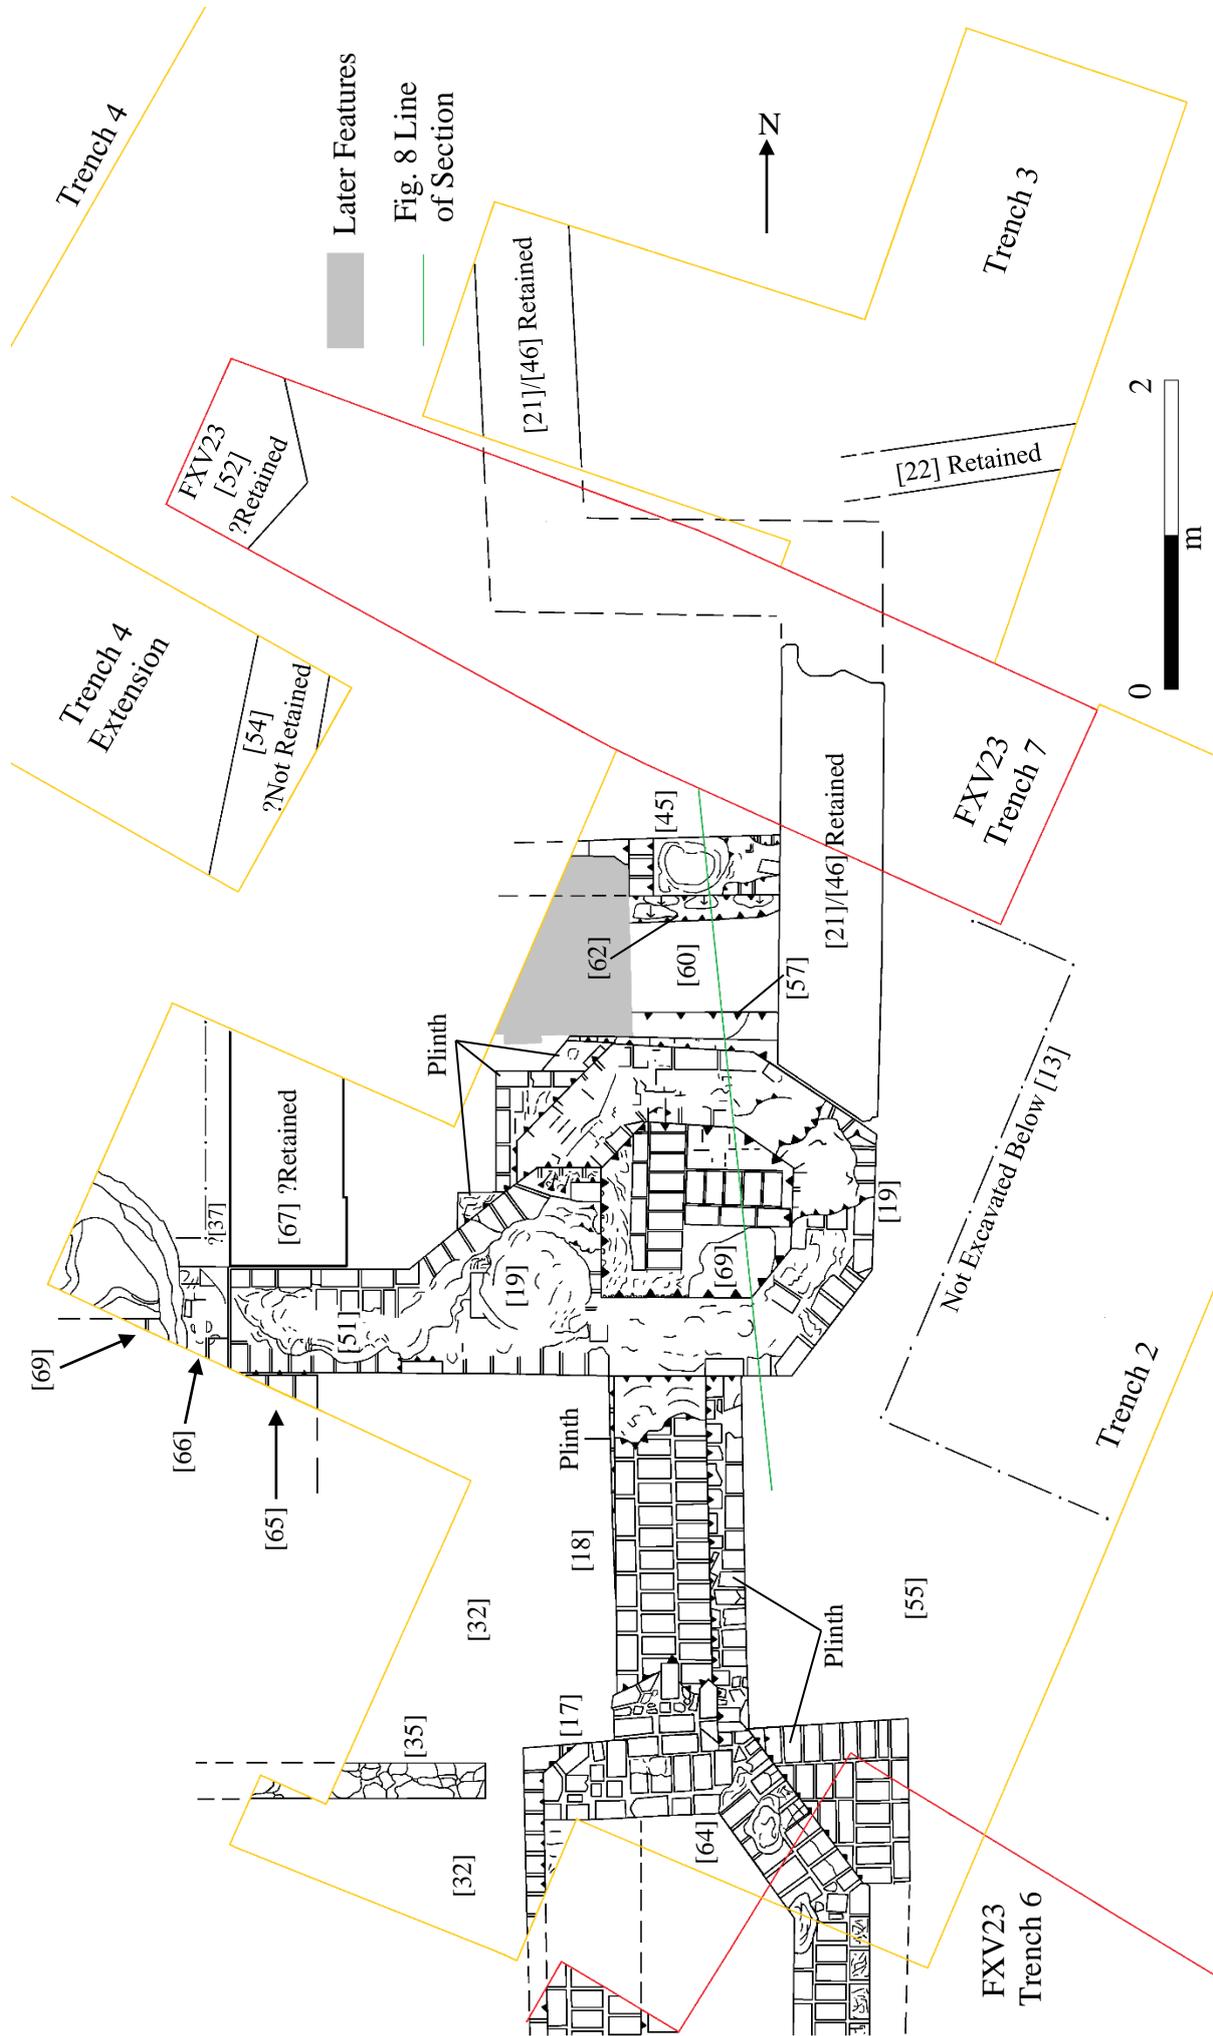
Fig. 7: Phase 2 Features in Trenches 2, 3, Trench 4 Extension and Fully Excavated Parts of FXV23 Trench 7

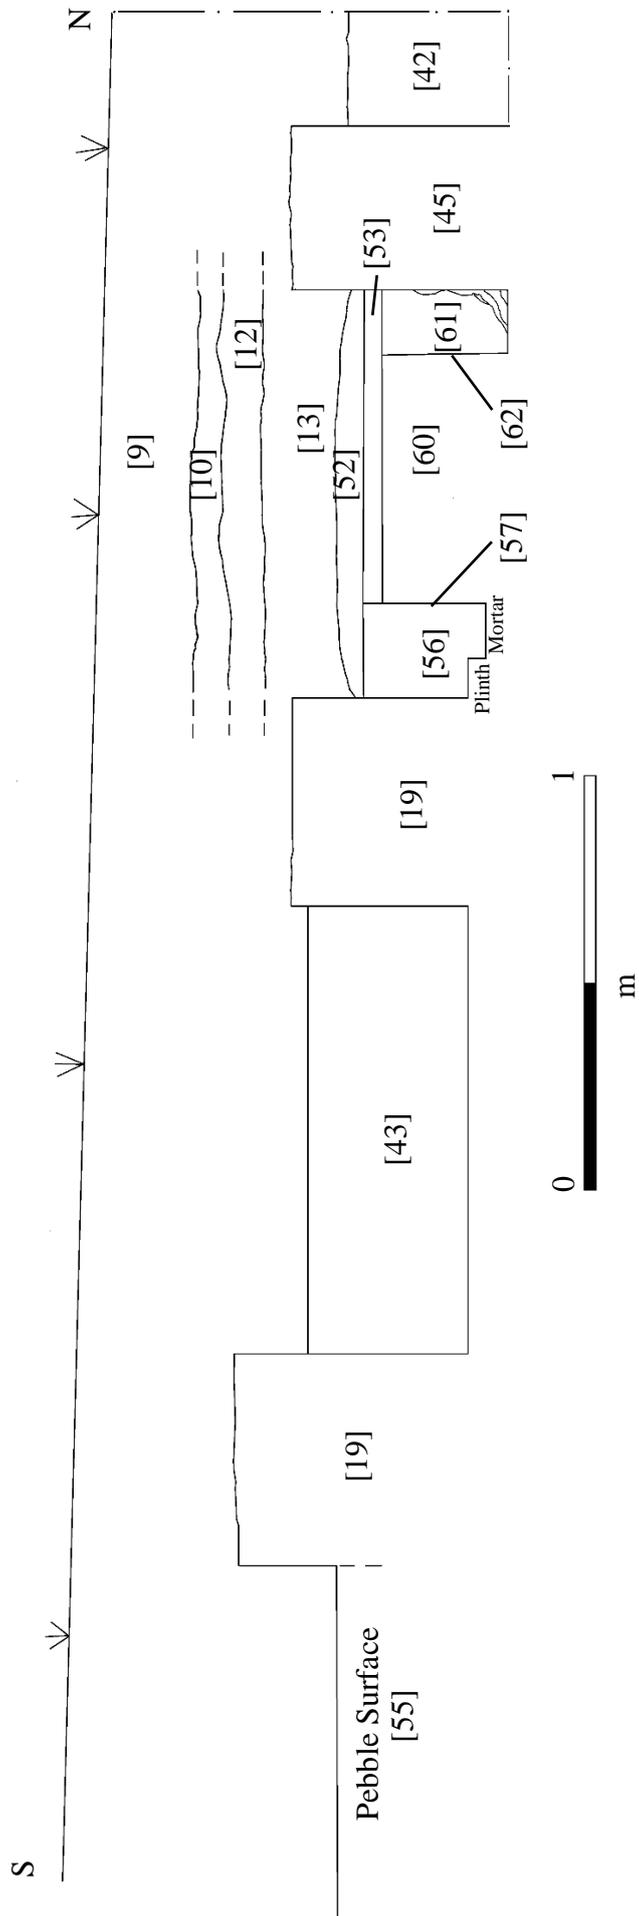
Fig. 8: Composite Schematic Section Across the North End of Trench 2 (for Location see Fig. 7)

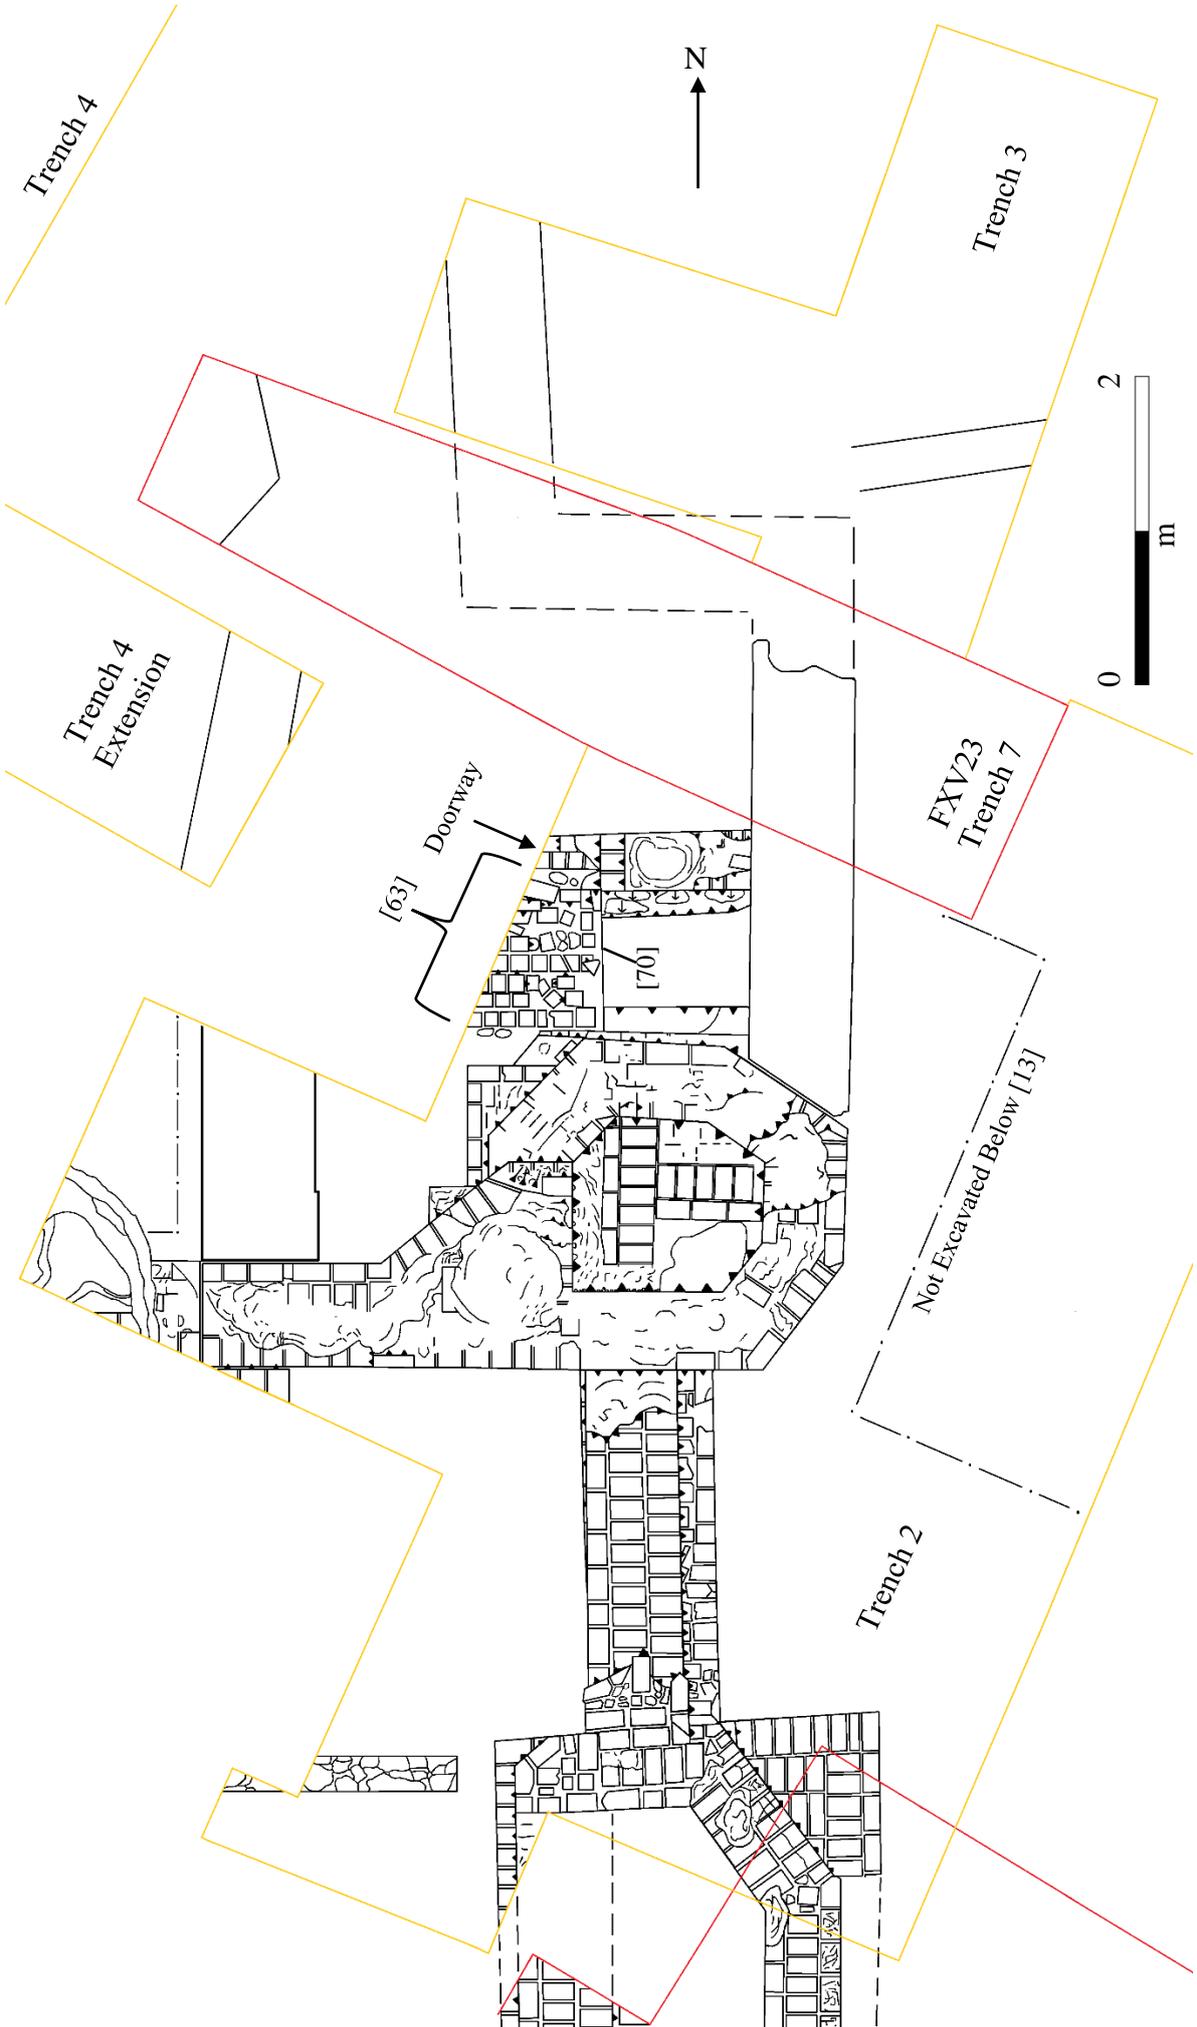
Fig. 9: Later Phase 2 – 4 Features in Trenches 2, 3, Trench 4 Extension and Fully Excavated Parts of FXV23 Trench 7

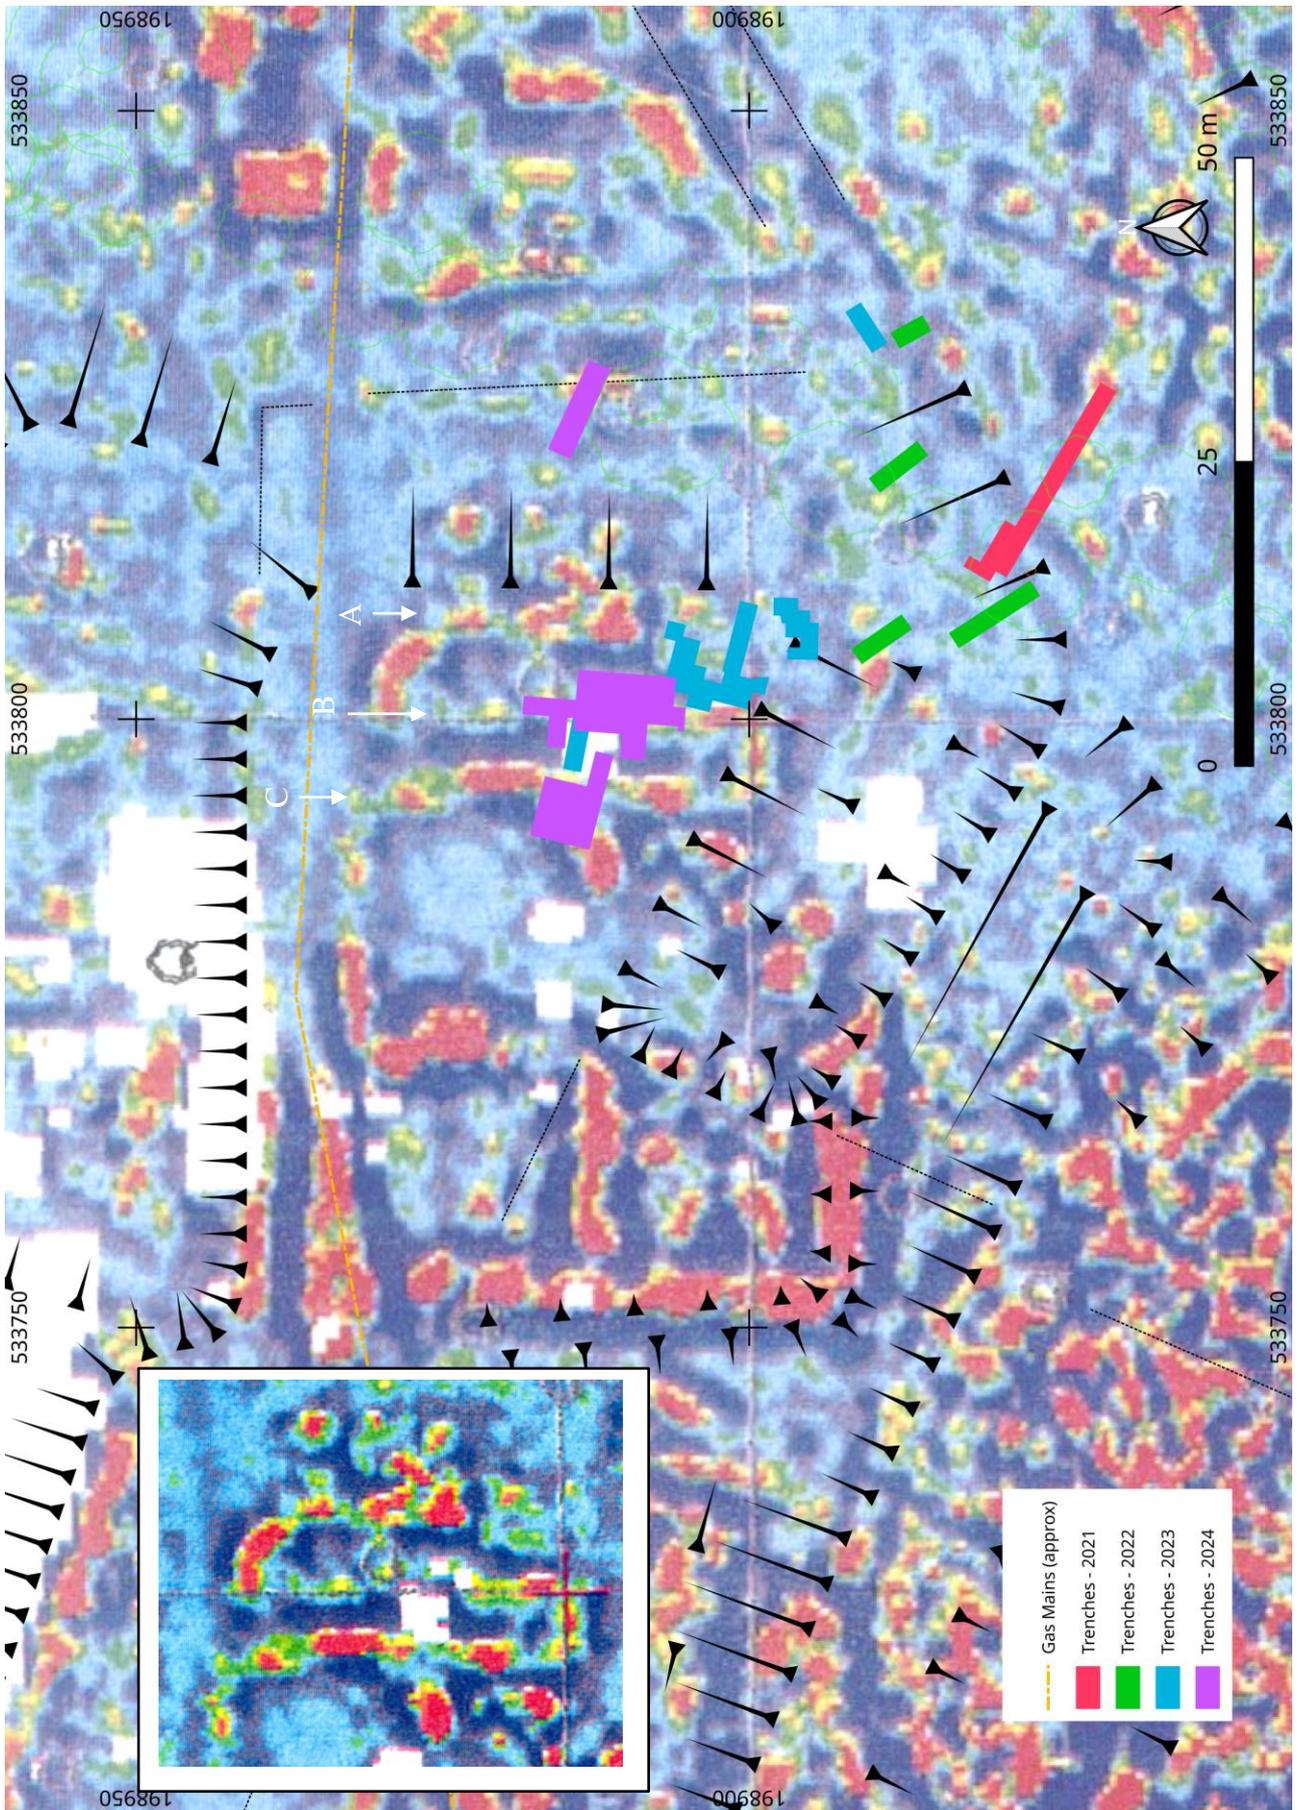
Fig. 10: Extract from Bartlett (1998) Plan 4 (Inset) and Superimposed on LiDAR Evidence (from Pinchbeck 2013) and 2021 – 2024 Trench Locations
 N.B. Superimposition has been Achieved by use of the OS Grid on Bartlett Plan 4 Which is Believed to be Imprecisely Positioned

(Fig. 10, A, B and C) running approximately north south are clearly present on the raised platform area¹³ and if the more easterly has been displaced around 6.80 m to the east by errors in tying the survey to the OS grid then it would provide a good match for excavated structures/rubble deposits, especially in Trench 2 of the current work. Moreover, its position in relation to site topography as mapped by LiDAR cannot match excavated evidence which indicates that there was nothing to cause such a band of high resistance readings at the eastern edge of (rather than several meters back on to) the raised platform, which is where this band of readings was originally plotted. One might even speculate that turret [19] is causing one particularly prominent high resistance anomaly in this band of responses which die away south of it in an area where excavation has shown far less if any rubble and less massive brick constructions.

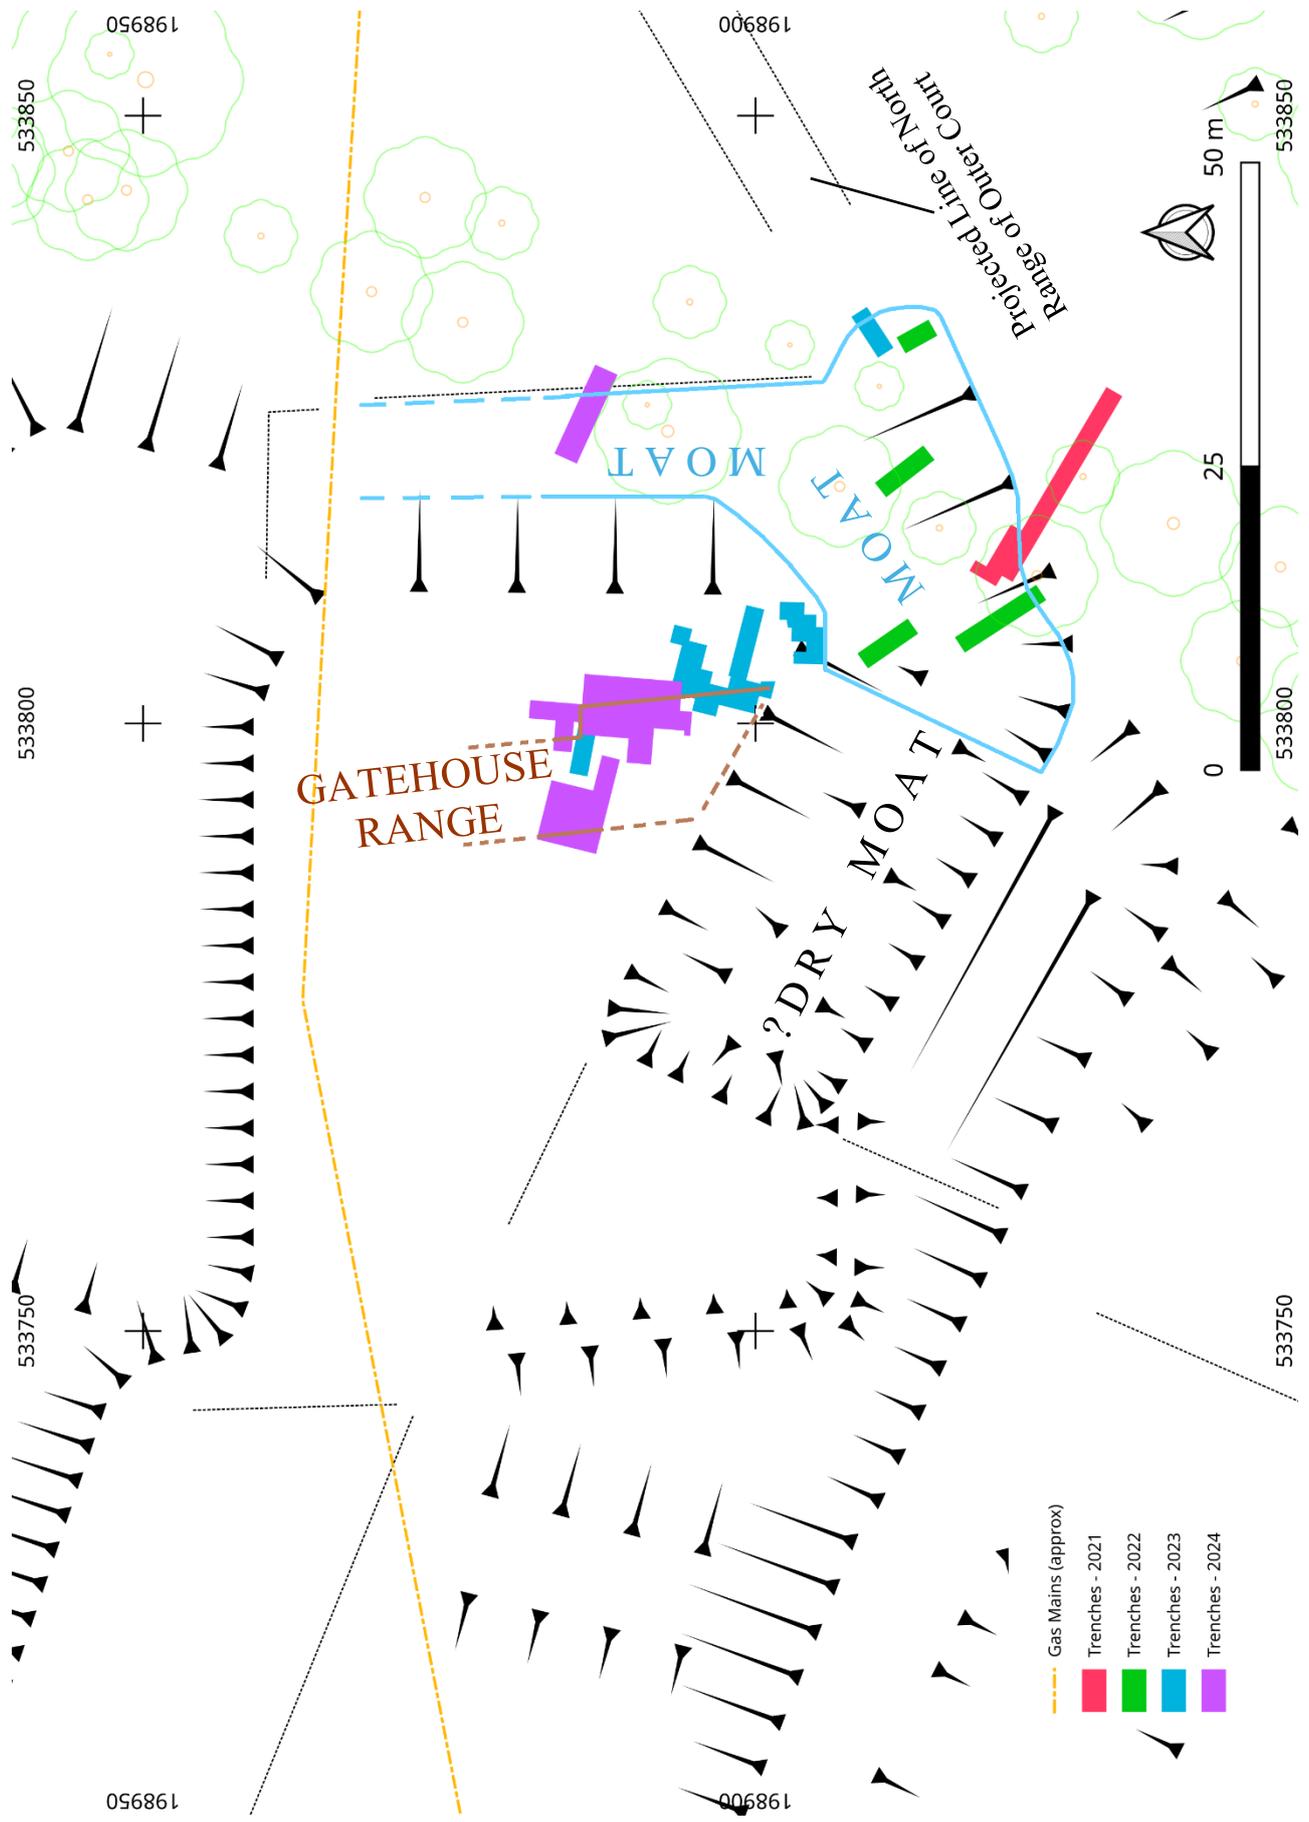
Fig. 11: Suggested General Site Plan
