ENFIELD ARCHAEOLOGICAL SOCIETY ARCHIVE REPORT

EXCAVATIONS AT ELSYNG PALACE, FORTY HALL, ENFIELD, MAY AND JULY 2024

(SITE CODE FXW24)

by
MARTIN J. DEARNE

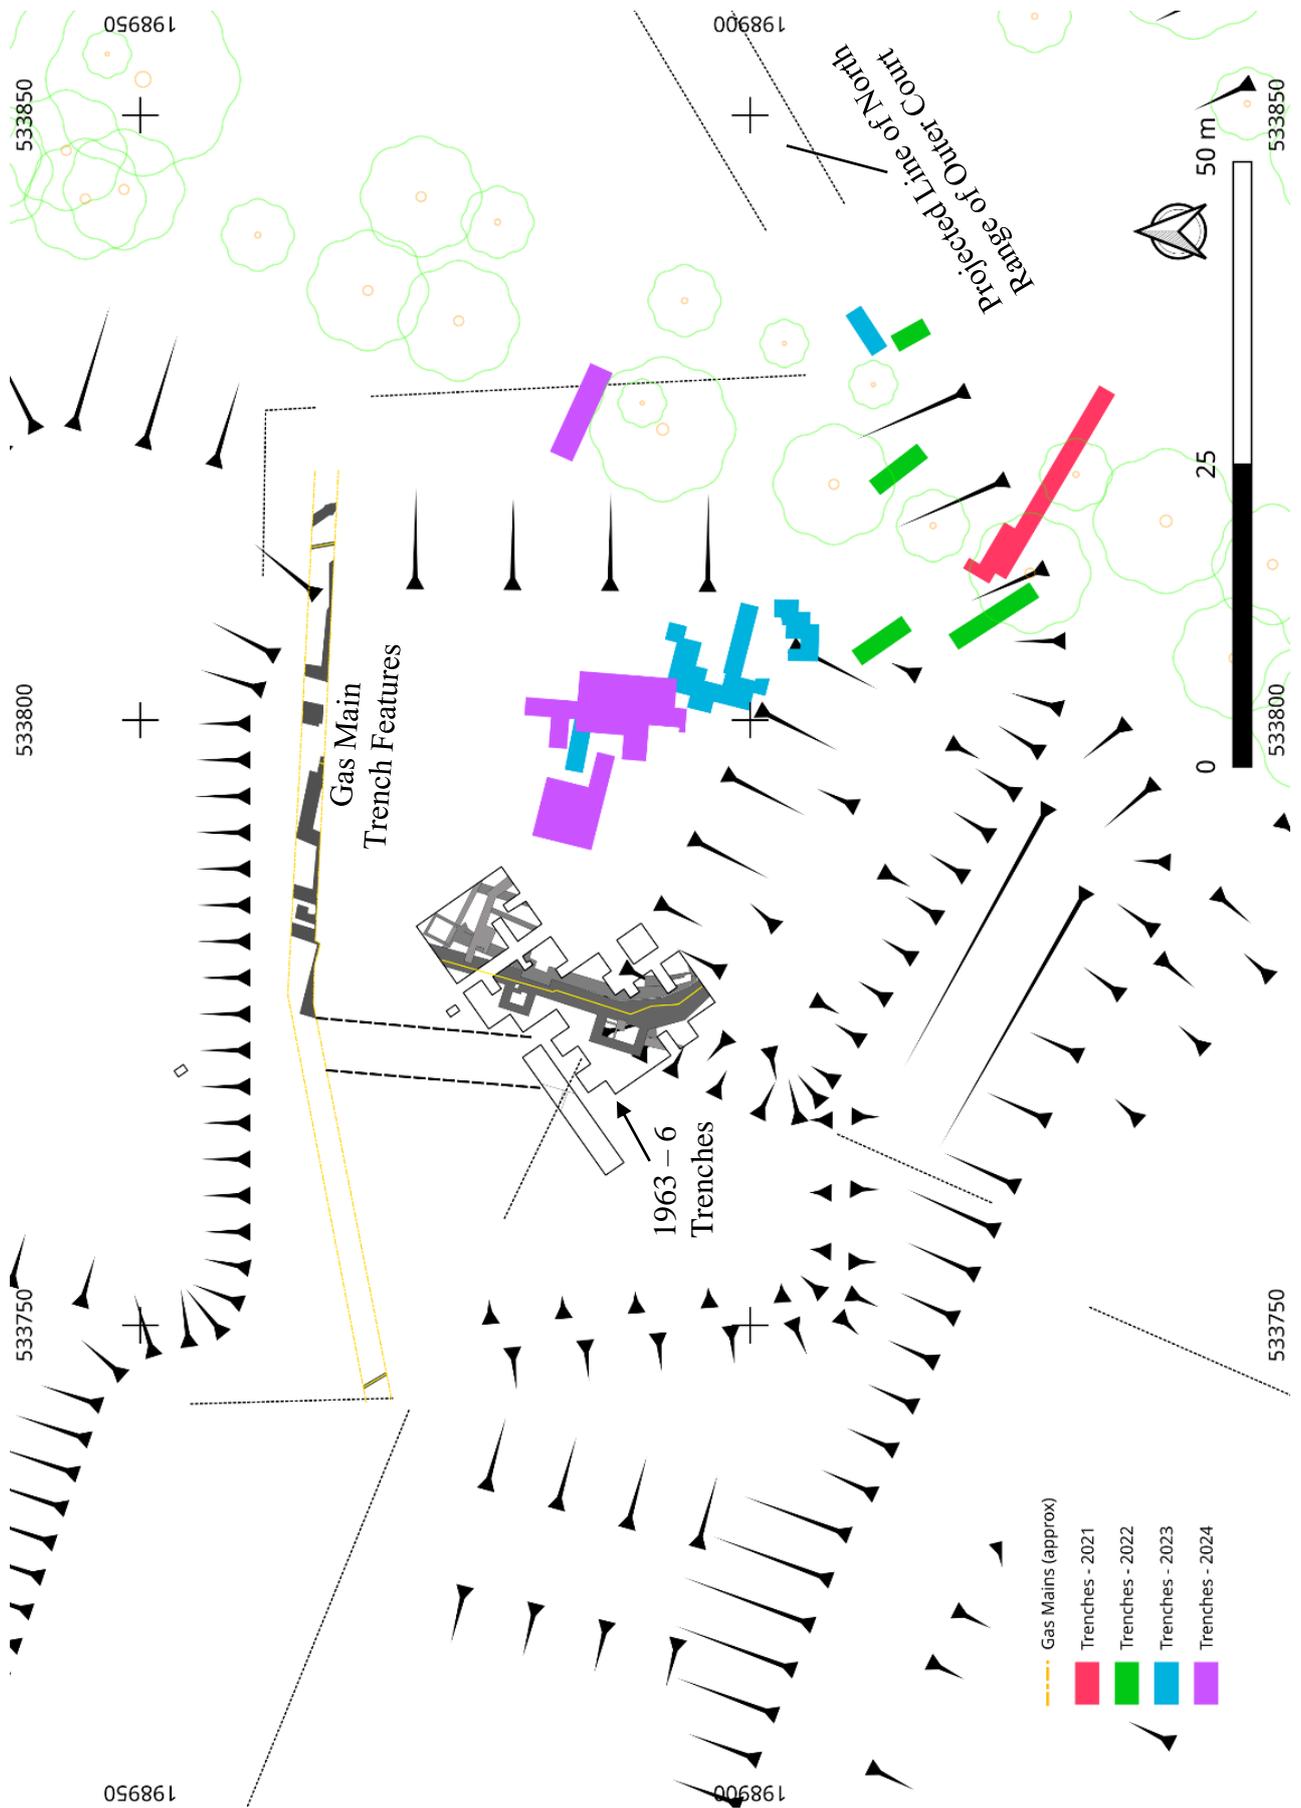
Fig. 12: FXW24 Trenches in Relation to Earlier Work, LiDAR Recorded Topography and Best Fit Locations for 1963 – 7 Excavations; and the Features Recorded in the 1967 Gas Main Trench (from Dearne and Drury 2022, Fig. 1)

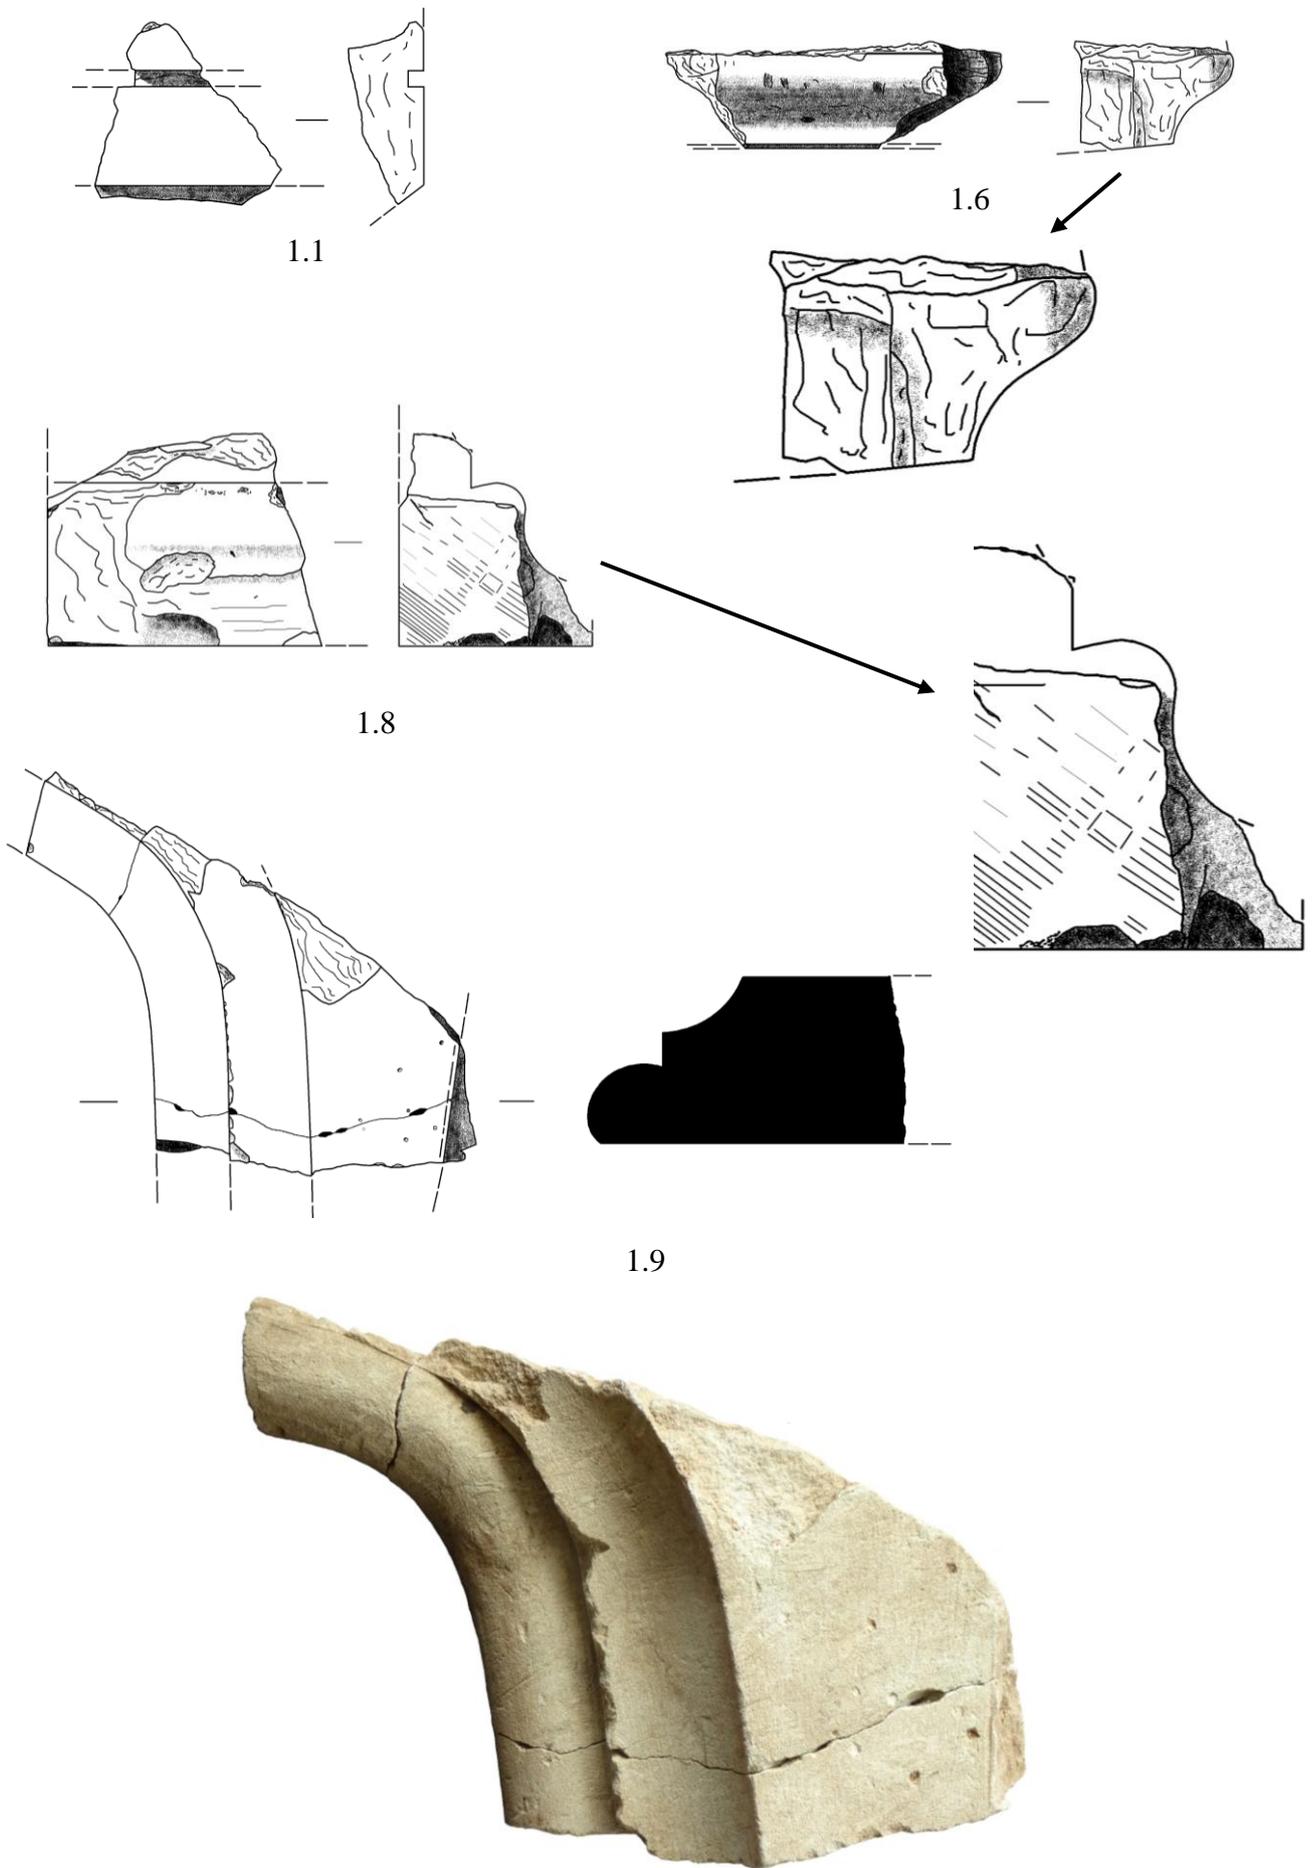
Fig. 13: Building Stone (Main Drawings 1:4, Enlargements Not to Scale), Photo Ian K. Jones

- *1.6 Fragment of Greensand from the external side or top of a window frame (L. 15.70; W. 6.70; Th. 5.20 cm). Broken just beyond the top of a reverse ogee (cyma reversa) moulding with some toolmark damage and considerable weather abrasion on the convex element. Concave element and surviving area of flat and smoothed 3.20 cm wide base less weathered. Fairly roughly finished back face. [13].

- *1.8 Fragment of Greensand from one end of a lintel from the exterior of a doorway or a large window (L. 12.58; W. 9.39; Th. 9.00 cm). Top of the block lost and upper moulding element(s) badly damaged, leaving only a surface trace of a shallow concave moulding, below which a vertical surface runs down to the beginning of a damaged reverse ogee (cyma reversa) moulding. A further probable moulding below this is entirely broken away, but ended in a short vertical surface running down to the base of the block. The end face has clear claw chisel marks, but the base of the block is generally smoothed. [13]

- *1.9 Three joining fragments of Greensand forming the top right hand corner of a fireplace surround (Ht. 18.00; W. 20.00 Th. 8.00 cm). Rounded corner from an almost flat arch which would originally have had a horizontal top below a (wood or stone) lintel. The block is broken at the top, bottom and, at the right hand edge, just beyond a vertical line marking the beginning of an uncertain continuation of the mouldings which otherwise comprise three elements. A well finished, flat, 6.27 cm wide face (but with several small holes made by a pointed tool) is flanked to its left by a 3.68 cm wide cavetto moulding, 1.37 cm proud of (at the left hand edge) a smoke stained, slightly asymmetrical, 3.52 cm wide quarter round (ovolo) moulding which runs back to (and whose face is up to 3.80 cm proud of) the faintly smoke stained, roughly finished rear face of the block. The style is typical of late Medieval (fifteenth century) fireplace forms and the high standard of the finish may suggest an origin in a high status room. [13]

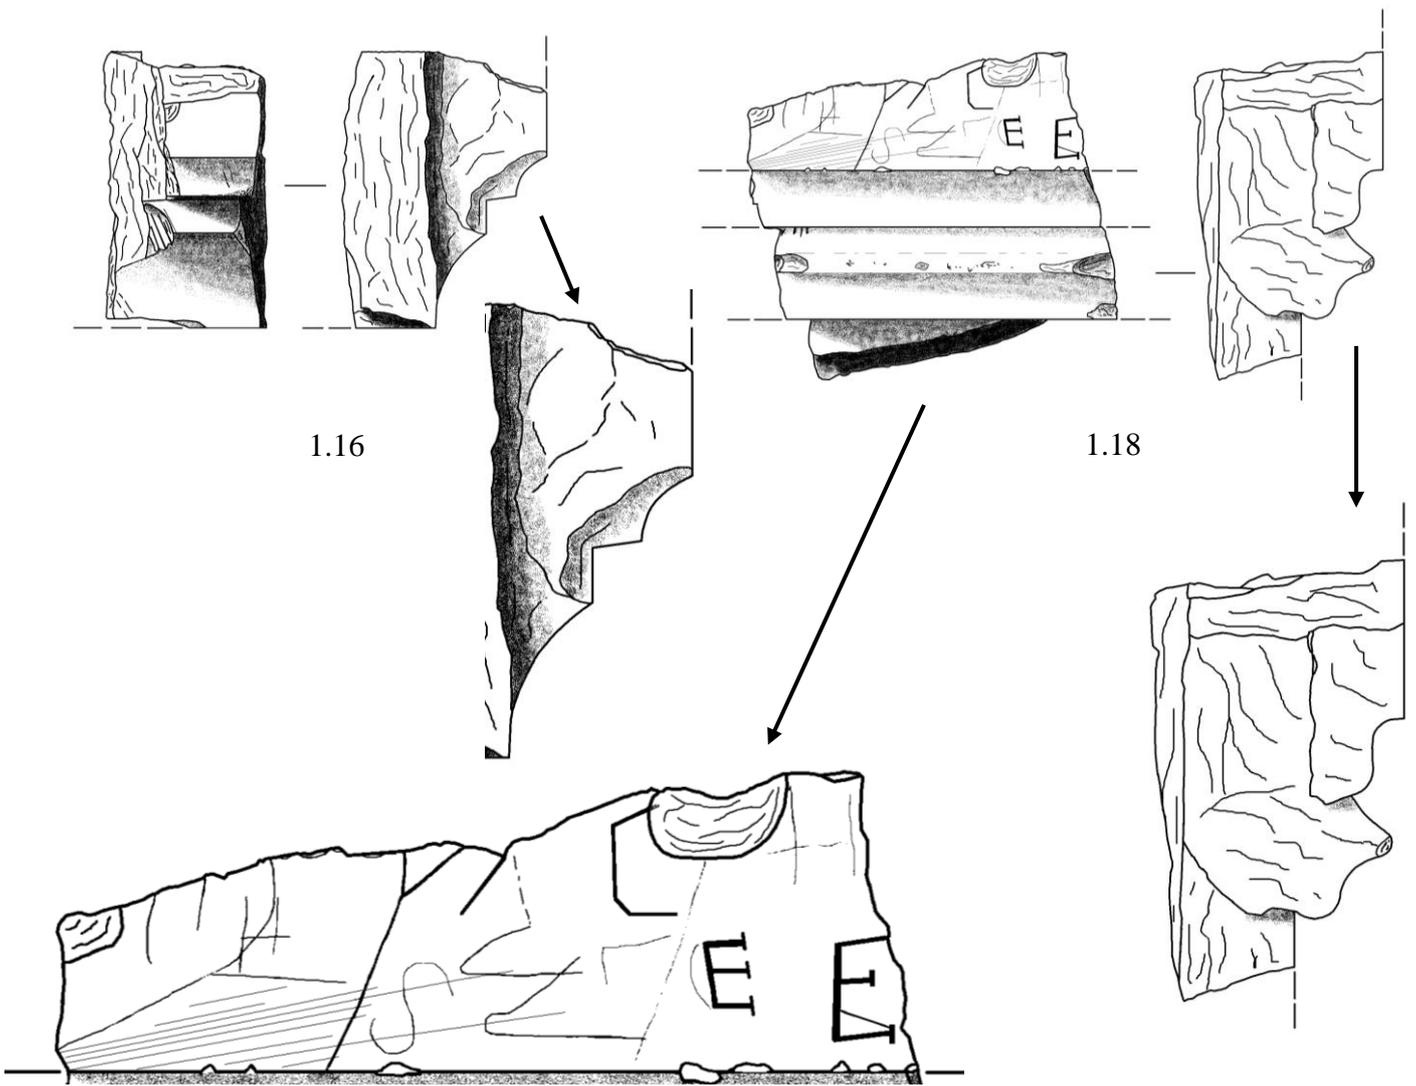
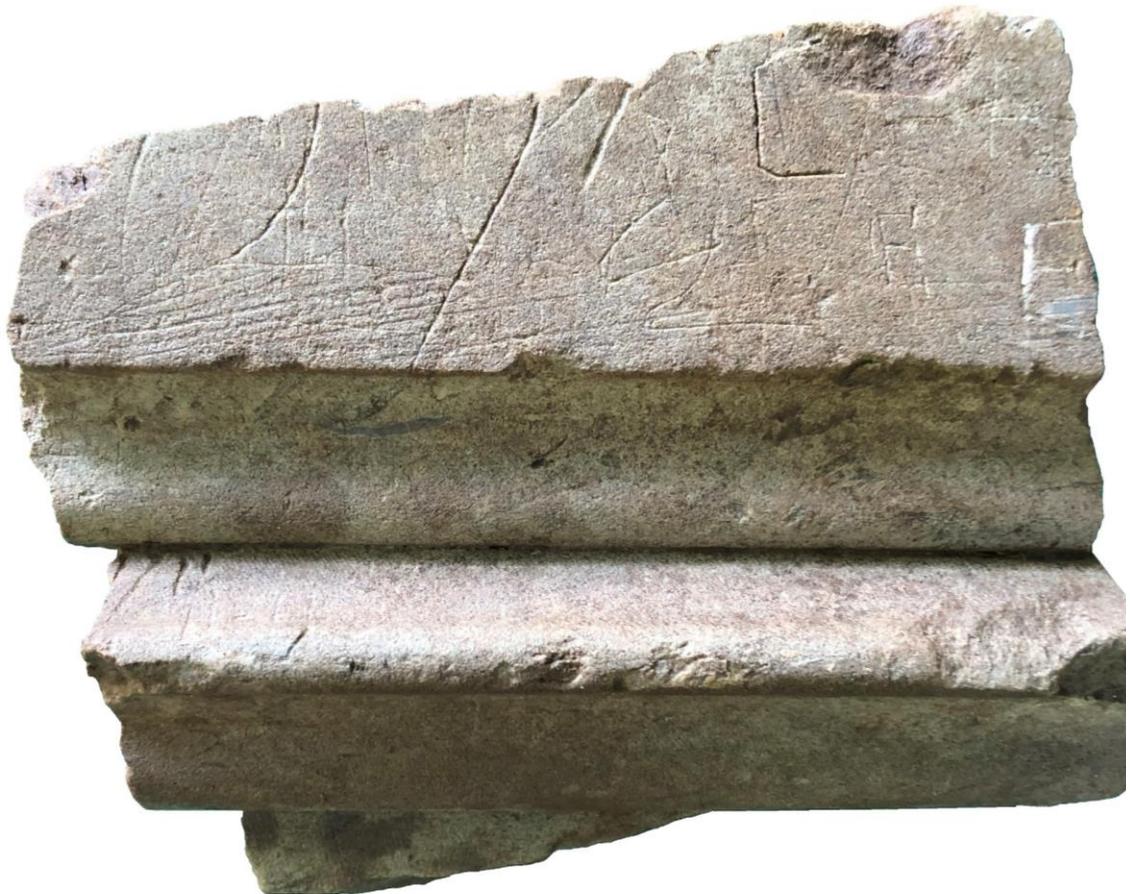
Fig. 14: Building Stone (Main Drawings 1:4, Enlargements Not to Scale), Photo John Pinchbeck

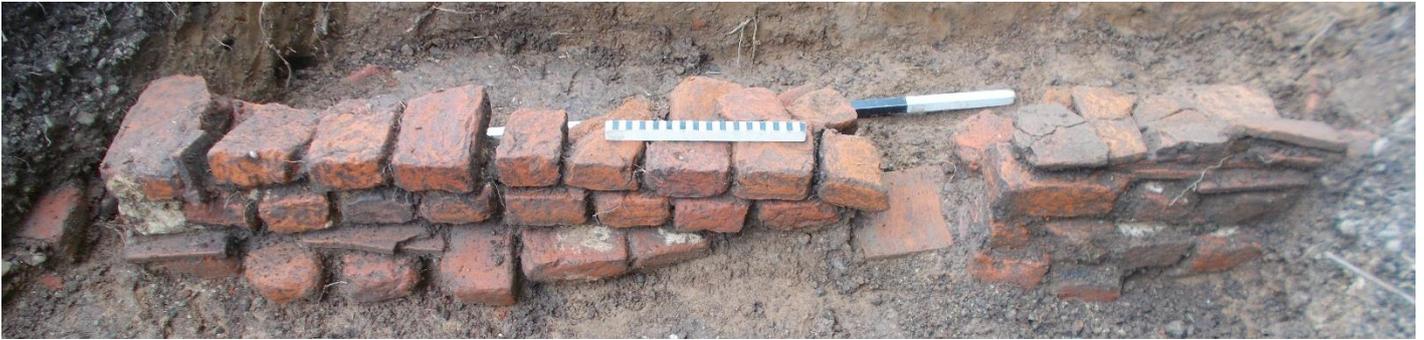
Pl. 1: Wall [4], Looking East (photo MJD)

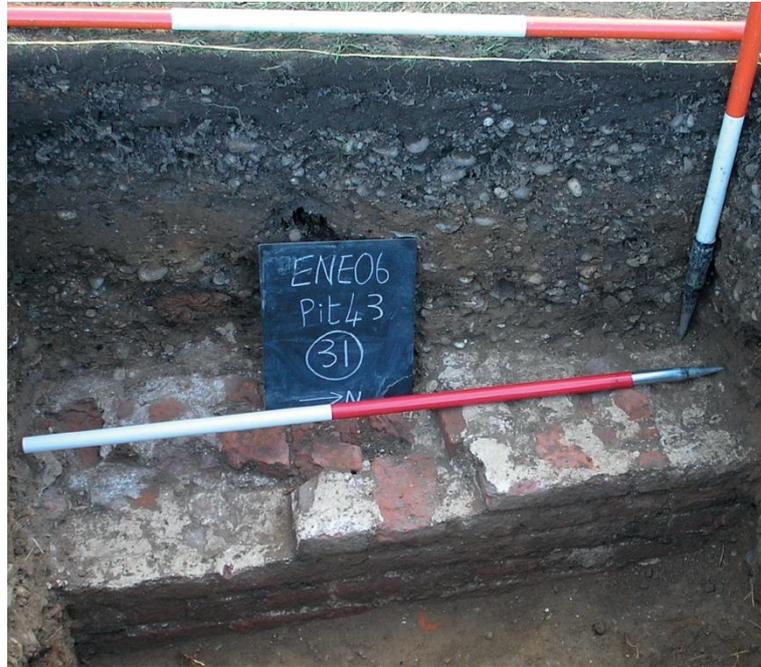
Pl. 2: ENE06 Pit 43, Wall [31], Looking West (Photo MJD)

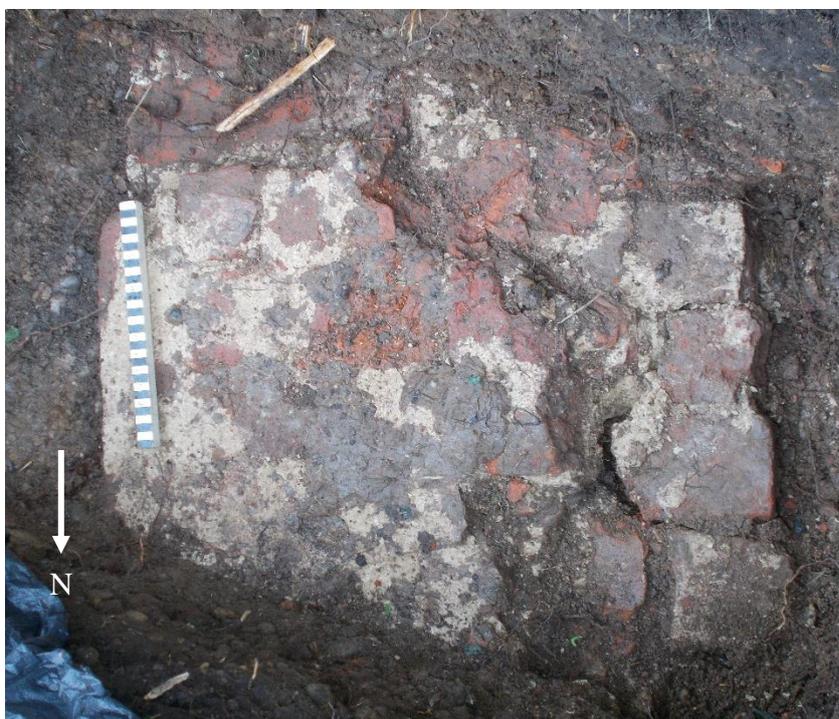
Pl. 3: Re-excavtion of Wall ENE06 [31] (photo MJD)

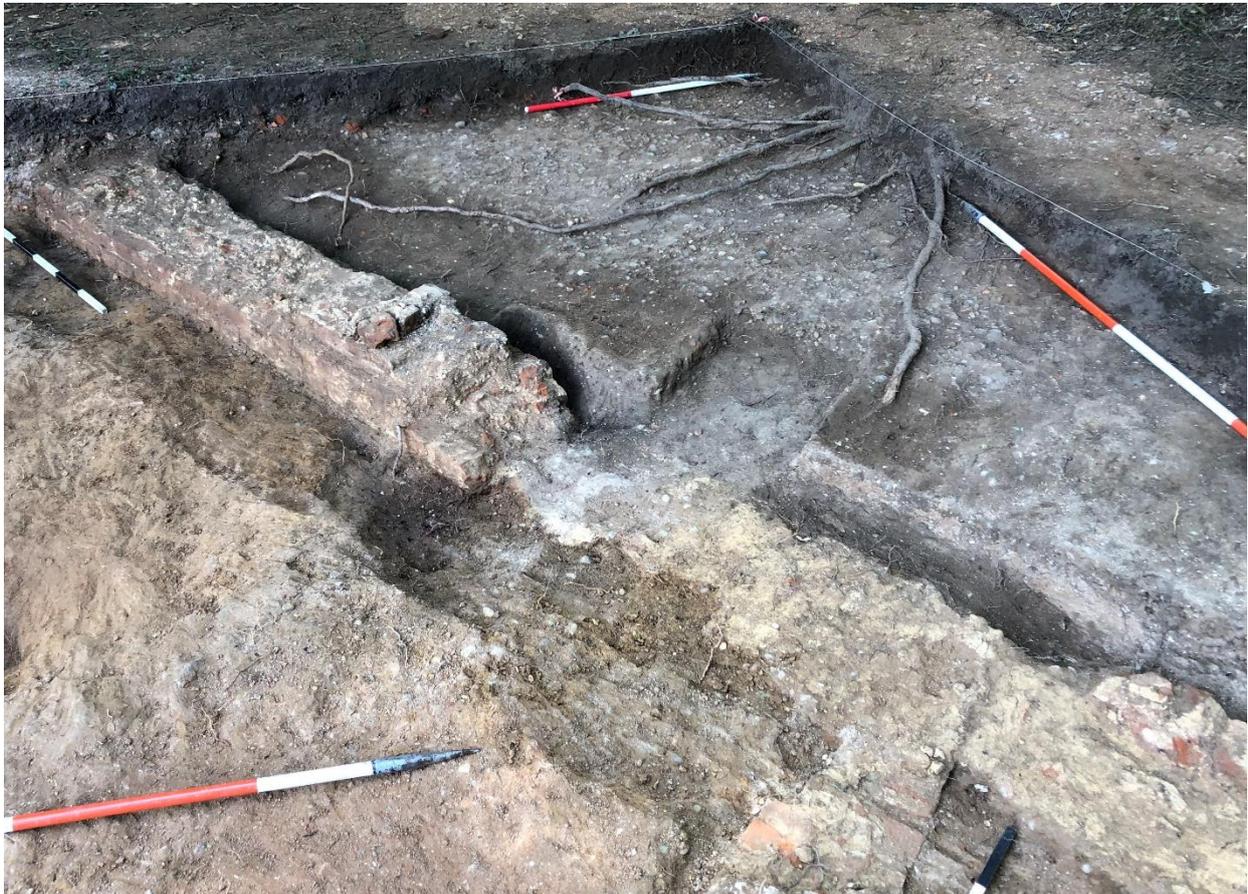
Pl. 4: Wall [30], Surface [29] Beyond it and (Bottom Right) Wall [36] with the Fill of Cut [44] Partly Excavated, Looking South West (photo John Pinchbeck)

- Its western presumed external wall, [30] (Pl. 4), had been heavily demolished in Phase 5a and survived in the north of Trench 4 as no more than a basal layer of soft sandy yellow mortar and further south to only a maximum of four courses (c. 0.30 m) of similarly mortared English bond brickwork. The wall, 0.49 m wide including a possible 0.06 m wide external offset, had been built over [37] with no obvious foundations (though a rubble in trench foundation below it cannot be discounted as the surviving wall was too unstable to allow more than limited excavation beside it) and ran south east to north west across Trench 4 for 6.10 m.

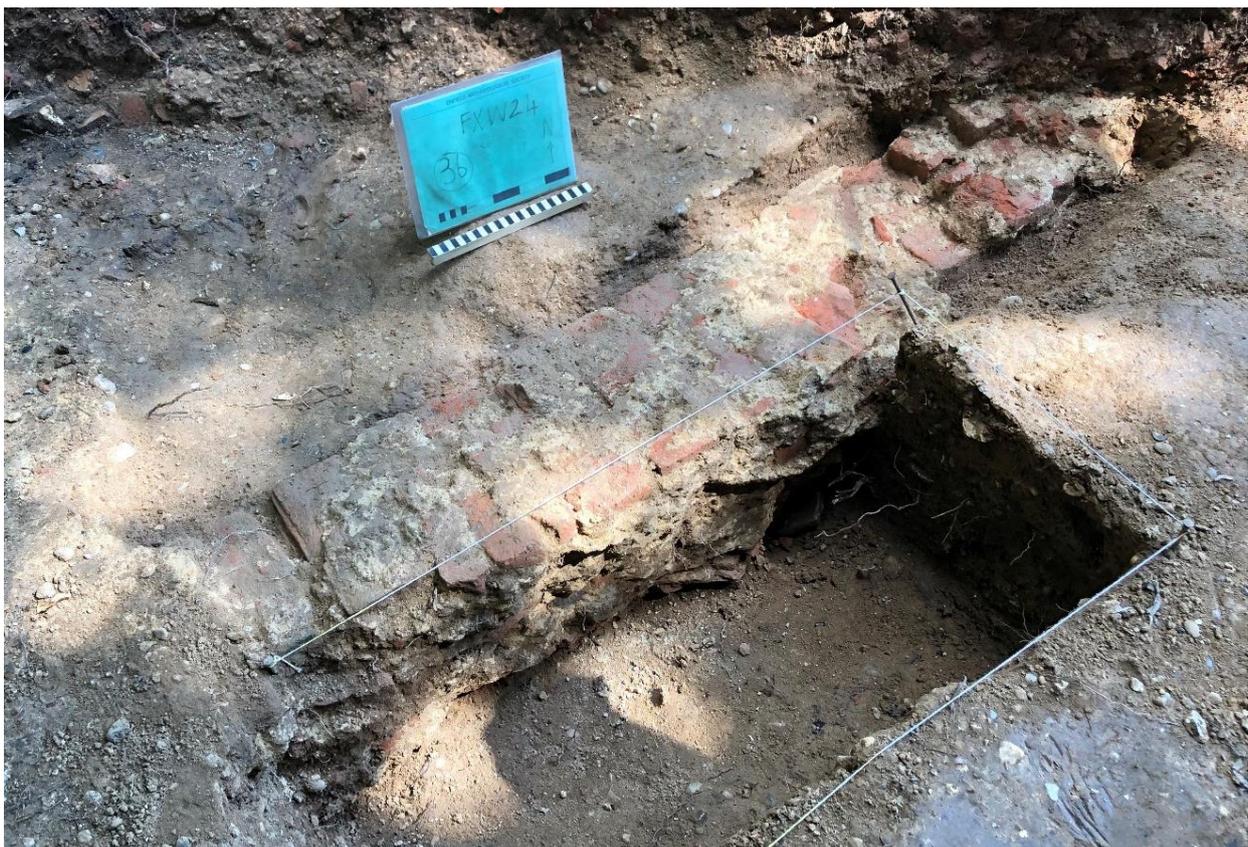
Pl. 5: Wall [36], Looking North (photo John Pinchbeck)

- A slightly better preserved partition wall, [36] (Pl. 5), ran north east from [30] and indicated the existence of at least two rooms on the west side of the building (Room 1 to its north and Room 2 to its south). The wall, 0.33 – 0.35 m wide (possibly broadening a little as it ran north east) and 1.90 m of which was within Trench 4, had been built on a 0.41 m deep rubble in trench foundation of roughly coursed brick fragments/part bricks and peg tile fragments in soft yellow sandy mortar no wider than the wall itself, which at most only survived to one header lain course of marginally creased bricks and part bricks.

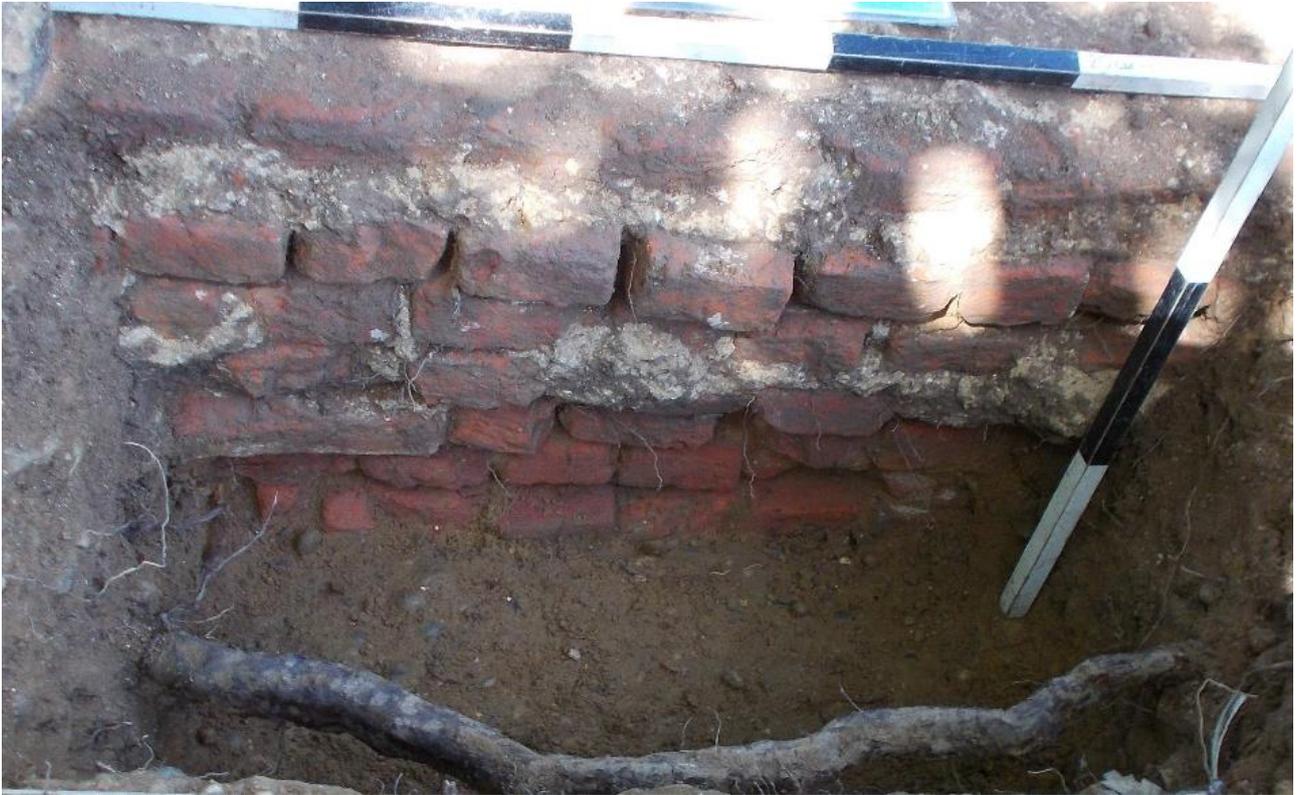
Pl. 6: East Face of Wall [21]/[46] in Trench 2 Showing the Rebuilding of the Upper Courses with Harder Whiter Mortar (photo MJD)

- The most clearly isolatable changes made to the existing Phase 1b structure appear to have involved the partial demolition and rebuilding of sections of its east wall (FXV23 [43] = FXW24 [21]/[46]) as first observed in 2023 (Dearne 2023, 11f). In the present work the evidence in Trench 2 (Pls 6 and 7) was for the wall (here [21]) having been demolished and rebuilt for a distance of 1.90 m north of the point where it was then truncated by new builds, so that taking the 2023 and 2024 evidence together an at least 3.15 m length of it had been demolished and then reconstructed using English bond and harder whiter mortar than the soft yellow/orange mortar and header ‘bond’ of the original construction, but not mortar as hard and white as that used in Phase 2 (i.e. a moderately hard buff/off white mortar).

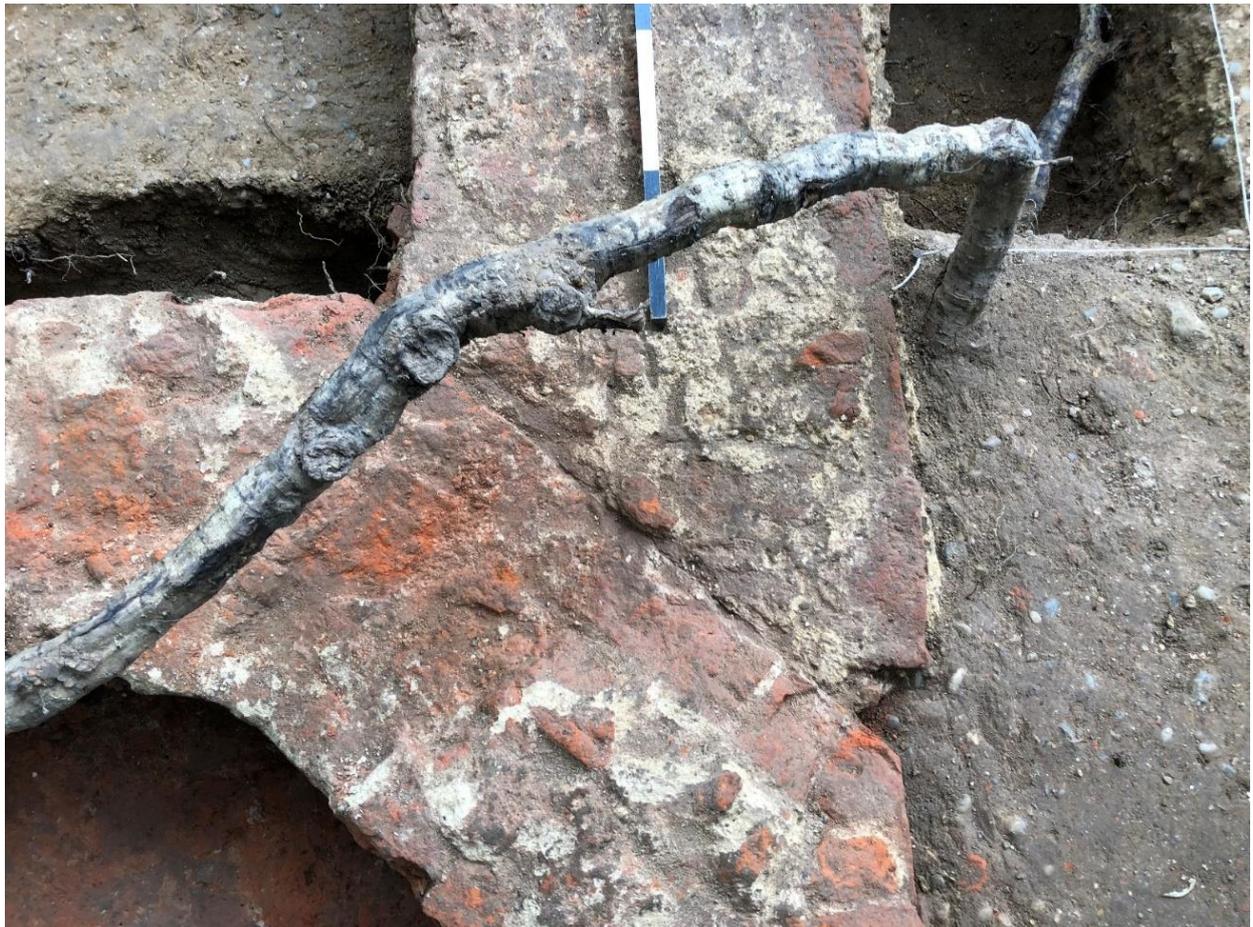
Pl. 7: Phase 2 Turret [19] Truncating Phase 1b/2 Rebuilt Wall [21]/[46] (Note Mortar Colour Difference), Looking North (photo John Pinchbeck)

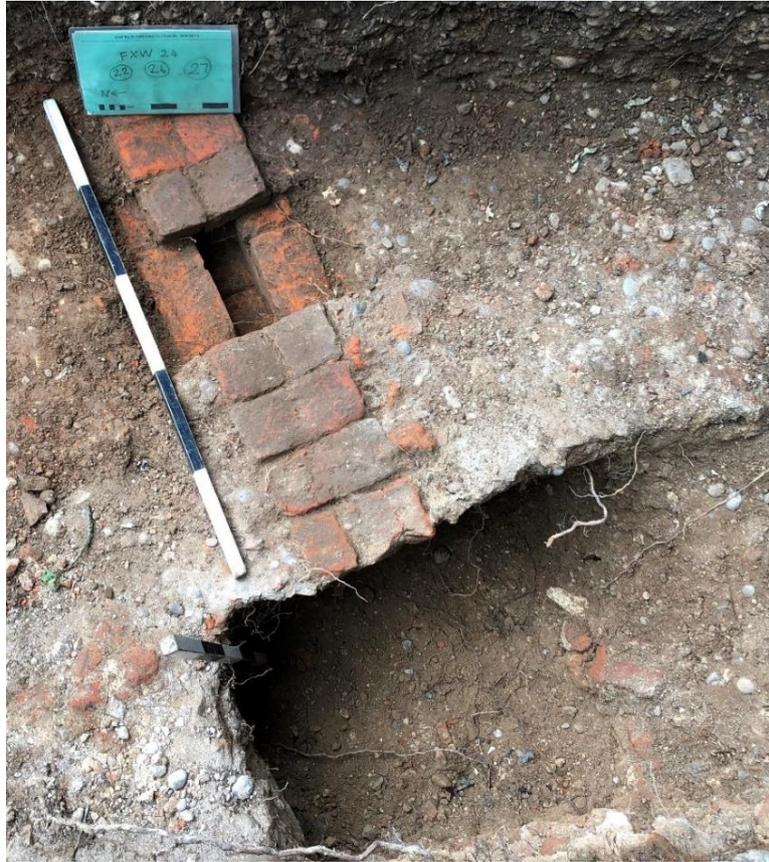
Pl. 8: Part Excavated Phase 5a Robber Trench [26] Truncating ?Phase 1b/2 Drain [22] (with Part of its Roof Removed) and Surface [24] to its Right, Looking East (photo John Pinchbeck)

- Part of this wall indeed had been found in 2023 to have been removed, at least to a far lower level than the rest of it (Dearne 2023, 11f), and the current work confirmed that this was a consequence of a Phase 5a robber trench ([26]) having been cut along the wall line. That cut indicated that wall FXV23 [43] = FXW24 [21]/[46] in fact described a dog leg immediately north of FXV23 Trench 7/within FXW24 Trench 3, turning west for 1.90 m before again turning north, where its deeply demolished surviving upper surface was encountered at the limit of permitted excavation in Trench 3 (though it was demolished throughout to a soft sandy yellow mortar surface largely obscuring the wall’s brickwork).

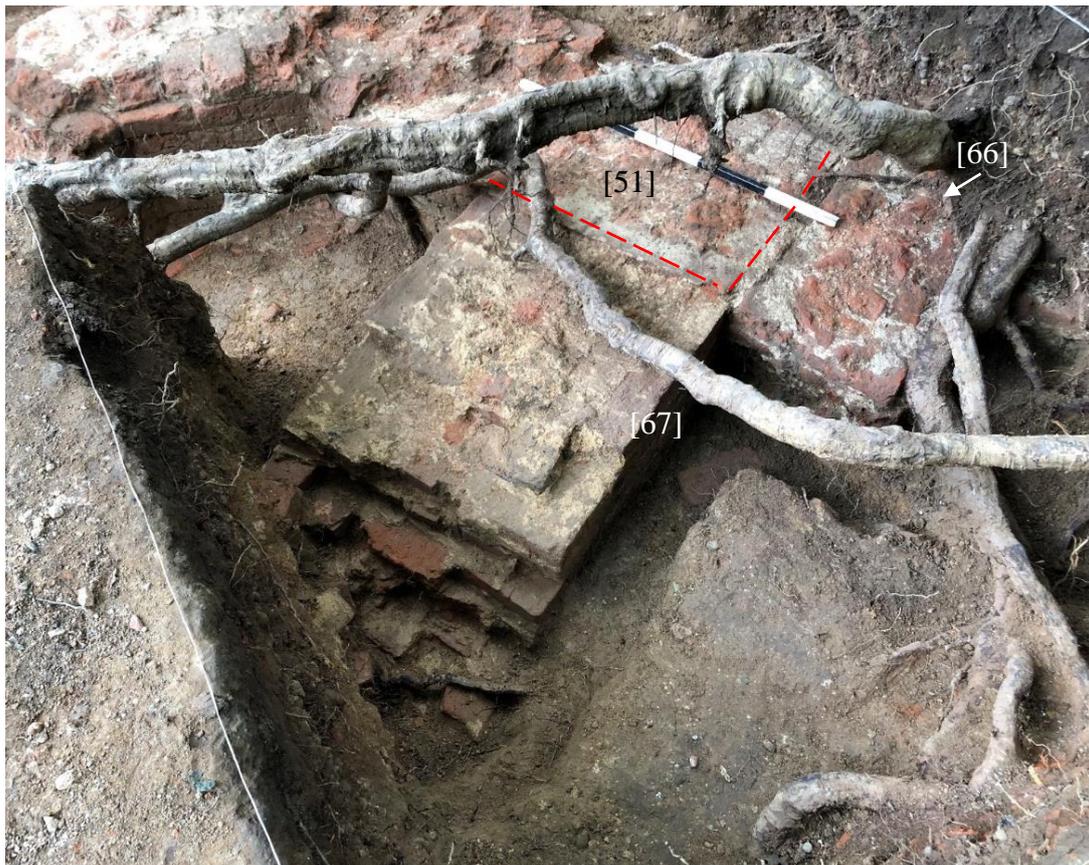
Pl. 9: Wall [67] (Foreground) Meeting Wall [51] with [66] to the Right of [51] (Note Mortar Colour Difference), Looking South (photo John Pinchbeck)

- Though it was not possible to fully understand the sequence at the west side of the probable Phase 1b cellar and Room 3 (see above), the most likely scenario appears to be that, at least towards its south end, a new west wall, [67], had been built which probably decreased the size of the cellar but made it a more rectangularised space. That this belonged to some point before the wider construction work of Phase 2 and wasn’t part of that scheme, and so not directly connected to the probable decommissioning of the cellar but a replacement east wall for Room 2, rests only on the, relatively small, difference in the mortar used compared to e.g. adjacent (Phase 2) wall [51] (Pl. 9); so its allocation to the Phase 1b/2 Modifications must be tentative. Equally whether what seems to have been the original west wall of the probable cellar, [54], was retained, in whole or part, or not it is impossible to say. But in Trench 2, only 0.90 m to the south of the one exposure of [54] obtained, [67] ran on a different alignment to it and one

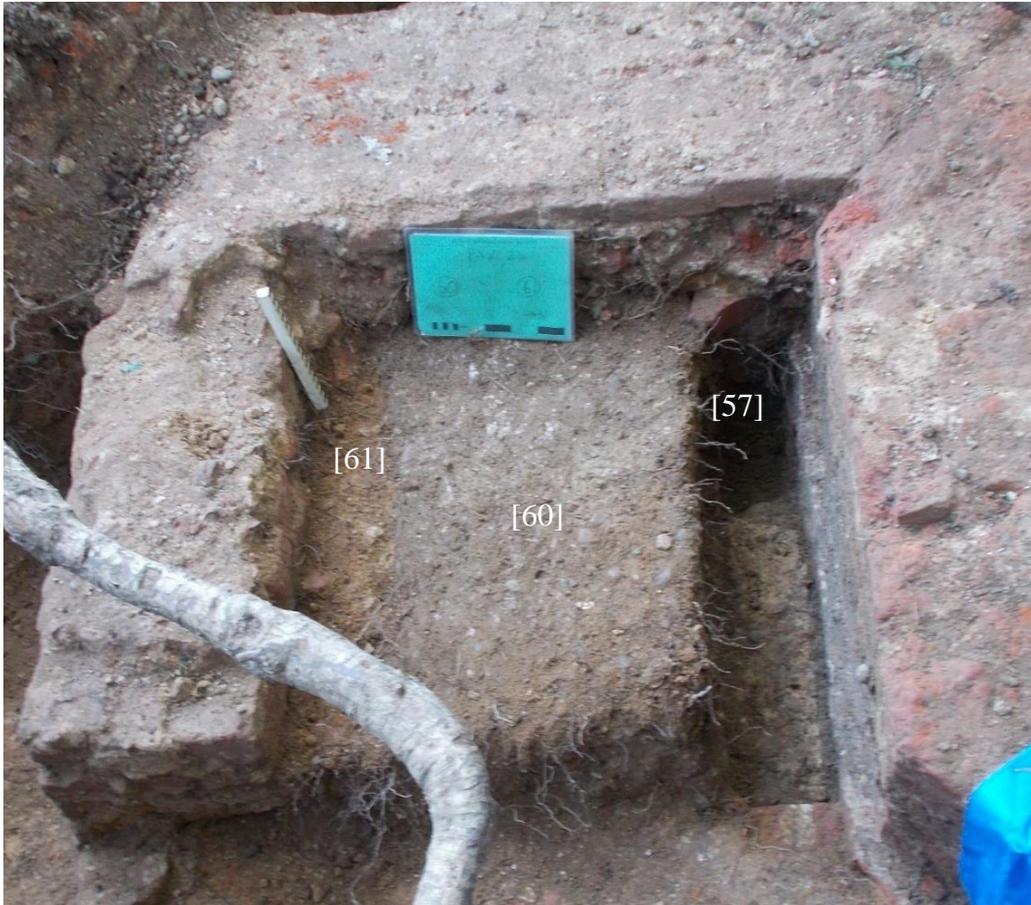
Pl. 10: Construction Trench [57] (to Right beside turret [19] with its Foundation Raft Projecting) Fully Excavated, Cutting Dump Deposit [60] and with the Unexcavated Fill ([61]) of Construction Trench [62] to the Left against Wall [45] with Wall [21]/[46] at Top Truncated by [19], Looking East (photo MJD)

- The construction trench itself was backfilled with [61], a loose, very sandy, yellowish brown (7.5 YR 5/6) deposit mottled with mortar smears and with moderately frequent brick fragments to 0.05 m and frequent chips and fragments (to 0.04 m) of white mortar. It had been capped off with a 0.04 m thick layer of [53], a fairly loose deposit of rounded pebbles (0.005 – 0.035 m) and pea shingle in a dark yellowish brown (10 YR 3/4) matrix of gritty, clayey silt that also covered the rest of [60].

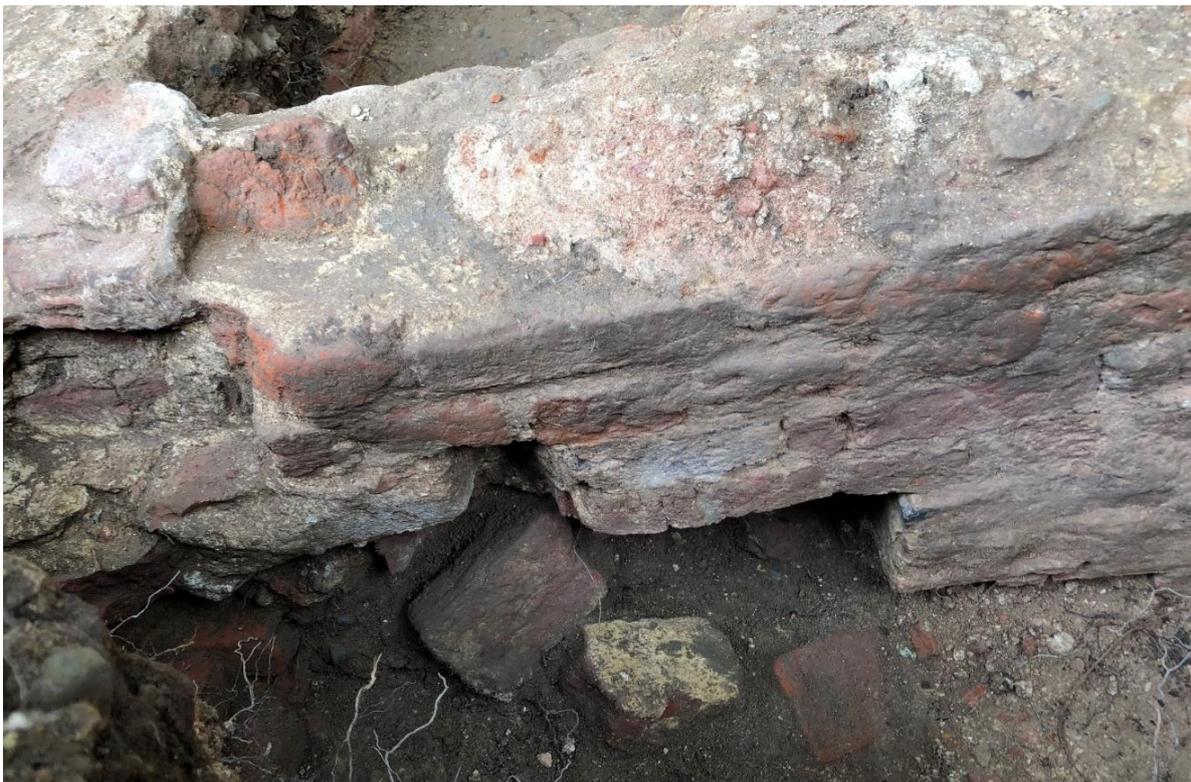
Pl. 11: The North Face of Phase 2 Wall [45] Showing the Void in its Lower Courses (Loose Bricks Within Phase 5a Rubble [42]) with Wall [21]/[46] to Left (photo John Pinchbeck)

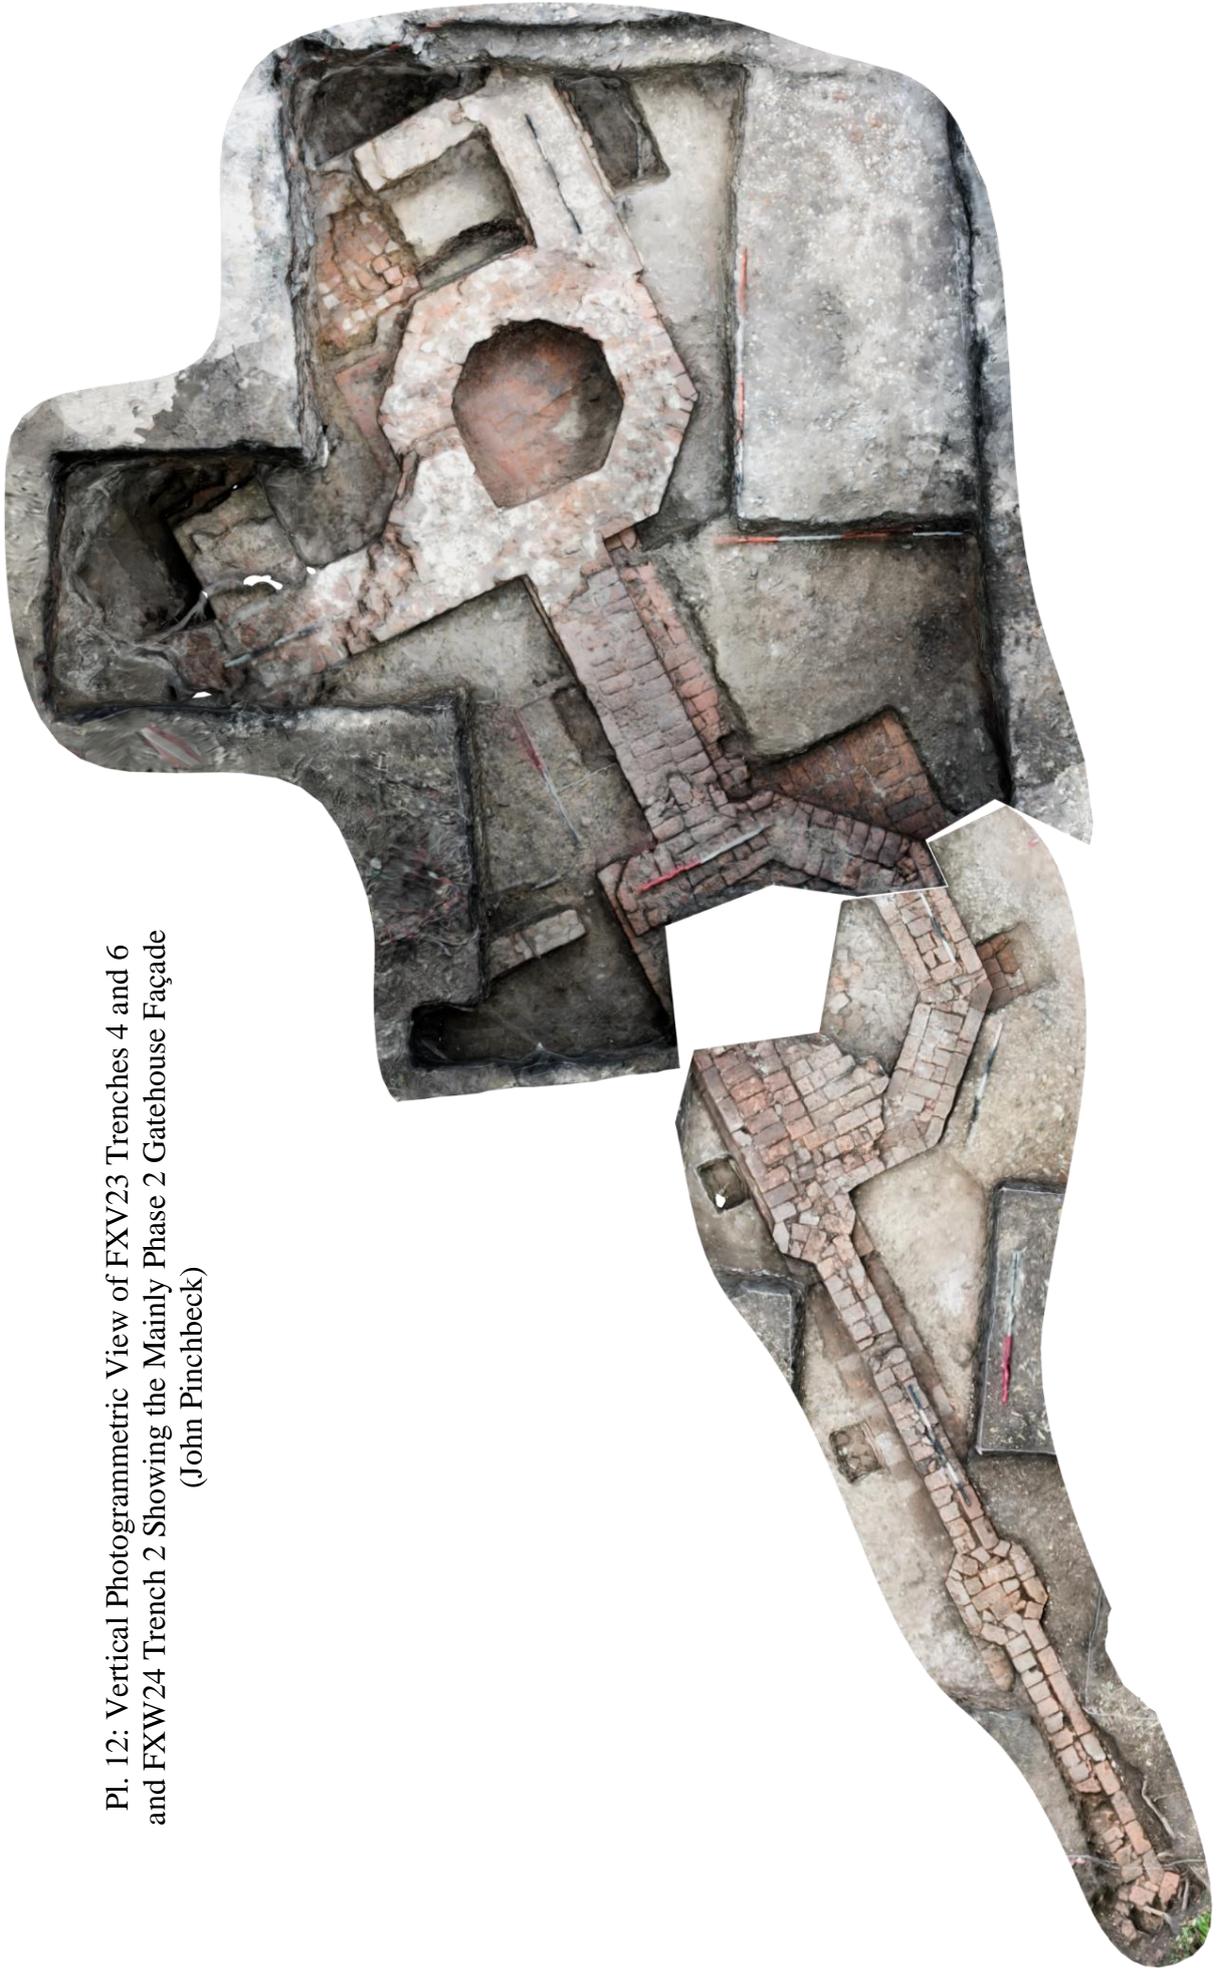
Pl. 12: Vertical Photogrammetric View of FXV23 Trenches 4 and 6
and FXW24 Trench 2 Showing the Mainly Phase 2 Gatehouse Façade
(John Pinchbeck)

be consistent with the building being extended as well as remodelled at this time. Certainly a complex of walls and features running around 13.50 m south from where one if not two of the walls of the Phase 1b building (the Phase 1b/2 Modifications rebuild of the east external wall and maybe the ?Phase 1b/2 Modifications wall [67] on the west side of the probably cellared Room 3) were truncated had been solidly constructed and indicate the building of a substantial multi storey structure requiring deeply founded and fairly broad walls and with an ornamental façade (Pl. 12).

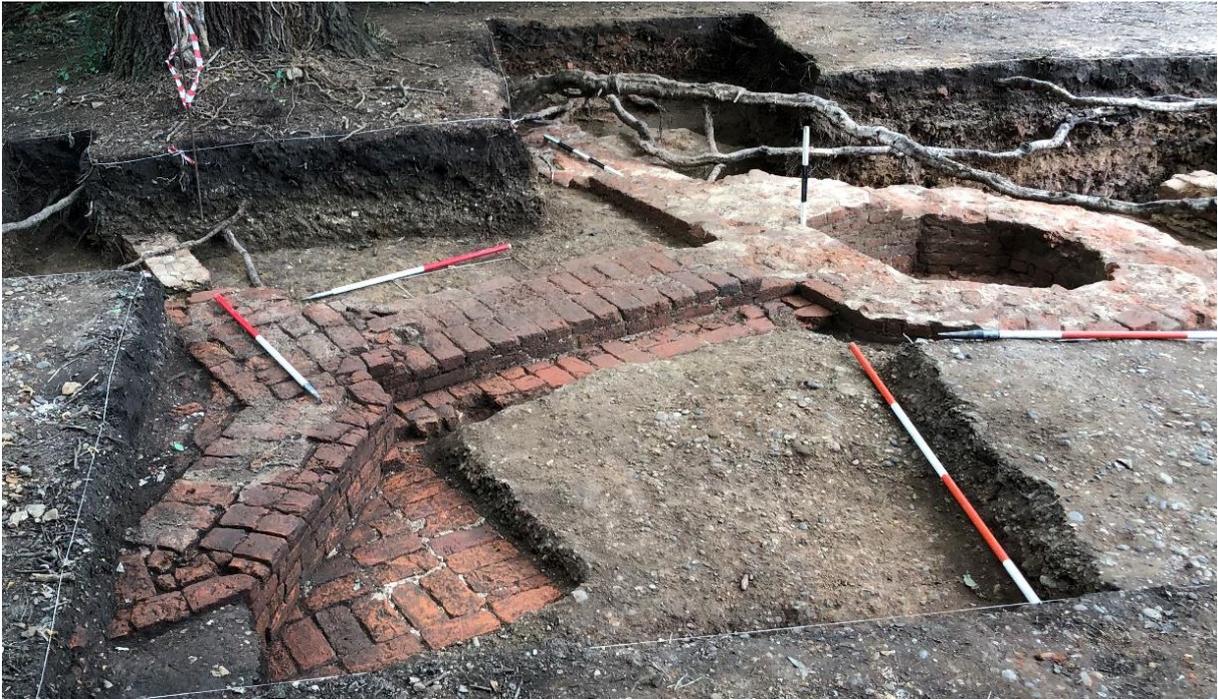
Pl. 13: Phase 2 Turret [17] (to Left with Wall [35] Beyond), 'Wall' [18] (with Surface [55] in Foreground) and Turret [19], Looking West (photo John Pinchbeck)

- If so it would be very attractive to regard [18] as a substantial upstanding threshold for a slightly raised column flanked entrance about 1.30 m wide between the two multi-angular turrets, additional support for which interpretation may be provided by the fact that there was no mortar on the upper surface of the bricks of [18] between the heavily mortar obscured north end of the ‘wall’ and the possible column base at its south end. However, if so, there was no significant wear to the top surface of [18], so it might have functioned as the base for a substantial timber door frame including a base plate.
