ENFIELD ARCHAEOLOGICAL SOCIETY ARCHIVE REPORT

EXCAVATIONS AT ELSYNG PALACE, FORTY HALL, ENFIELD, MAY AND JULY 2024

(SITE CODE FXW24)

by
MARTIN J. DEARNE

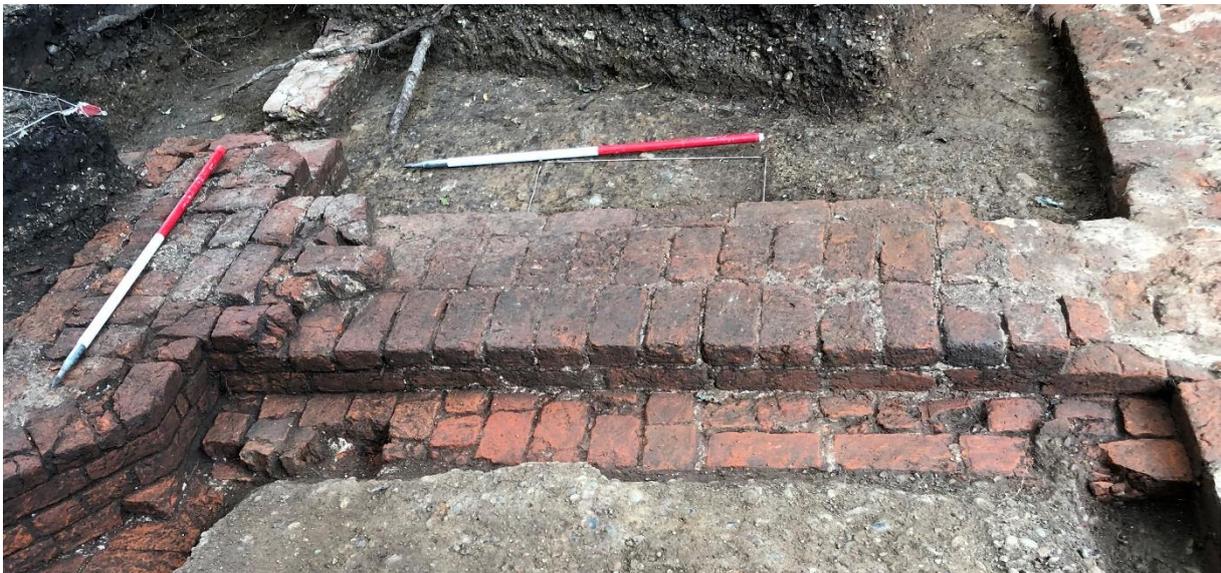
Pl. 14: 'Wall' [18] (with Turrets [17] to Left and [19] to Right), Looking West (photo John Pinchbeck)

- The highest surviving course at the south end, however, may have been the base for an engaged brick column as, though demolition damaged, it used brick fragments and a possible cut brick to pack complete bricks. Indeed, this course extended 0.04 m further west and east than those on which it lay and these lower courses appeared to abut [17] not be engaged with it. Whilst the details of the construction could have been the result of [18] being built after [17] and working from north to south (as [18] also showed a butt joint with the northern turret, [19]) resulting in a difficulty in achieving a neat bond, it was similar to the construction of column bases on FXV23 [10] excavated to the south in 2023. Moreover, brick tumble that could have been almost *in situ* over the north end also included a king closer brick double cut at the same end (as used in column bases on FXV23 [10]) and, if not part of the adjacent turret [19], it might suggest a matching column base at the other end of the wall.

- If so it would be very attractive to regard [18] as a substantial upstanding threshold for a slightly raised column flanked entrance about 1.30 m wide between the two multi-angular turrets, additional support for which interpretation may be provided by the fact that there was no mortar on the upper surface of the bricks of [18] between the heavily mortar obscured north end of the ‘wall’ and the possible column base at its south end. However, if so, there was no significant wear to the top surface of [18], so it might have functioned as the base for a substantial timber door frame including a base plate.

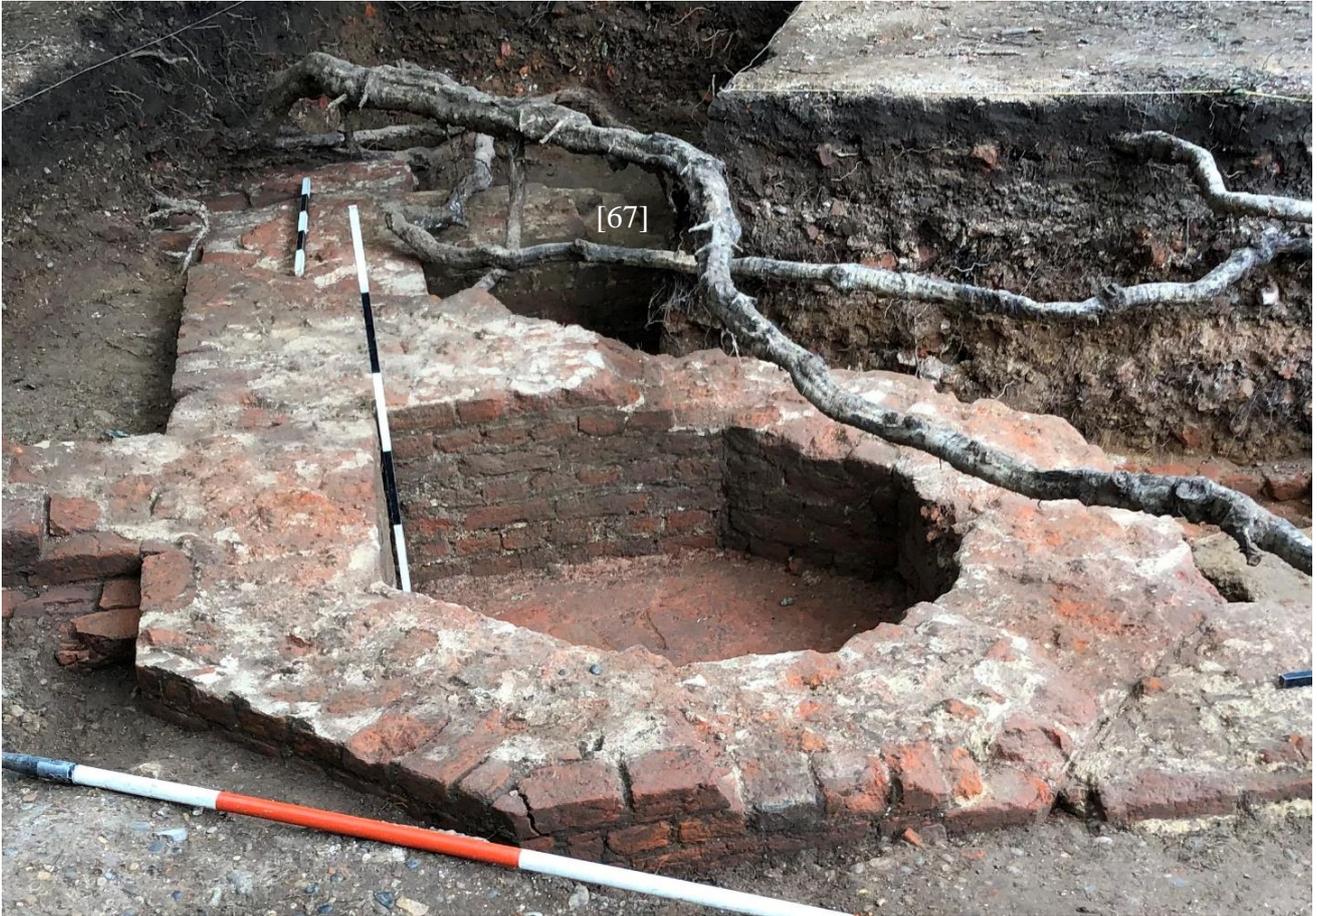
Pl. 15: Turret [19] (With 'Wall' [18] to Left and Wall [21]/[46] to Right) Becoming Wall [51] (with Wall [67] to Right), Looking West (photo John Pinchbeck)

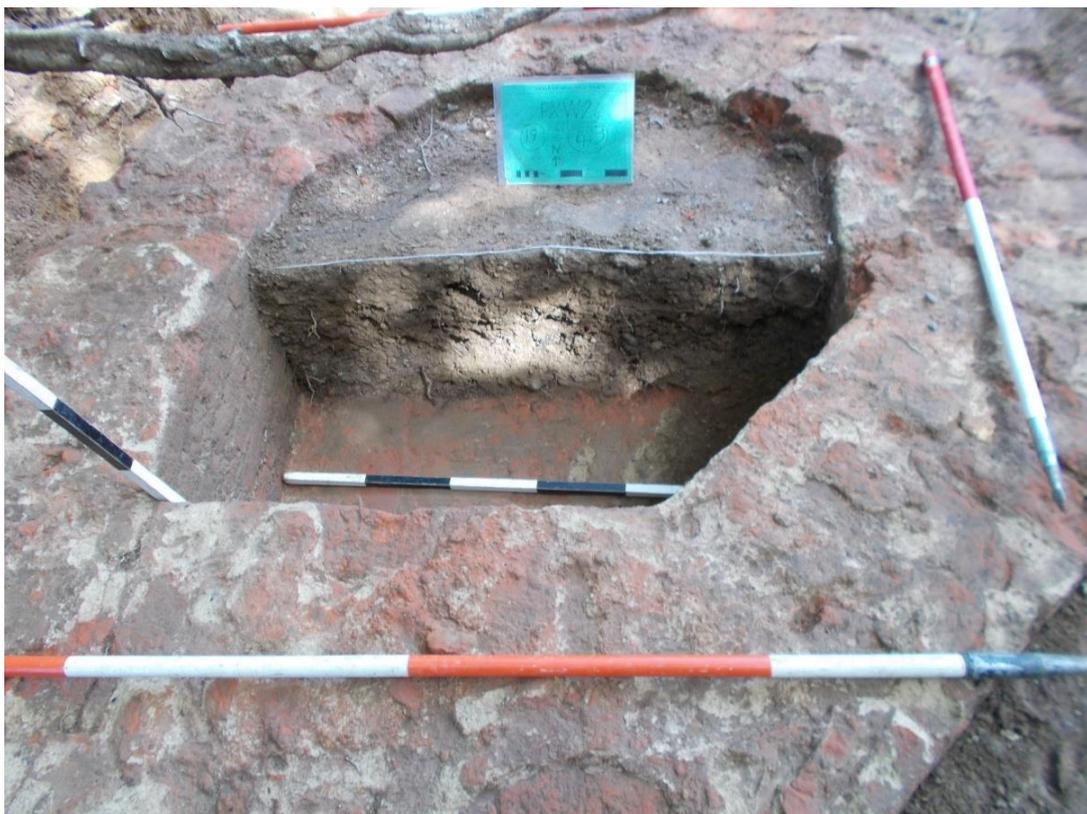
Pl. 16: Half Section of [43], the Pre-Phase 5a Fill of Turret [19], Looking North (photo MJD)

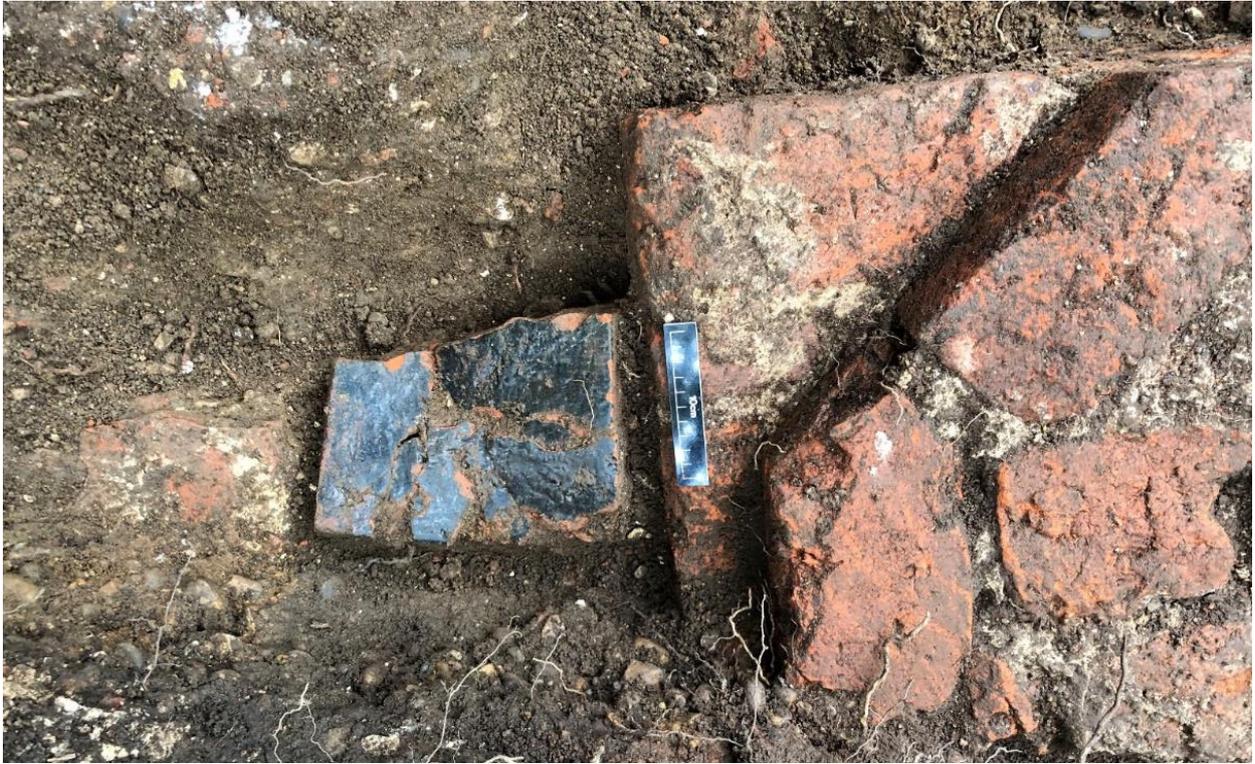
Pl. 17: Possible Glazed Tile Post Pad Between Dwarf Wall [35] (to Left) and Turret [17], Looking North (photo John Pinchbeck)

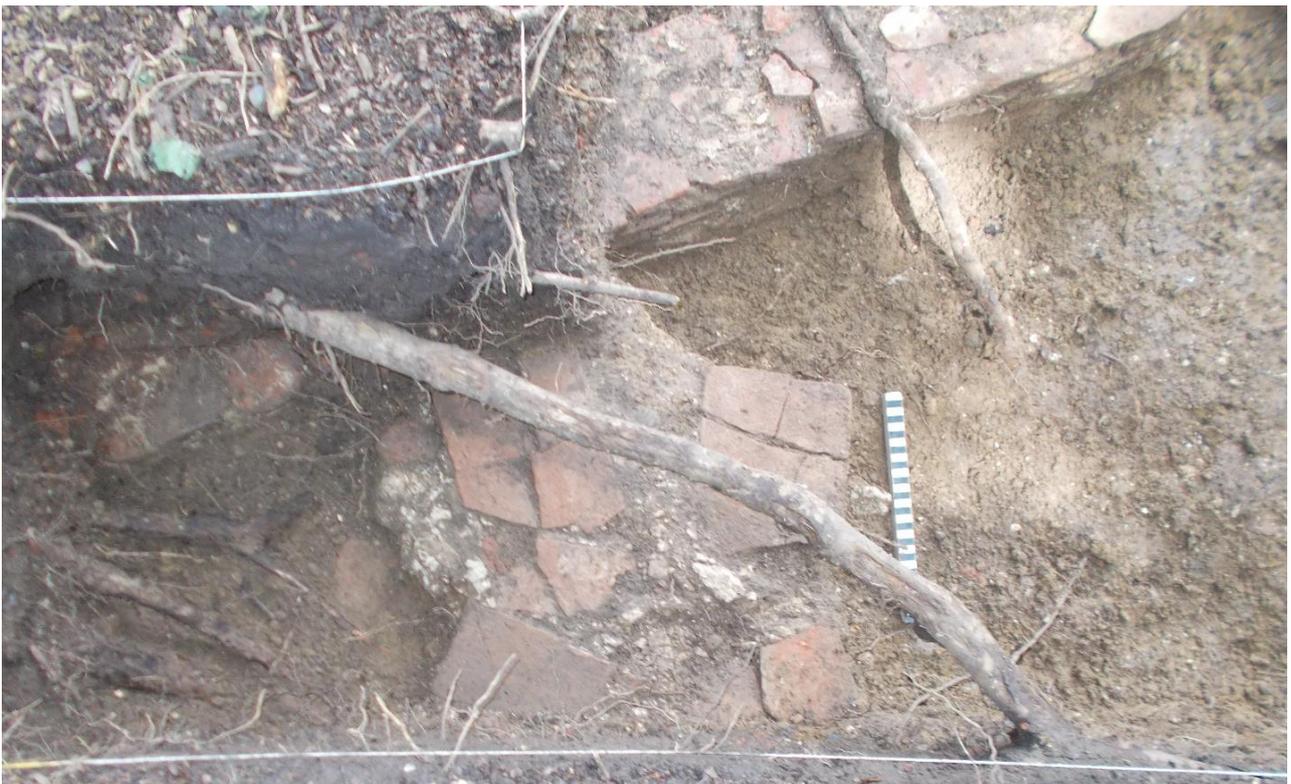
Pl. 18: Horizontally laying ?*in situ* Broken Peg Tiles beside Wall [35], Looking North (photo MJD)

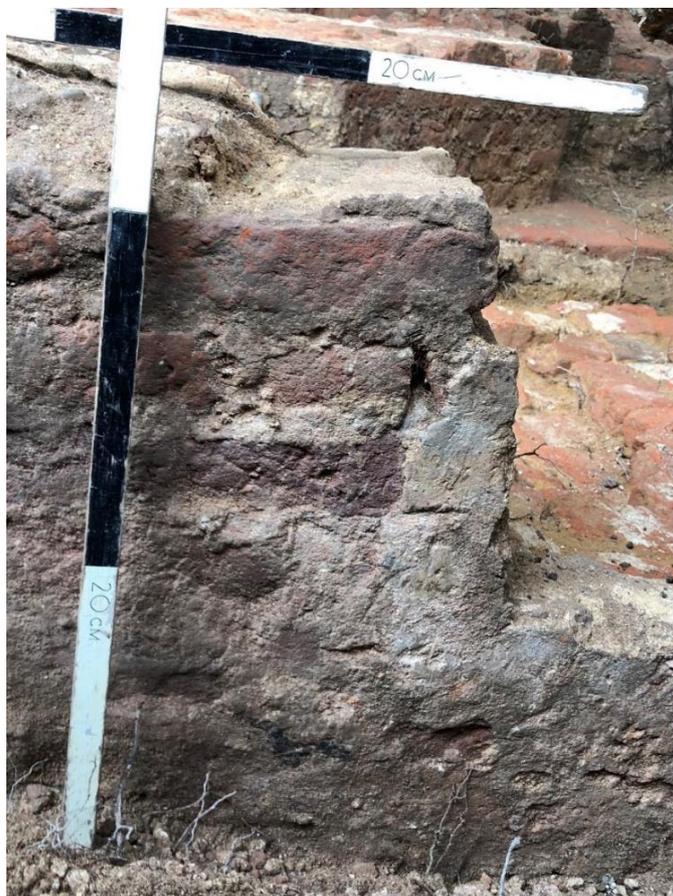
Pl. 19: West End of North Face of Wall [45] Showing Re-rendering of the Doorway and Threshold Inserted Later in Phases 2 – 4, Looking South (photo John Pinchbeck)

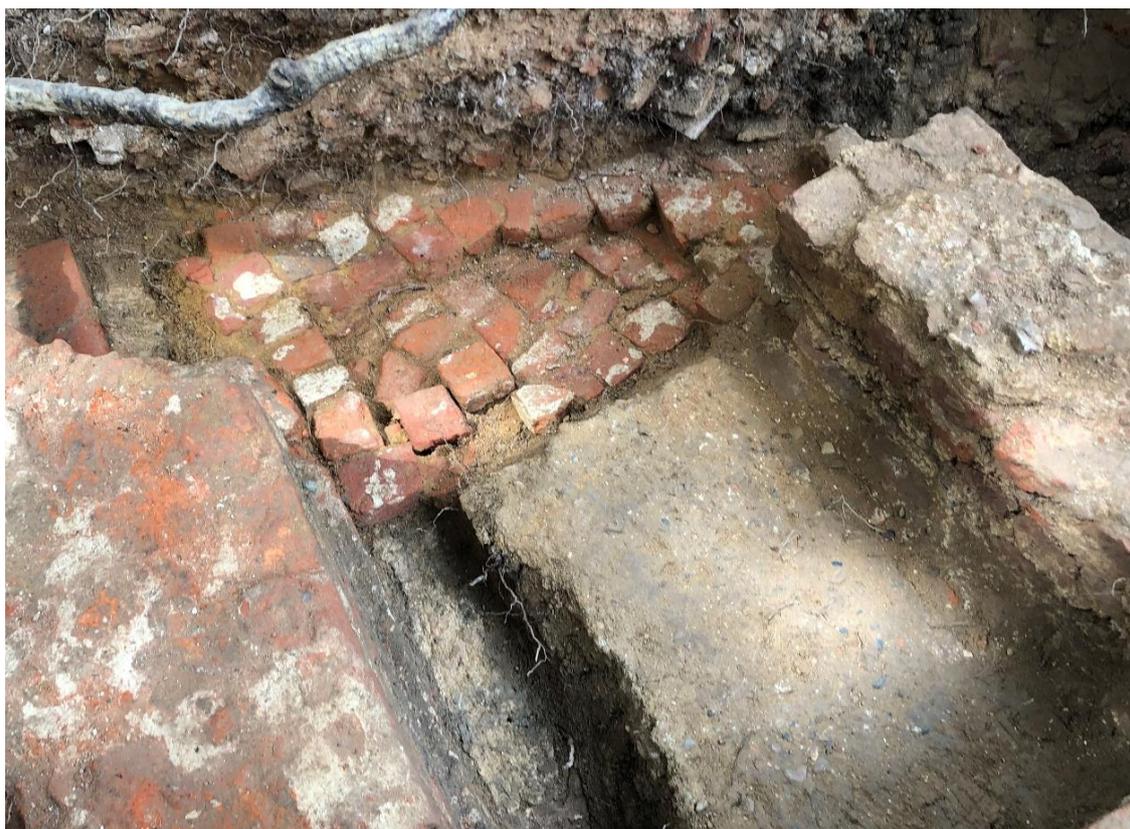
Pl. 20: Floor [63] with the Inserted Doorway Through Wall [45] to Right and Turret [19] to Left (Foreground Dump Deposit [60] Cut on Left by Construction Trench [57]), Looking West (photo John Pinchbeck)

- The cutting of this doorway was probably contemporary with the laying of a brick floor, [63], to its south. Much of an upper layer of bricks in the central area of the anyway small exposure of the floor was missing/dislocated (be it due to Phase 5a demolition damage or not), but it comprised at least two layers of hard white mortar stained part bricks, probably fairly roughly lain and without mortar bonding, butted against both the threshold of the door and, on the south, against the edge of the construction plinth for turret [19] (Pl. 20). They had been lain in a probable cut, [70], in line with the east edge of the new doorway and which had truncated the sequence of deposits including [60], [53] and [52] as well as the filled construction trenches ([62] and [57]) for wall [45] and turret [19], so the floor did not run all the way to the east wall of the building and, as noted above, perhaps respected some upstanding feature in the intervening space. The floor presumably represented a room to the south of the (now much smaller) Room 3, very likely one with its floor at a lower level to that of Room 3’s.
