# **ENFIELD ARCHAEOLOGICAL SOCIETY ARCHIVE REPORT**

**EXCAVATIONS AT ELSYNG PALACE, FORTY  
HALL, ENFIELD, JULY 2025**

**(SITE CODE FXX25)**

**by  
MARTIN J. DEARNE**

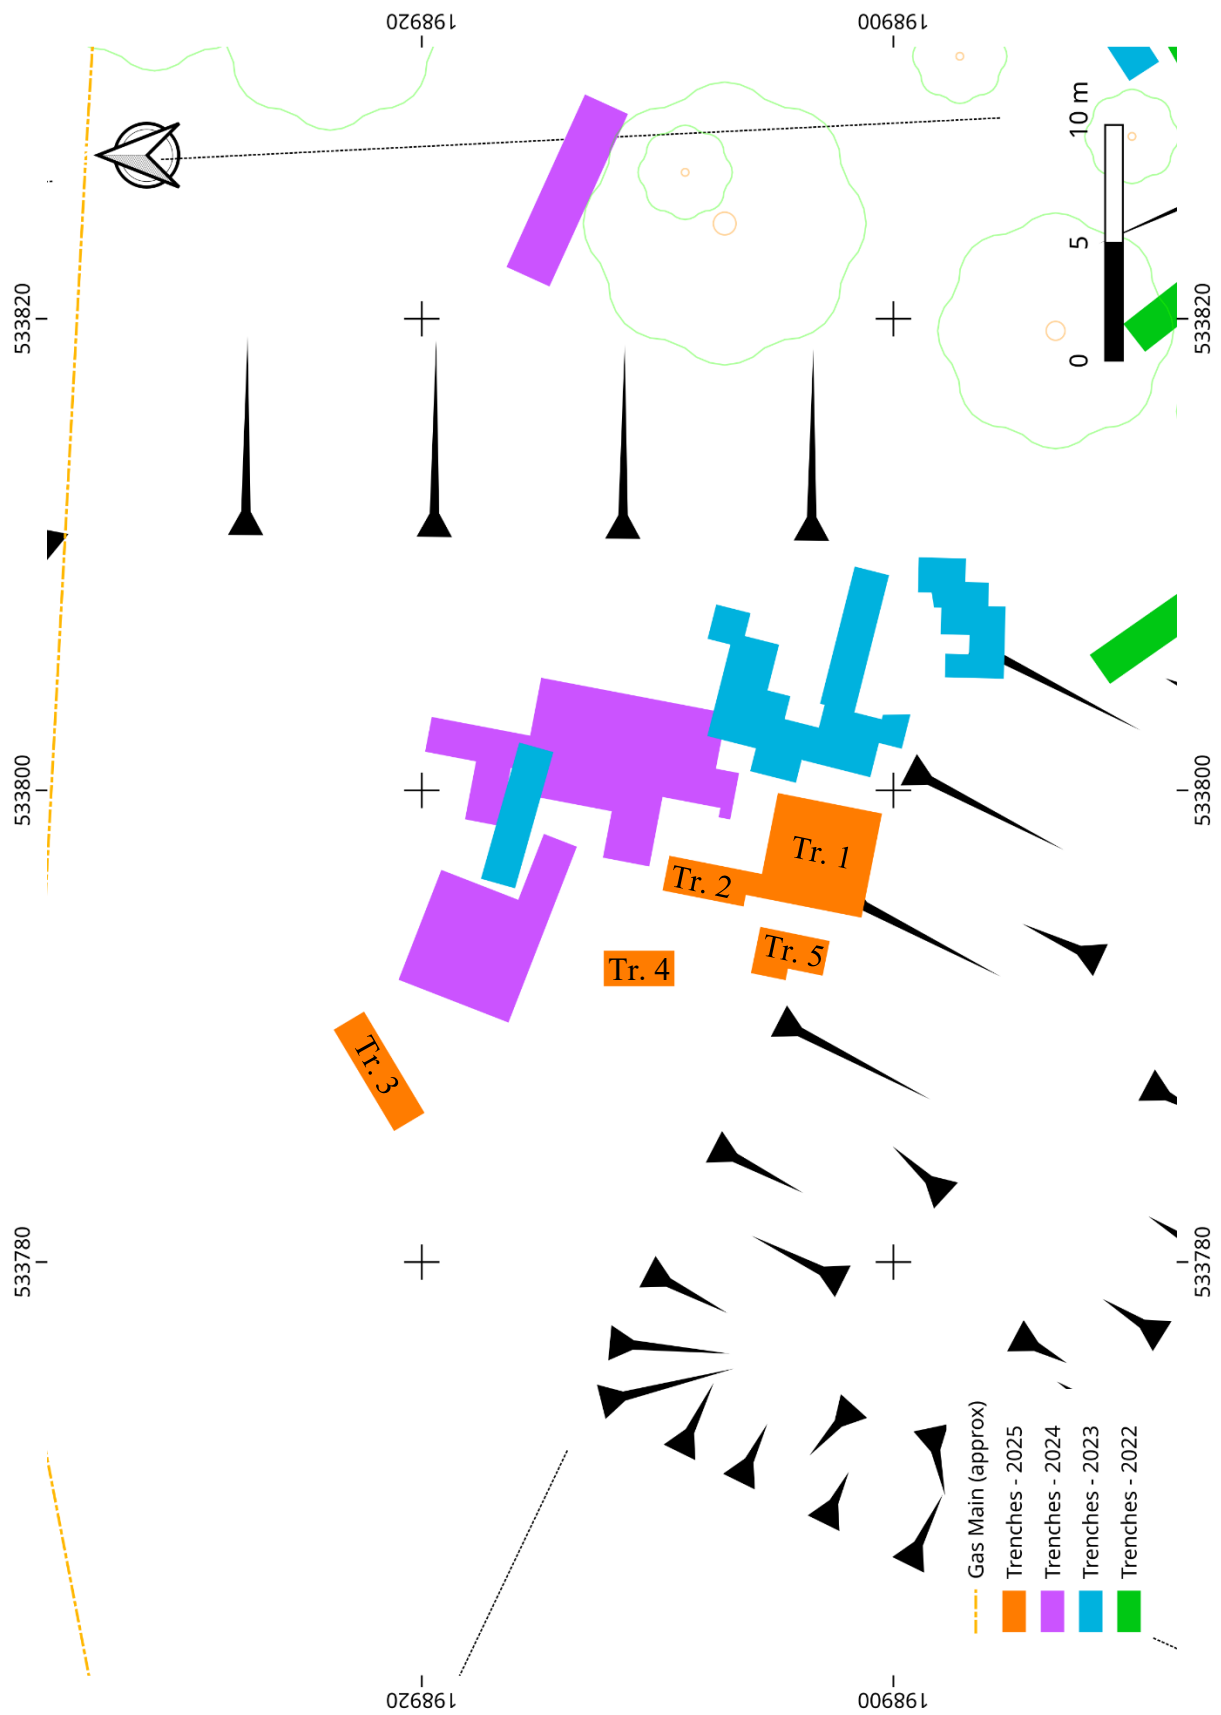
Fig. 1: Trench Locations in Relation to Previous Work  
(LiDAR Generated Topography is Approximate – see also Fig. 6)

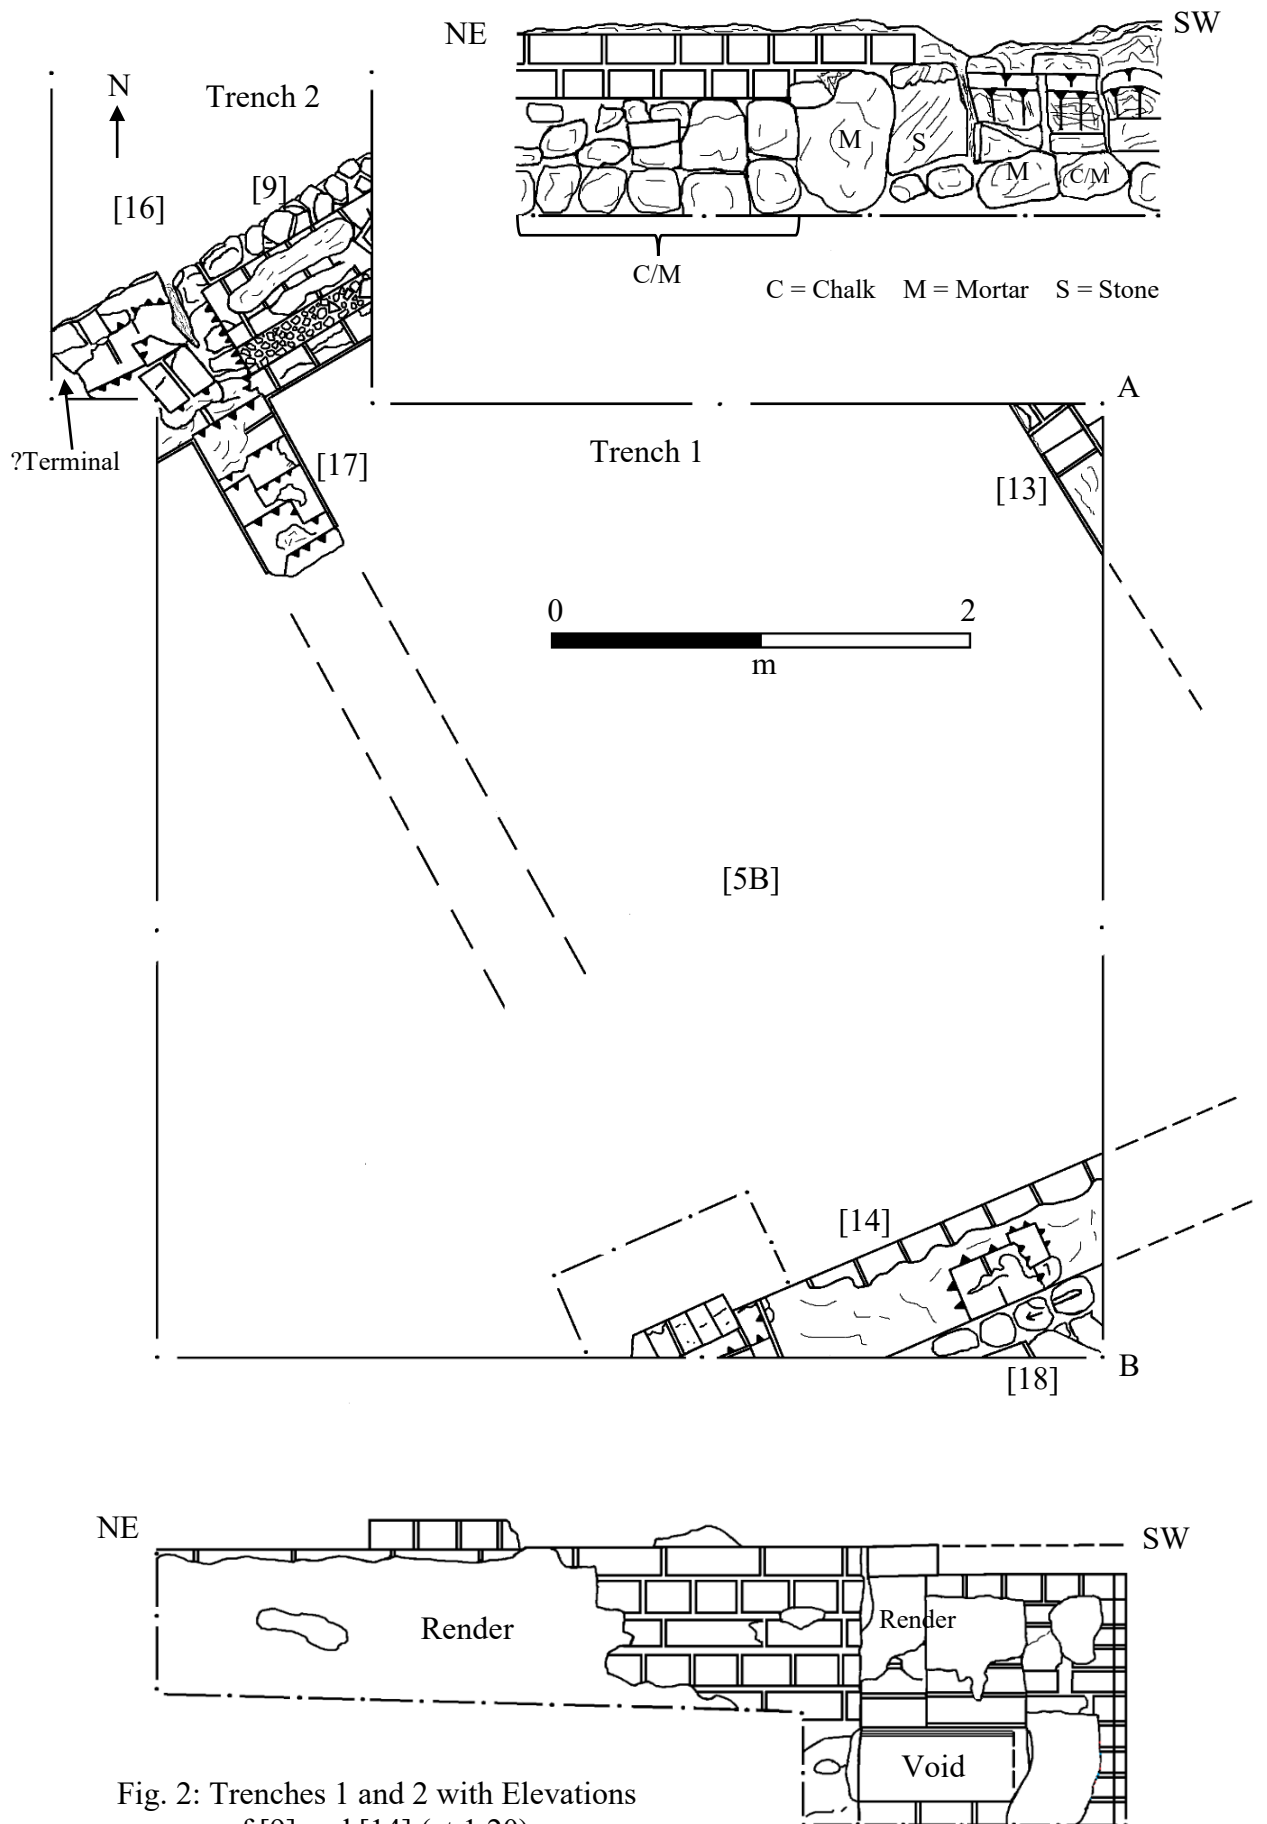
Fig. 2: Trenches 1 and 2 with Elevations of [9] and [14] (at 1:20)

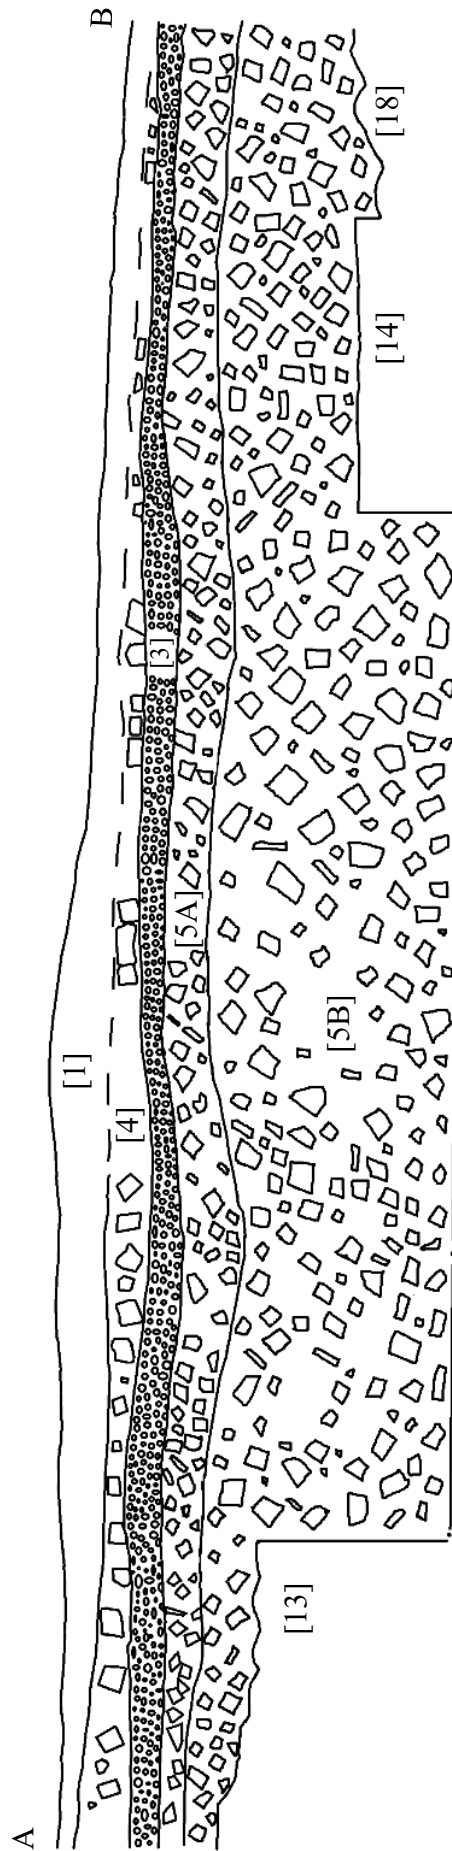
Fig. 3: Trench 1 Section A – B (1:20)

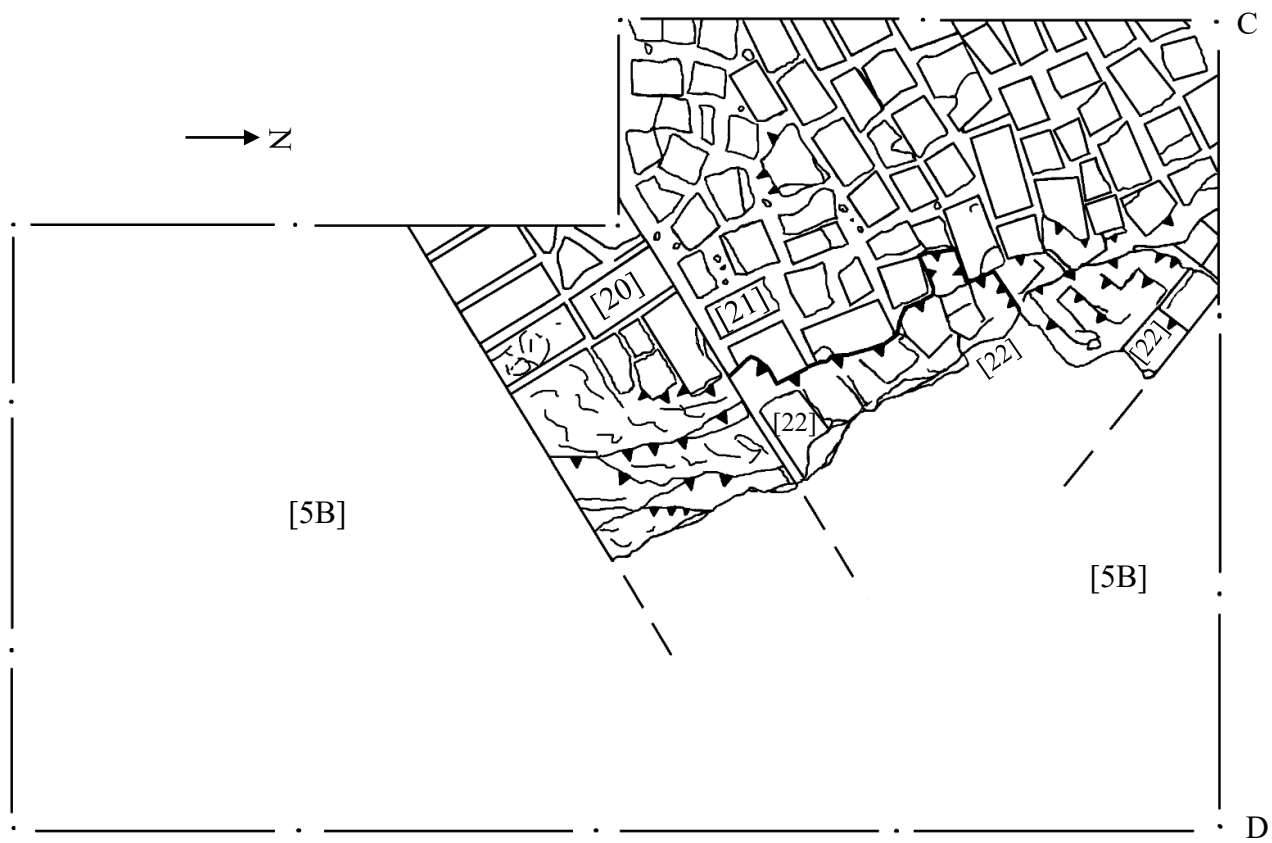
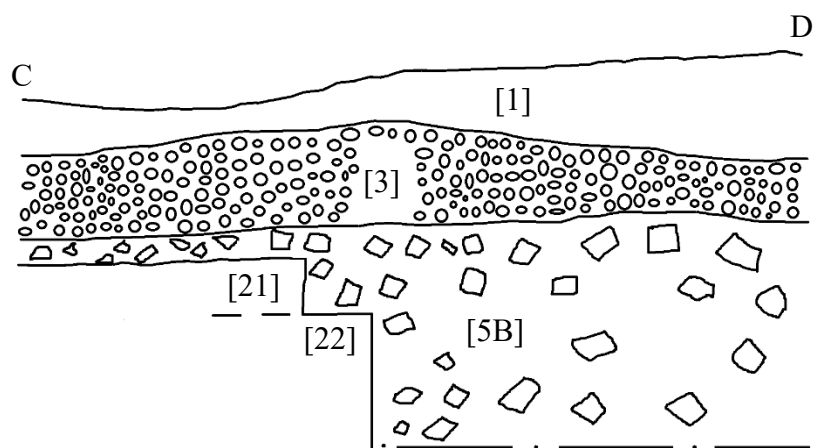
Fig. 4: Trench 5 Plan (Tree Roots Omitted for Clarity) and Section C – D (1:20)

- If it was the case that walls [20] and [9] flanked a doorway it would provide a possible interpretation of another section of what appeared to be walling in Trench 5. This, [22], had probably, but not certainly, been truncated and overlain by a new structure perhaps at some point in Phases 2 - 4 (see below) and probably further damaged by Phase 5a demolition. Though its width could not be ascertained, one short section of its original fair but unrendered face survived to seven courses above the limit of excavation and indicated that it ran south east to north west. It could therefore have run on to meet wall [20] beyond the point where it was preserved, ?again to form one side of a doorway.

- Thus, demolition damage meant that differentiation of [22] from this, which appeared most likely to be a new overlaying brick feature that respected and abutted the north side of [20], was very difficult. However, the most likely interpretation seemed to be that at some point [22] had been partly truncated and overlain by [21] and that it was a fairly roughly lain brick floor. It was over 1.00 m east west and over 1.50 m north south and seemed to consist of two layers/courses of part (half to three quarters complete, though also smaller fragments of) and occasional whole bricks with one or two lumps of hard

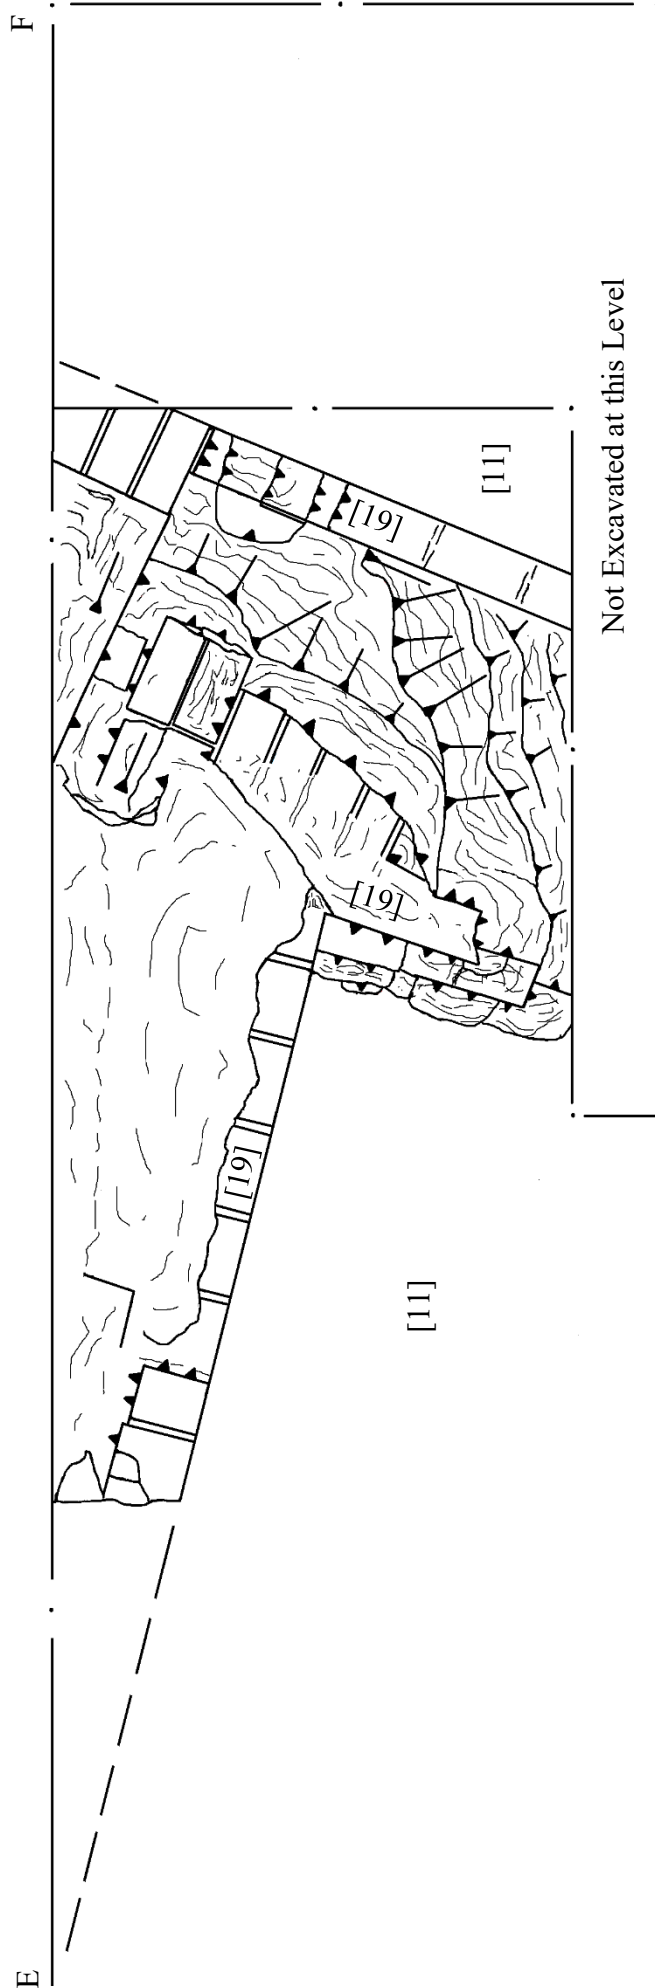
Fig. 5: Western Part of Trench 3 and Section E – F (1:20)

- The east west arm of the wall, only the unrendered (presumably internal) north face of which was within the trench, was over 1.00 m wide and over 2.50 m long and survived to at most five courses (0.28 m) above the limit of excavation. Little of its north south arm was seen beyond the return, partly due to the need to step the section forward to avoid the collapse of loose demolition material and ensure safe working. However, it was probably c. 1.15 m wide, even if one face at the only point where measurement was possible had been demolished in a way that left the position of that face uncertain. The two arms of the wall did not meet at right angles rather, though demolition damage and the small exposure made accuracy difficult, they met at an angle of something like 77° or a little more.

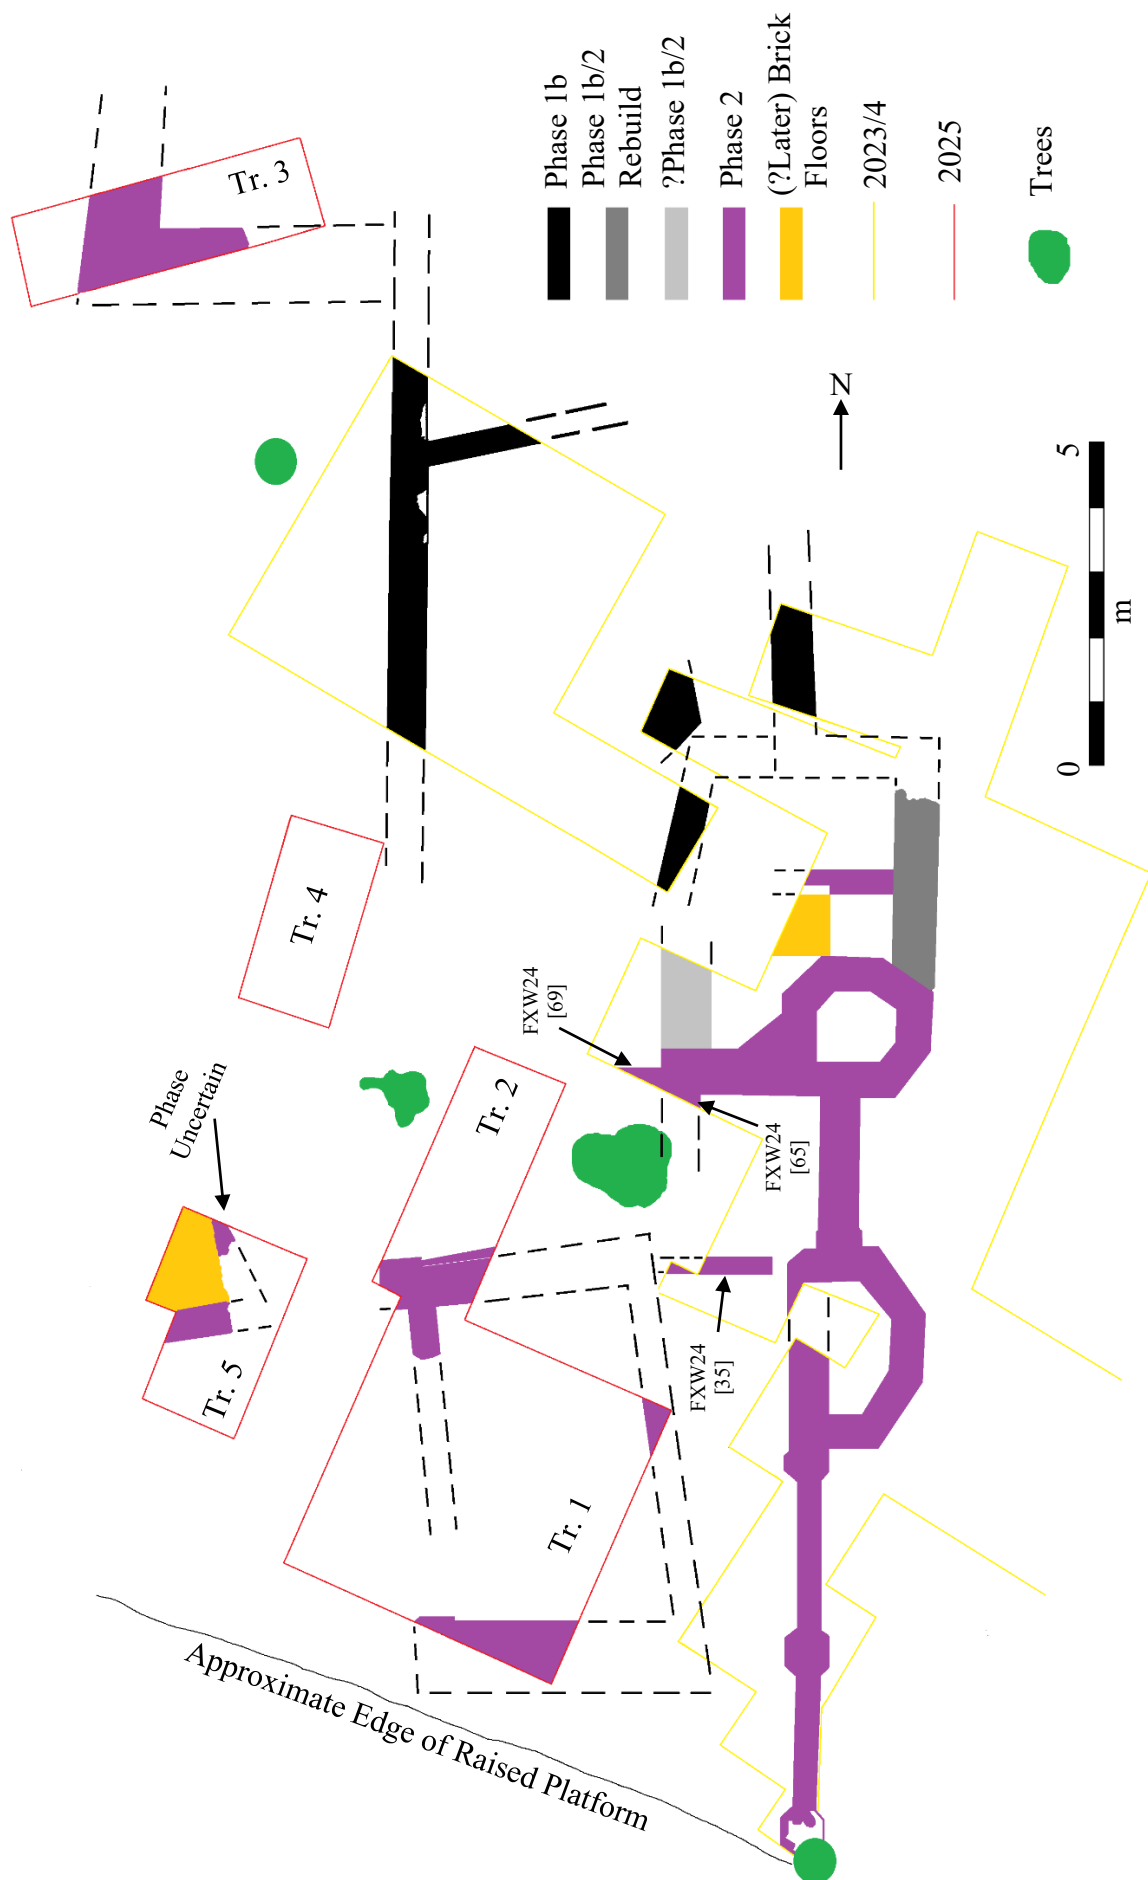
Fig. 6: Phased Structural Features Excavated 2023 – 2025

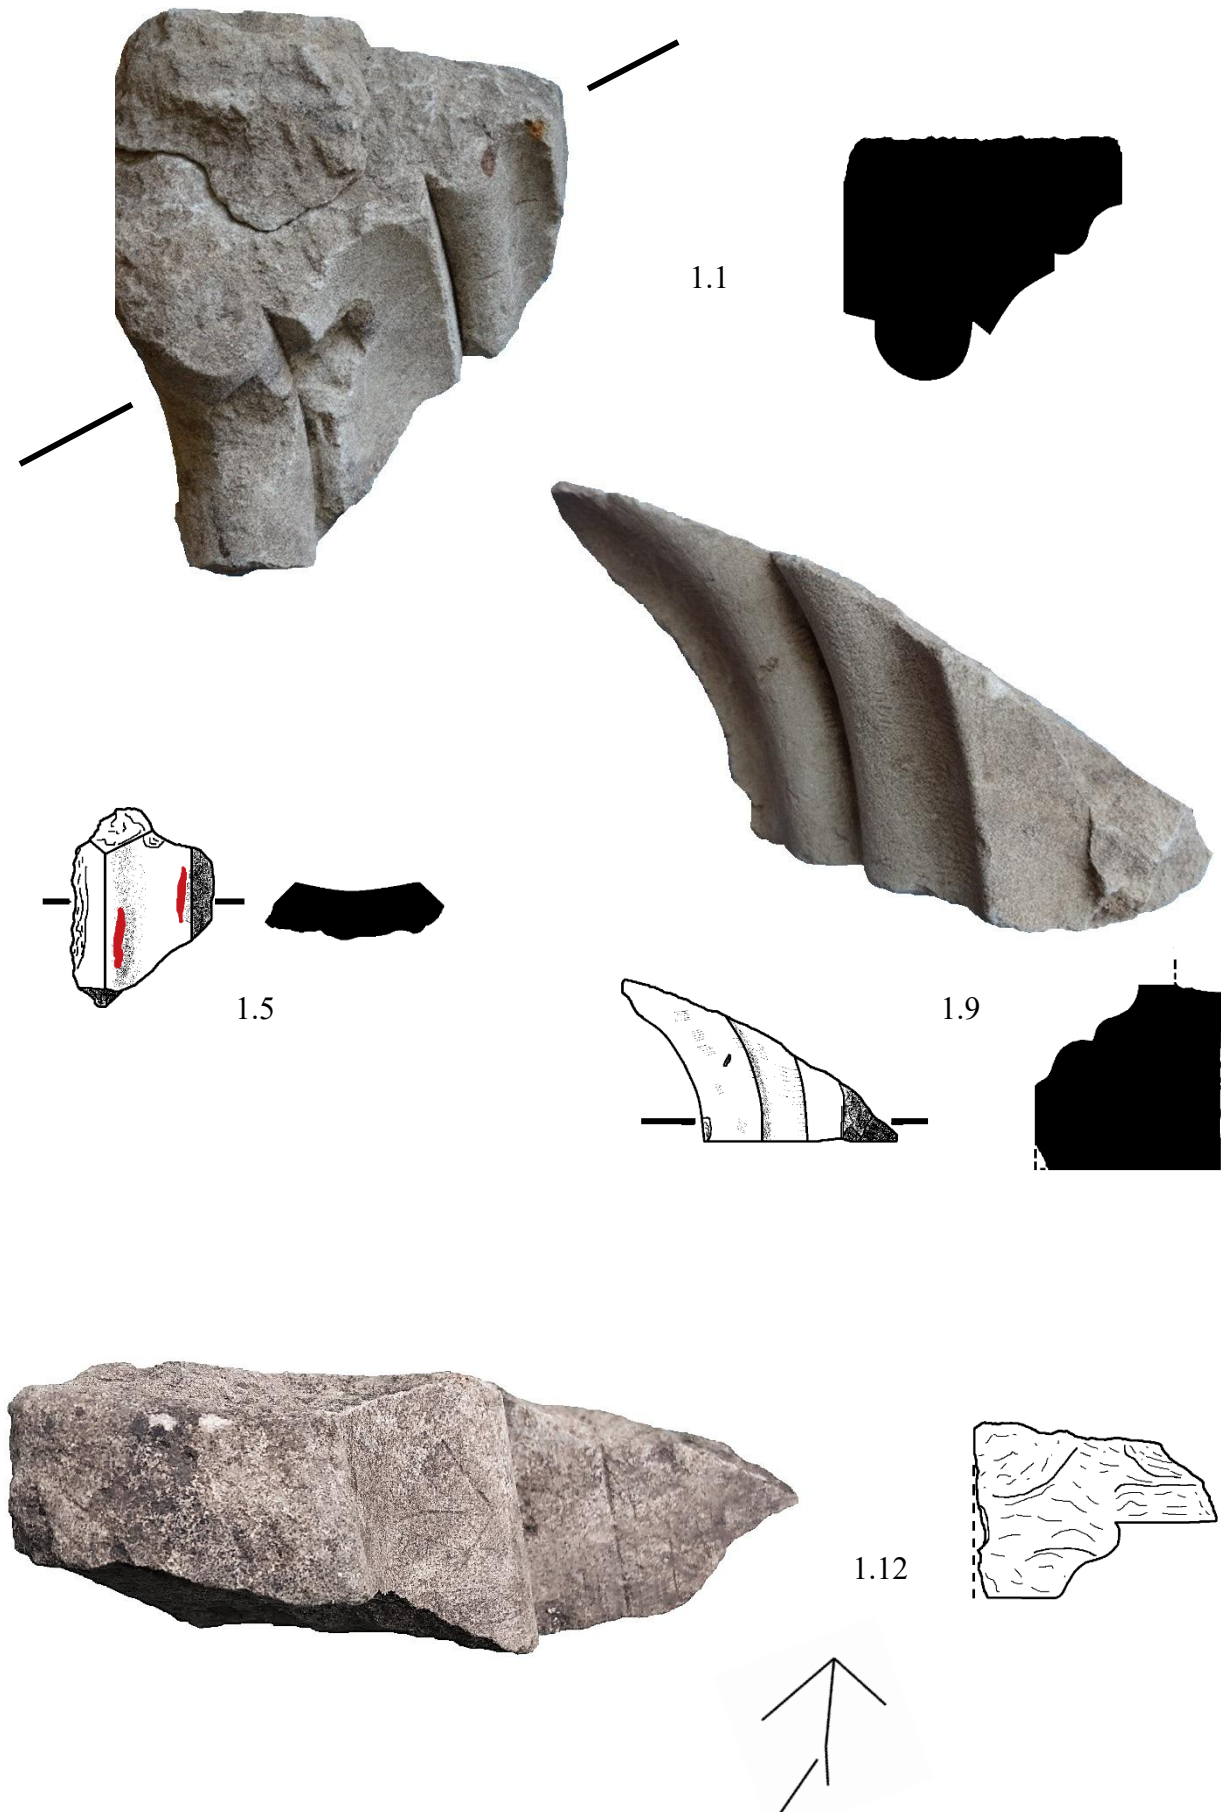
Fig. 7: Architectural Stonework (Drawings and Sections at 1:4, except Mason's Mark at 1:1; Photos Ian K. Jones and John Pinchbeck)

- \*1.1 Two joining pieces from a Greensand block, broken at both ends (W. 10.20; Ht. 18.00; Th. 14.65 cm). Well finished, but with slightly abraded curving mouldings, the abrasion suggesting that it comes from the outside of a building, while its form shows that it is from a corner block and its size suggests that it is probably from a doorway (there are slight traces of burning, but not where one would expect if it were from a fireplace). Working from the outer face, a small area of which survives, there is a 4.30 cm wide cyma recta moulding, separated by a 0.93 cm wide flat step from a 4.94 cm wide cavetto moulding. This leads to a second c. 40°, 1.02 cm wide step which flanks a 4.76 cm wide roll moulding with a flat inner side. This runs back to a poorly preserved, 1.54 cm wide chamfer, flanking the partly preserved inner face of the block which is parallel to the outer face. The beginning of the chamfer has quite a deep chisel cut at its beginning and there is a large area of damage to the cavetto and roll mouldings. [5]

- \*1.12 Fragment of a Greensand block forming part of the base of a fireplace overmantel (W. 4.39; Ht. 9.07; Th. 12.34 cm). Part of the base of the block survives and is smoke stained, as is a small area of the worked surface of the back of the block. From the base rises a well finished 4.95 cm wide cyma reversa moulding, ending in an over 5.24 cm long flat, horizontal (becoming very slightly angled) surface with two slight lines scored along it. The concave element of the cyma reversa bears a fairly lightly scored probable mason's mark comprising a 2.11 cm long upward pointing arrow probably with a bifurcated tail. [5]

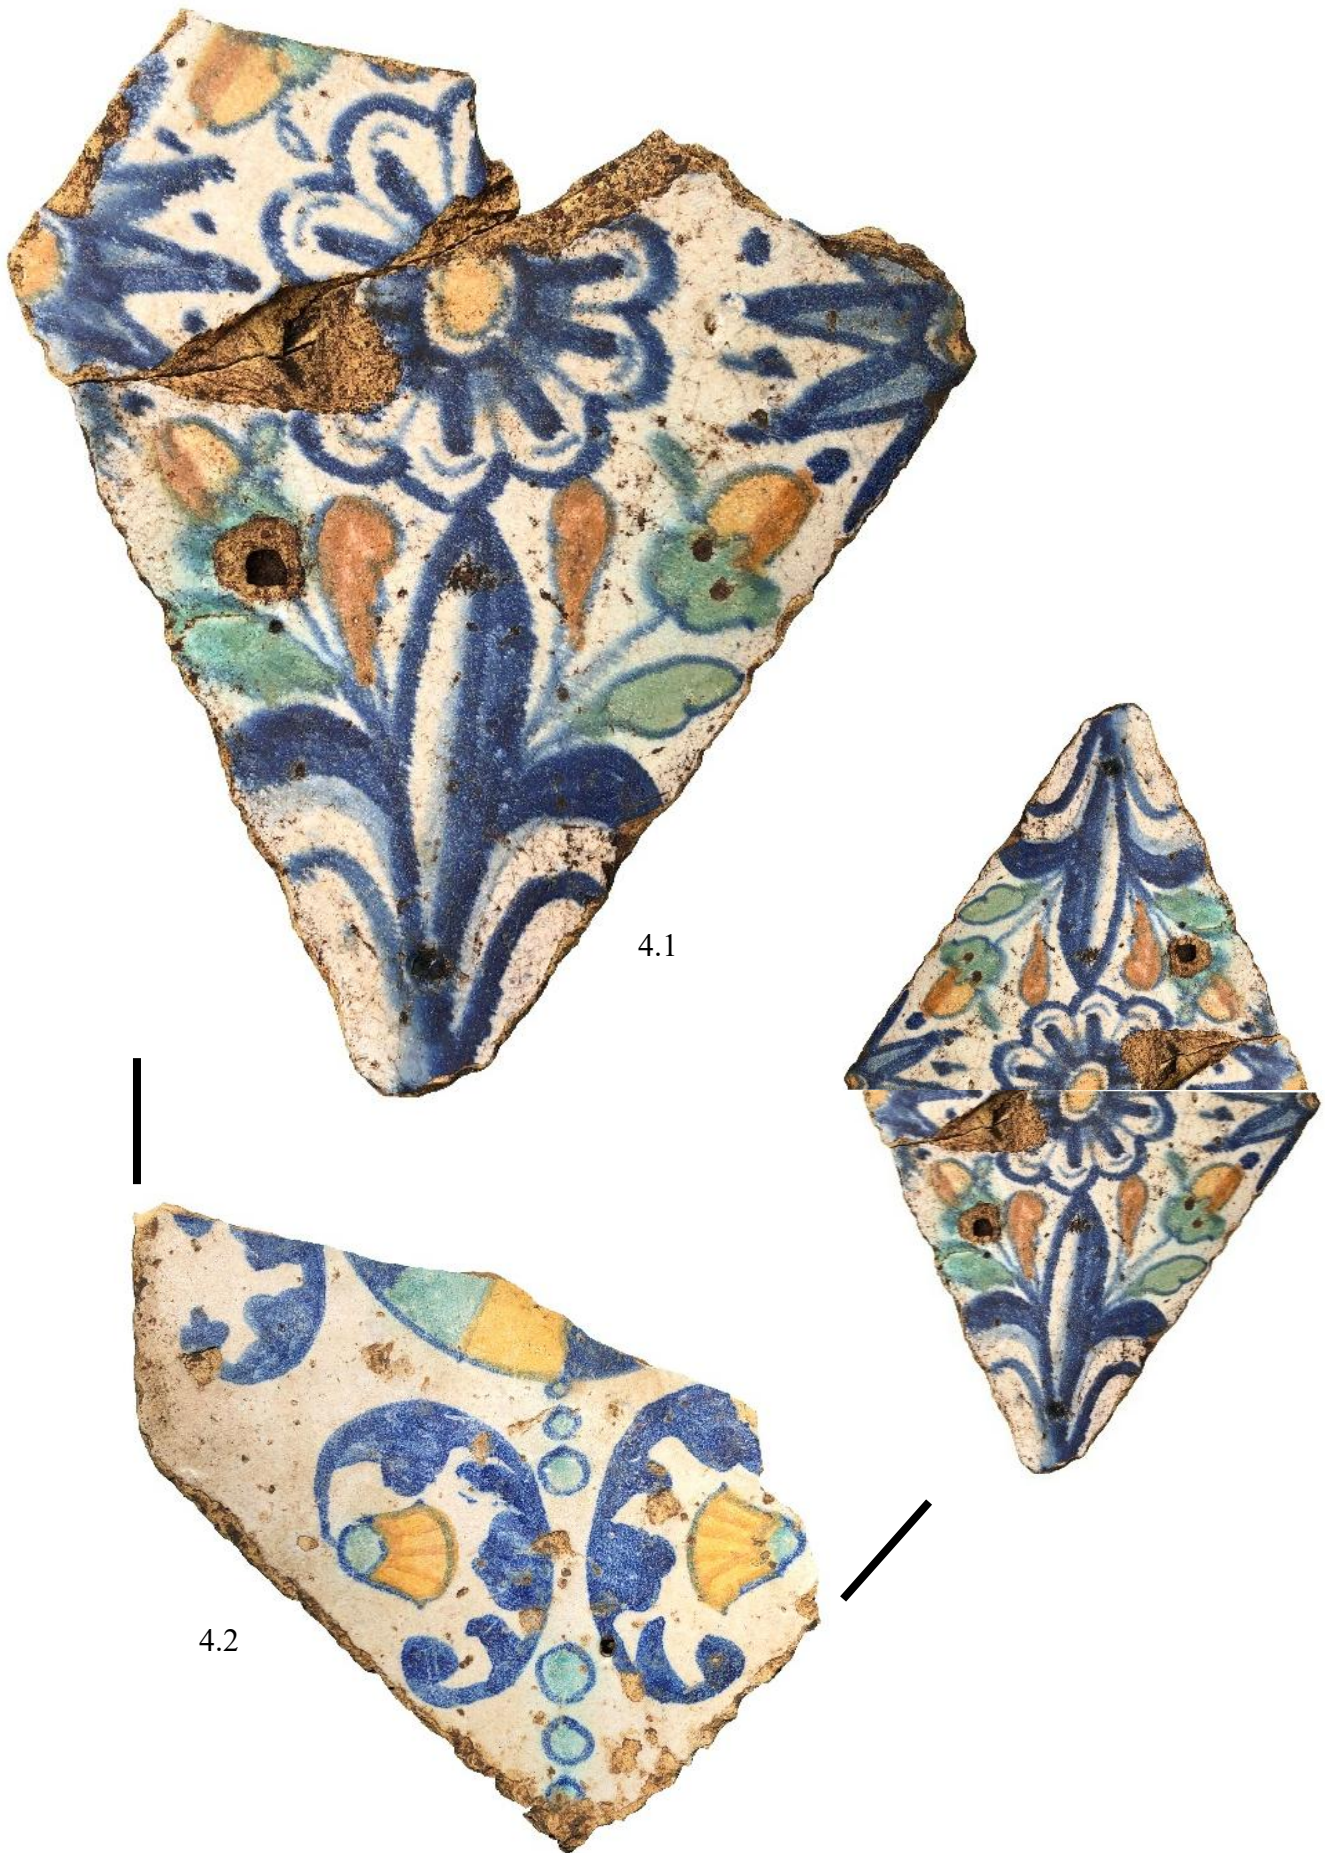
Fig. 9: Delft Tiles (Not to Scale) and Suggested Reconstruction of 4.1  
(photos John Pinchbeck)

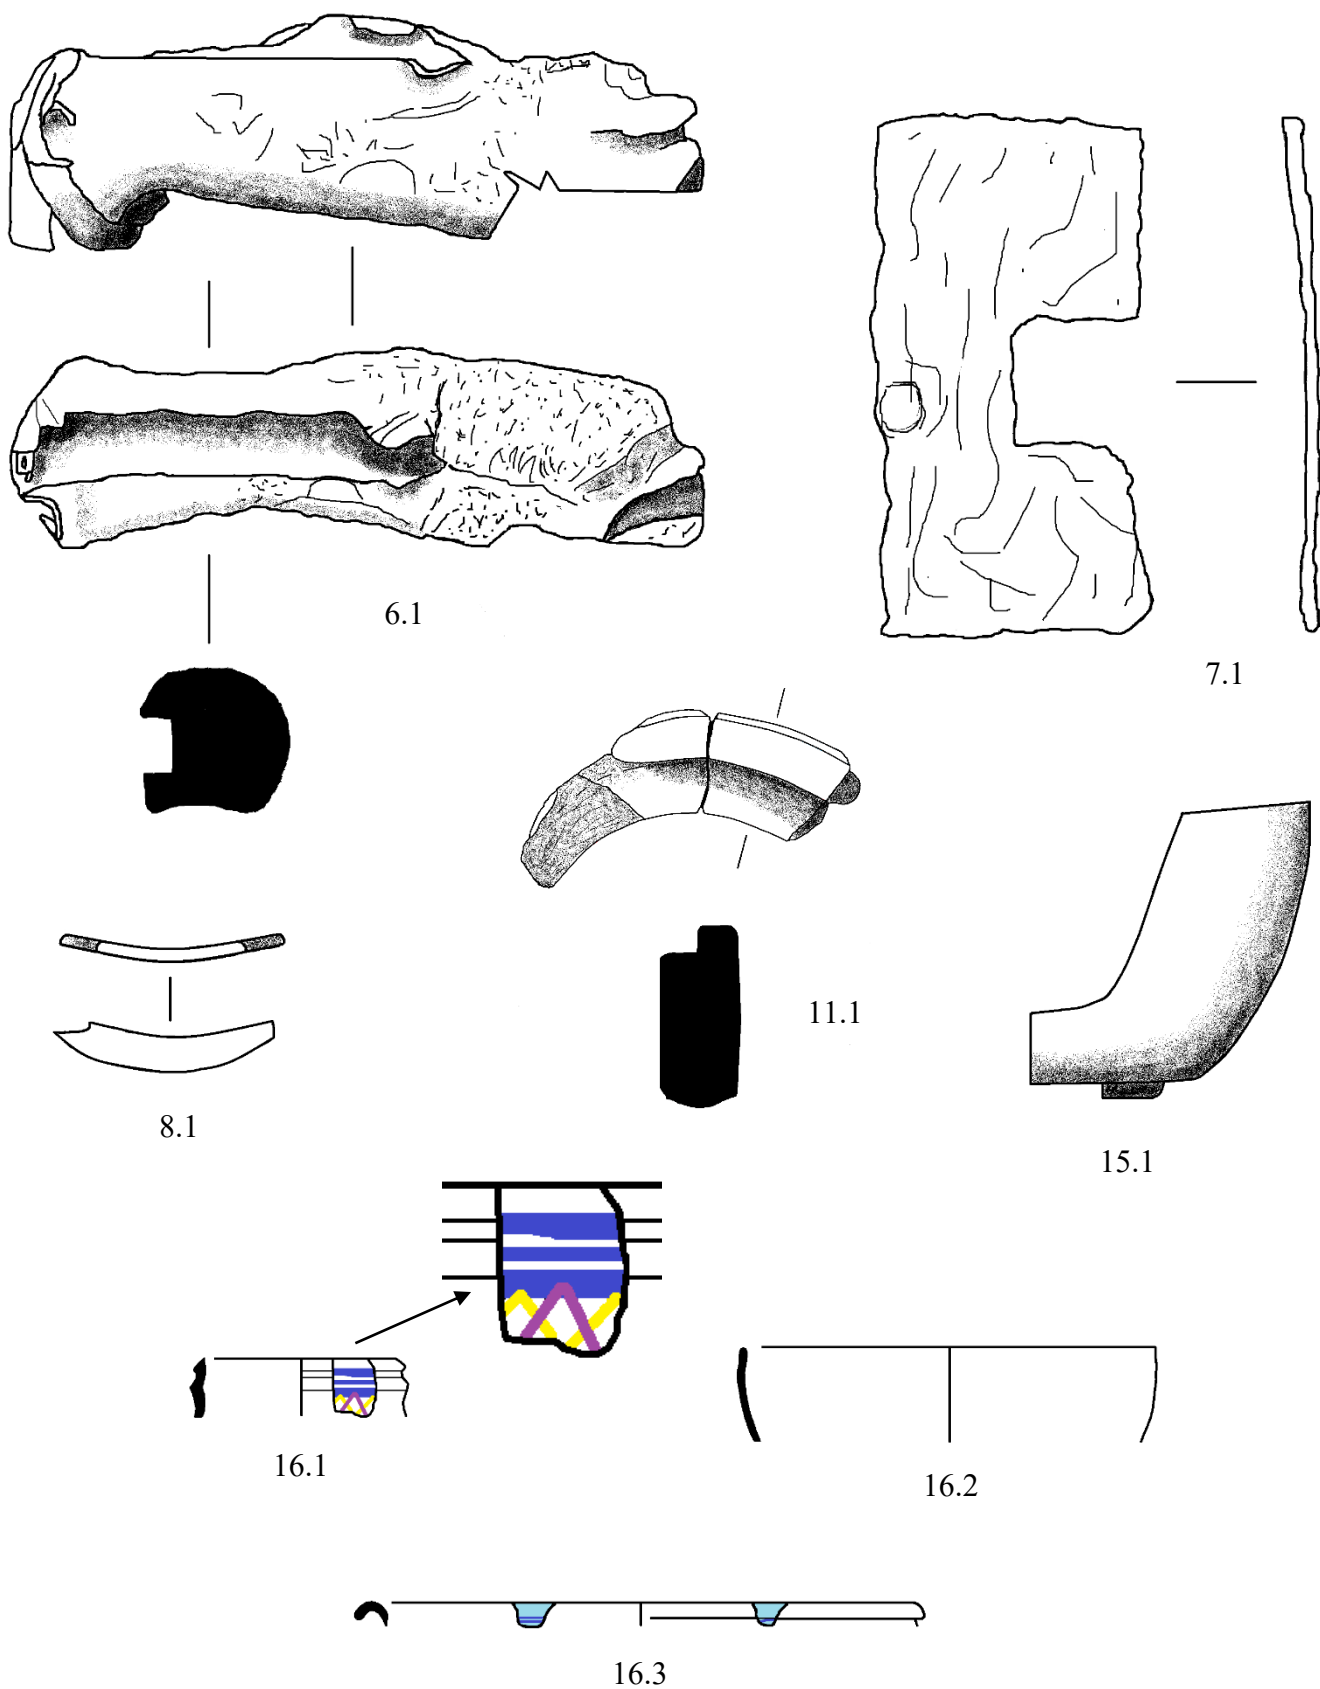
Fig. 10: Metal, Stone and Fired Clay Finds (1:1 Except 11.1 at 1:2) and Delft Pottery (1:4)

\*7.1 Fe ?? chest mount (L. 6.75; Max. W. 3.45; Th. c. 0.15 cm). A corroded rectangular plate of flat sheet metal with a 1.73 x 1.59 cm rectangular cut out at the centre of one long edge and a possible rivet along the other long edge, opposite one edge of the cut out. It is possible that this framed one side of a keyhole or a handle attachment point on a chest. [12]

- A single Ae lace chape (aglet) fragment (L. 3.00 cm) was [U/S] and one Ae dress pin fragment (L. 3.00 cm) came from [5]. There was also:
- \*8.1 Ae ?lace edging (L. 2.77; Max. W. 0.39; Th. 0.18 cm). A short, curved binding formed of thin sheet, left open at the (?broken) ends and closed by folding a slightly wider 'lip' over in the middle. White fibrous material (??lace) protruding from the ends of the 'lip'. Although not a lace chape, which are straight and closed along their entire length, this suggests some form of binding from the edge of a lace dress element, intended to prevent fraying. [U/S]

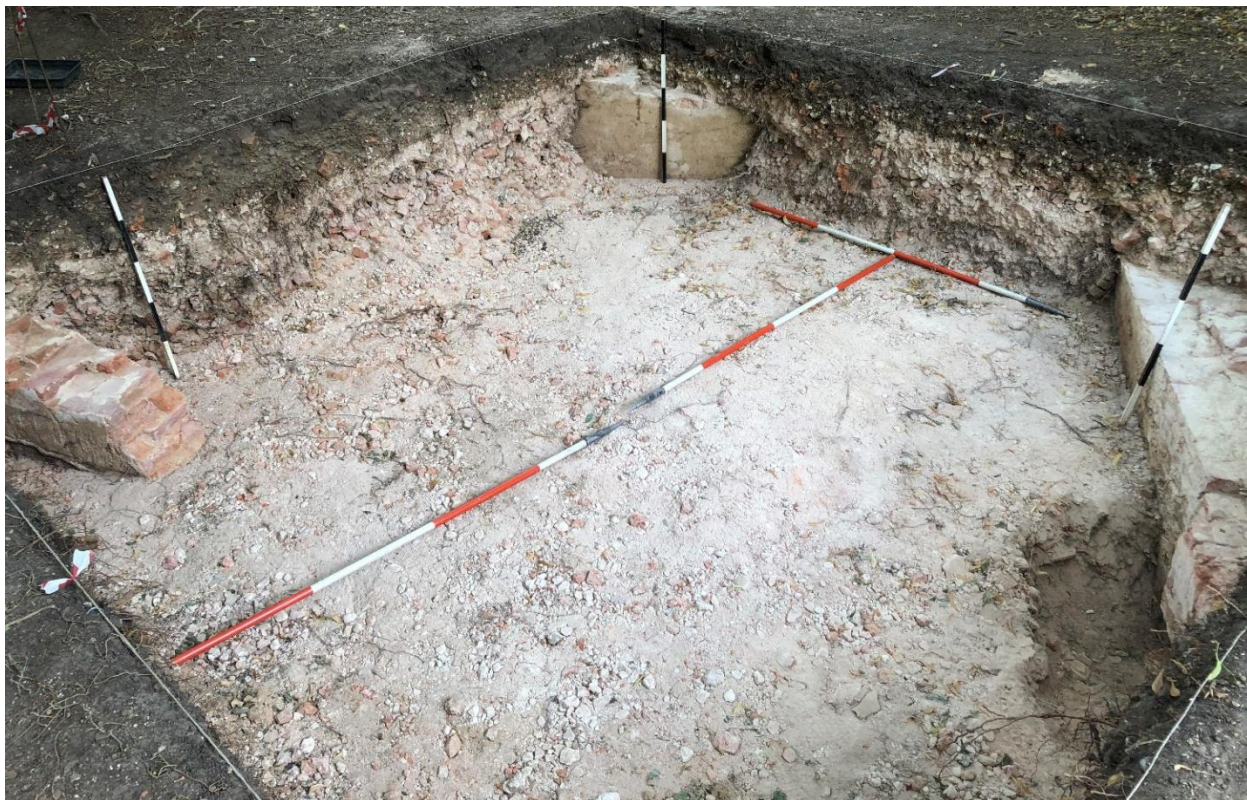
Pl. 1: Trench 1 Looking East with Walls [17] (to Left), [13] (centre) and [14]/[18] (to Right)  
(photo John Pinchbeck)

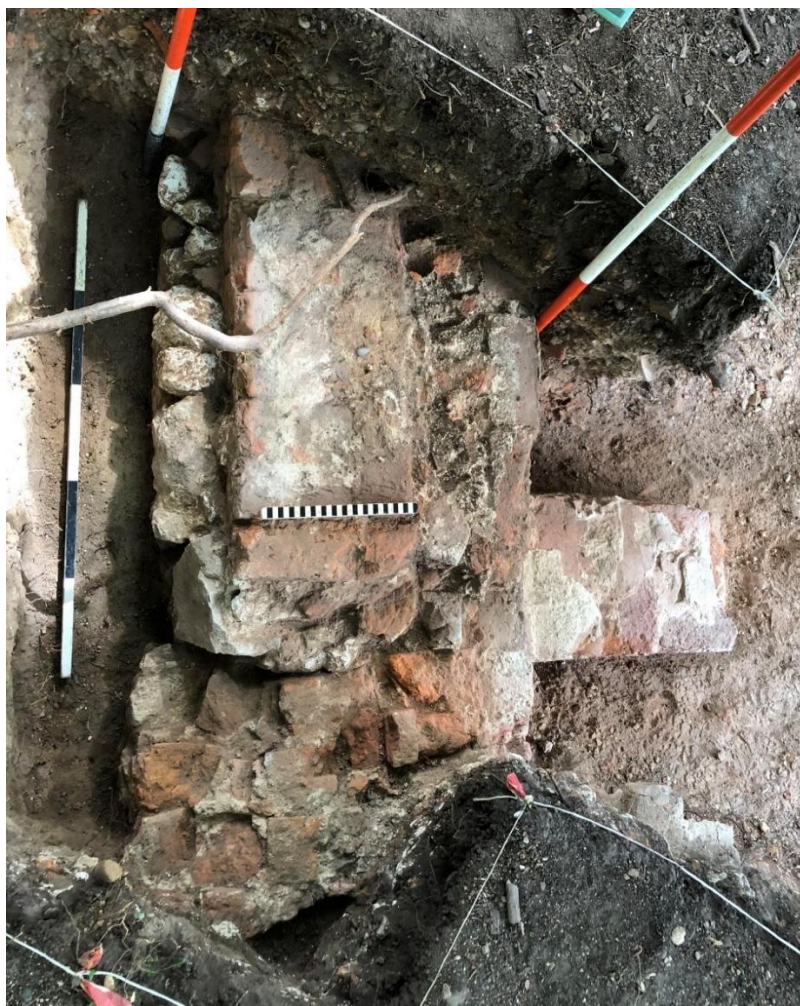
Pl. 2: Walls [9] and [17] (Photo John Pinchbeck)

- The wall most fully available for study was [9], the north west wall, which comprised five elements and a maximum length of 1.80 m of which was available for study (Pl. 2). Where it abutted and ran north east from an adjoining wall ([17]; see below) its north west side comprised a mortared rubble raft as a foundation for a brick wall, which wall was fronted on the south east by a band of mortared rubble separating it from a narrower rendered brick facing. Where it ran south west from [17] (and so to the south west of the tower) though it had a different construction, comprising a single wide brick wall on probably the same foundation raft.

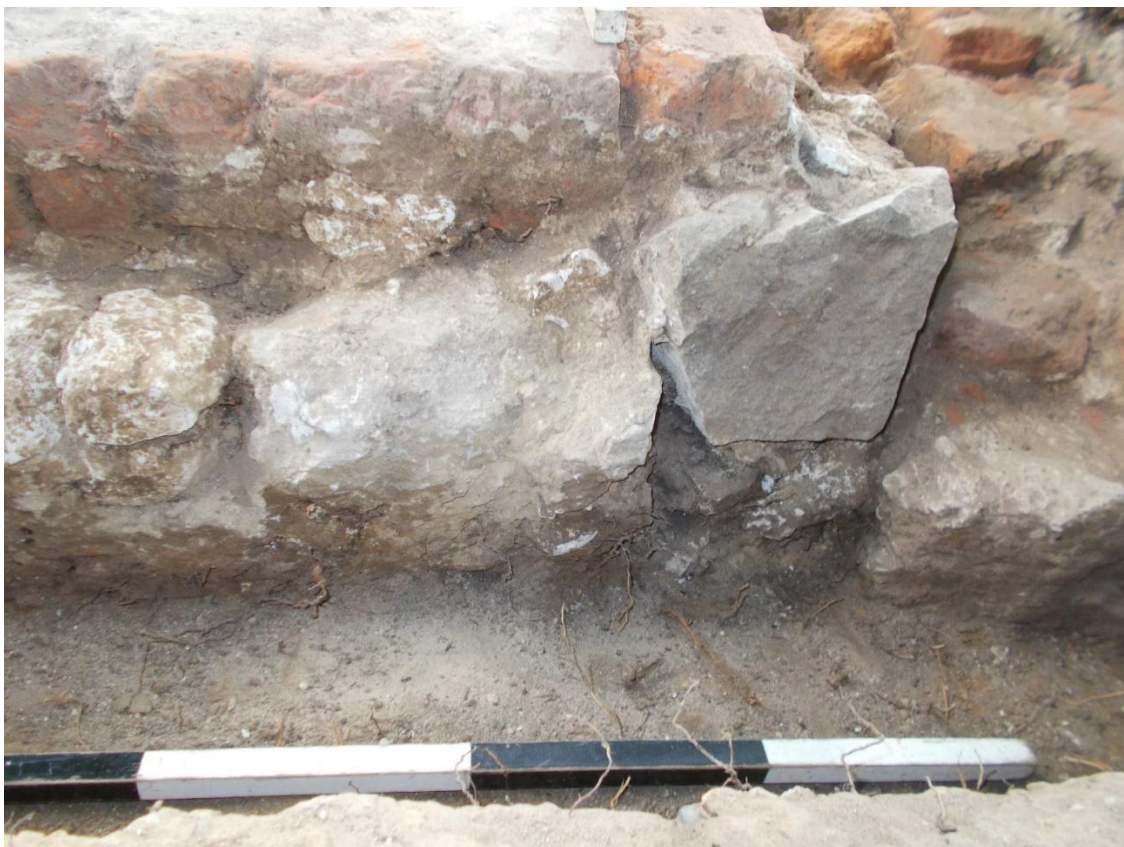
Pl. 3: Detail of Wall [9] Showing the Stone, Chalk and Mortar Raft (photo MJD)

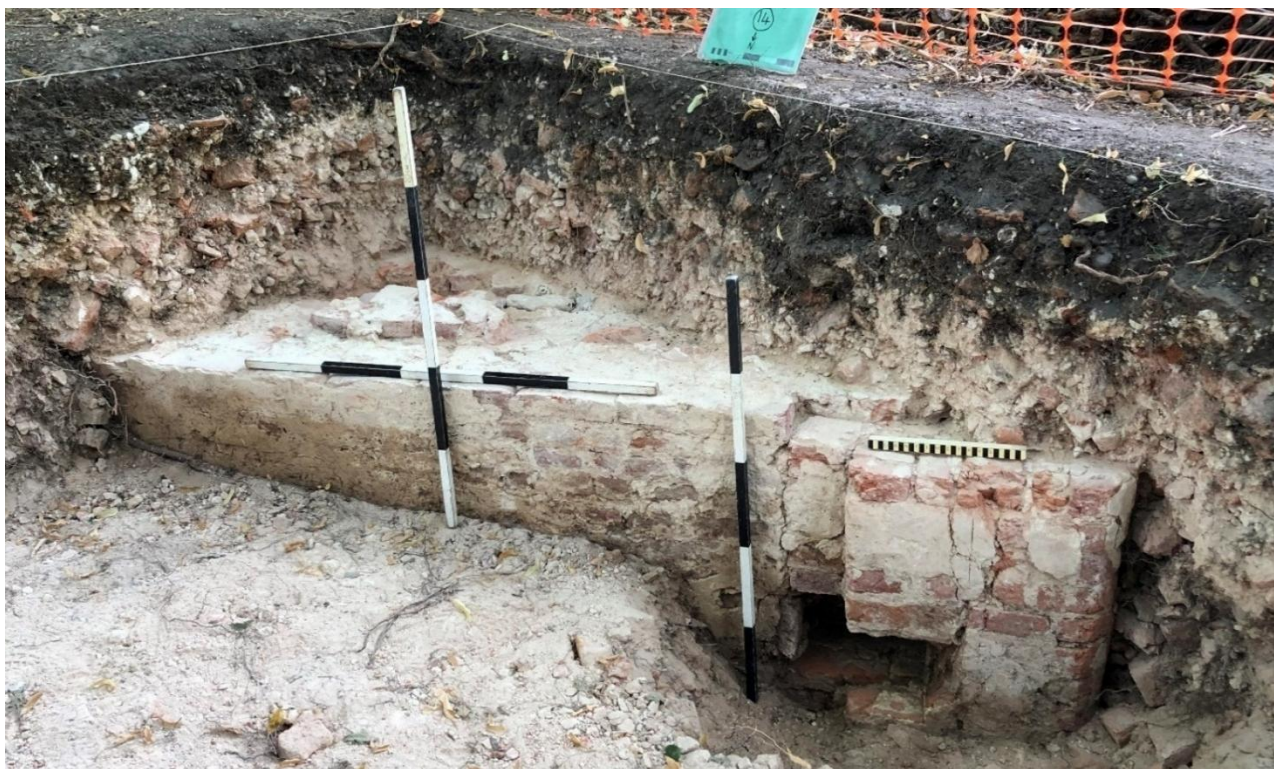
Pl. 4: Wall [14]/[18] Looking South East (photo John Pinchbeck)

- Opposite to [9] and forming the south east side of the tower was [14]/[18] (Pl. 4), again constructed in at least two stages (unless one was a later modification) and a length of 2.40 m of which was available for study. Its main element was an English bonded wall using hard white mortar, surviving to a maximum of six courses (0.80 m) above the base of excavation. It was 0.47 m wide and appeared to have a fair (north west) face parts of which had been rendered, though it was unclear how far any rendering had been demolition damaged and so how extensive it was. It appeared to have a mortared rubble core flanked by single skins of brickwork and its south east face was 0.02 m lower than its north west which, if not corrected higher up, would have given it a 3° lean to the south east.
