# **ENFIELD ARCHAEOLOGICAL SOCIETY ARCHIVE REPORT**

**EXCAVATIONS AT ELSYNG PALACE, FORTY  
HALL, ENFIELD, JULY 2025**

**(SITE CODE FXX25)**

**by  
MARTIN J. DEARNE**

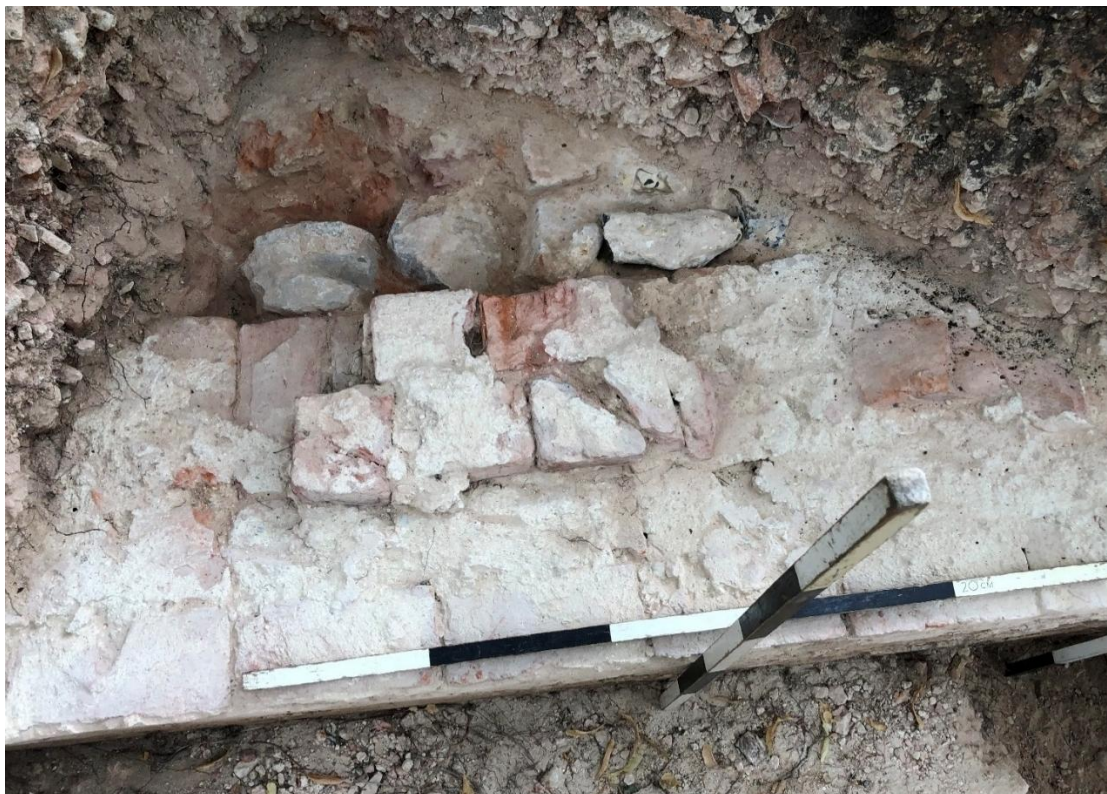
Pl. 5: Wall [14]/[18] Showing the Mortared Stone Reinforcement ([18]) Behind the Wall (photo John Pinchbeck)

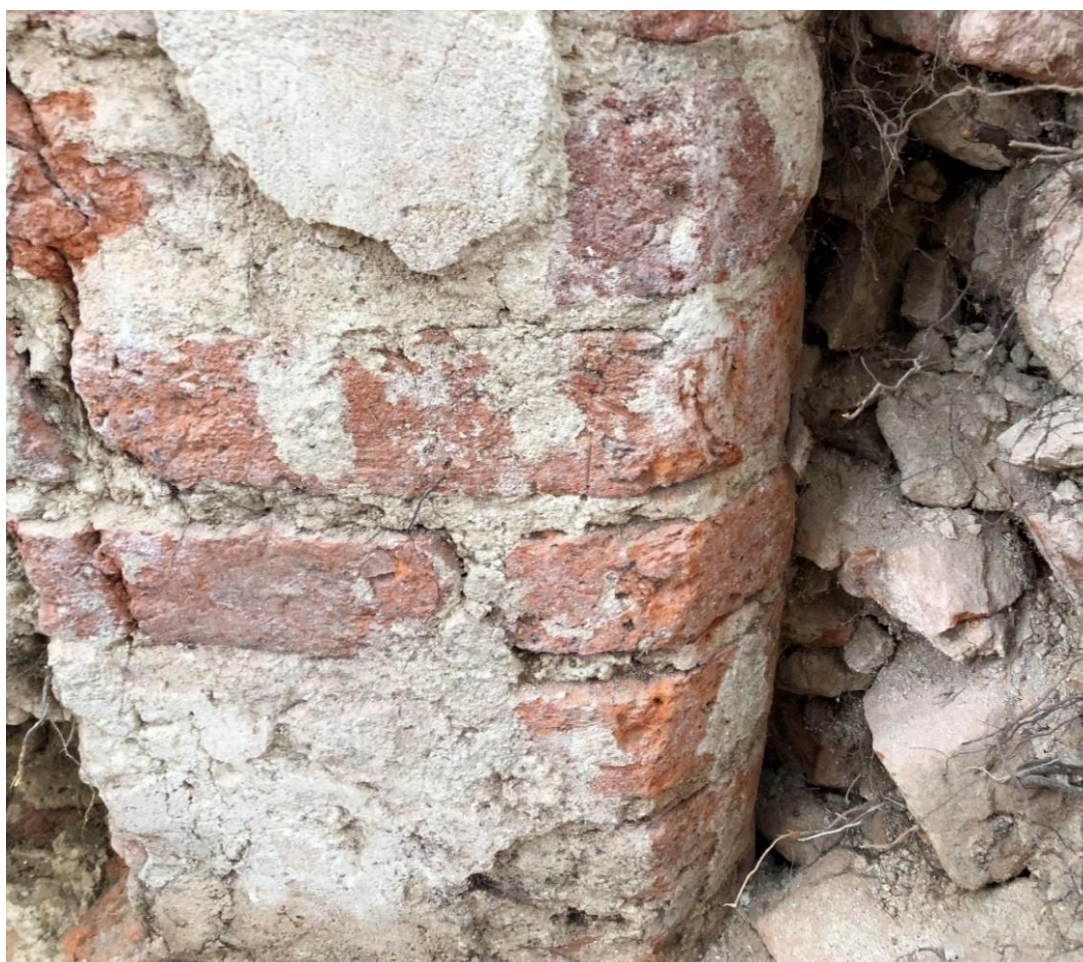
Pl. 6: Detail of the Chamfered End of Wall [14] (photo John Pinchbeck)

- At the south west end of the main brick wall a vertical straight joint showed that a 0.65 m long terminal to the wall had been added, be it as a modification or just in a separate stage of the construction process. Though the end face of the wall was largely beyond the excavated area, sufficient of it was accessible to establish that it had a rendered, chamfered corner using cut bricks (Pl. 6) and its north west face was also partly rendered (and may have been fully rendered but demolition damaged), if with a less careful finish than seen on walls such as [9], [13] and [14].

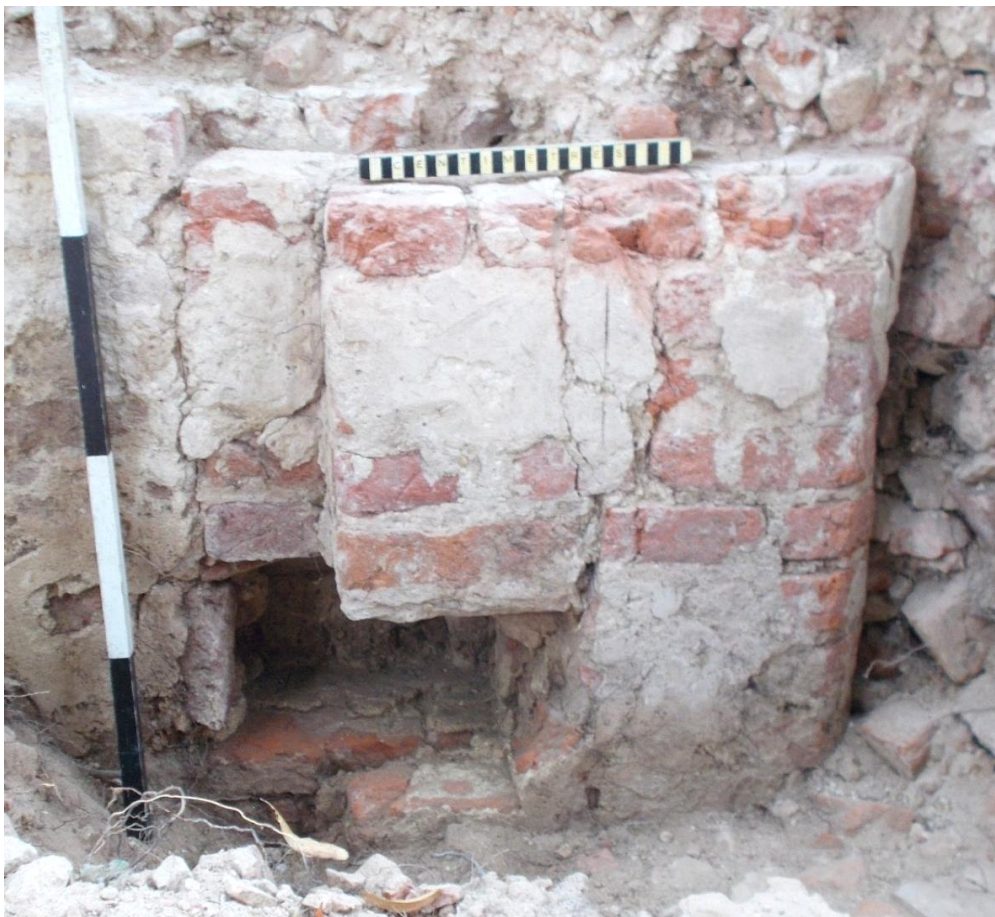
Pl. 7: The South West End of Wall [14] Showing the Void (Demolition Damaged to the Right)  
(photo MJD)

- This section of the wall was excavated sufficiently, showing that it survived to around 11 courses (0.72 m) above the limit of excavation here, to investigate a feature in its north west face which was found to be a rectangular void 0.21 m high, 0.27 m wide and 0.27 m deep (Pl. 7). The roof of the integrally built, rather than later cut out, void had been formed by thickly mortaring sections of peg tile into place and the void was almost certainly the setting for a very substantial timber beam.

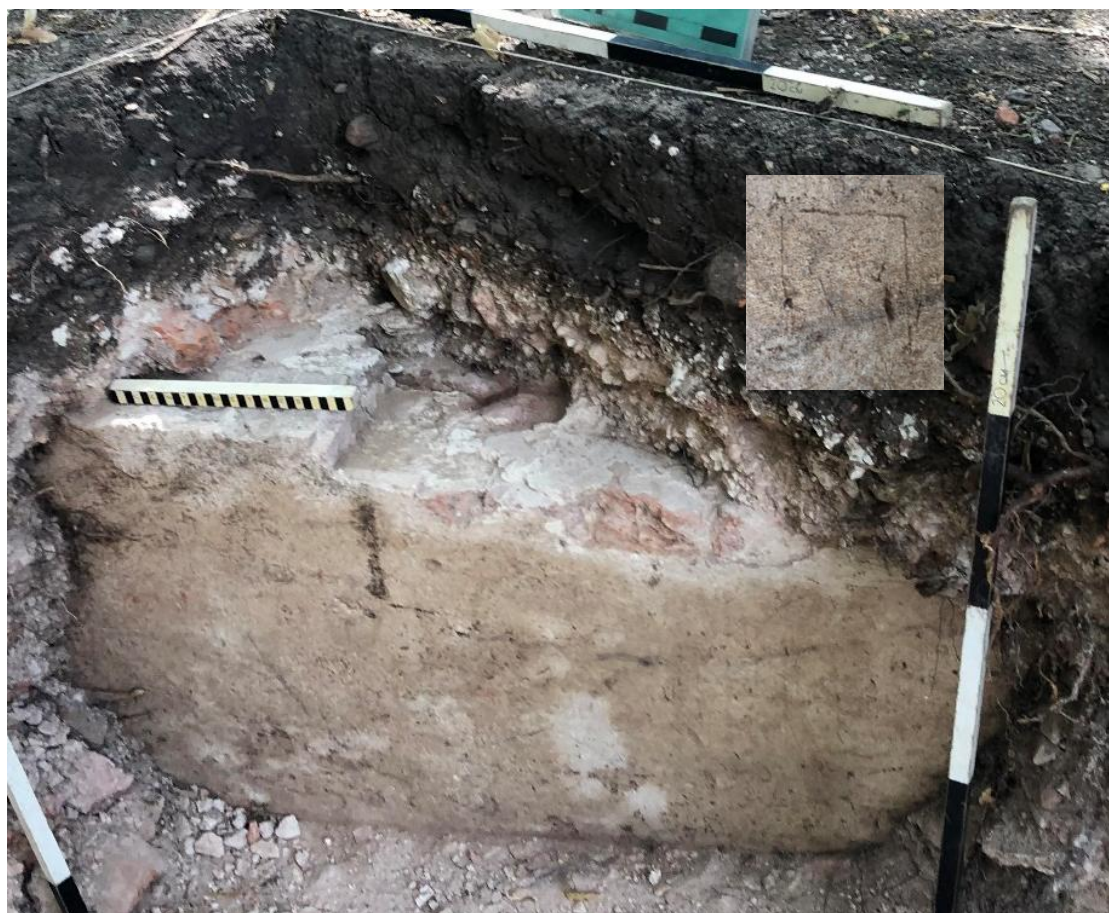
Pl. 8: Wall [13] Looking North East with the Graffito Inset (photos John Pinchbeck)

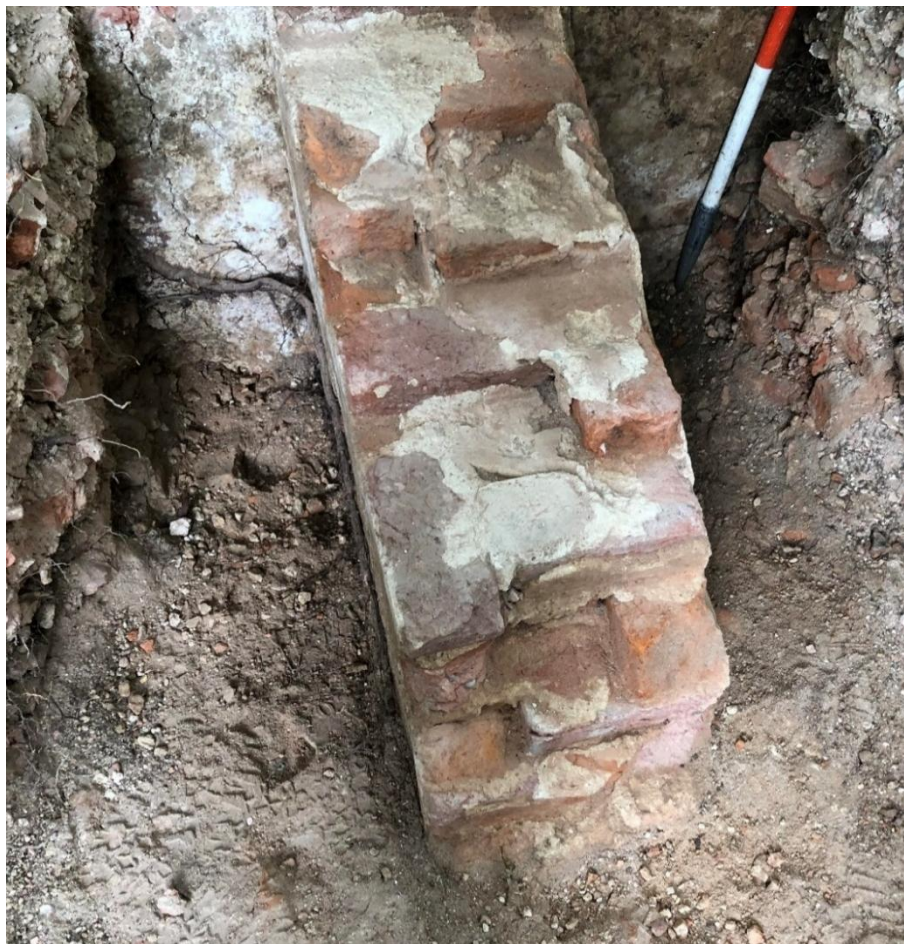
Pl. 9: Wall [17] Looking North (photo John Pinchbeck)

- If so this doorway would probably also have given on to another cellared room to the north west. Separated from the tower by wall [17], the rendering of its north west face indicating that it was an entirely internal wall, excavation was too limited to establish the dimensions of this second room. Indeed, it could have been subject to modifications in Phases 2 – 4, but both the limited exposure obtained and the extent of demolition damage at the level where excavation ceased meant that it was not possible to fully understand the building sequence here.

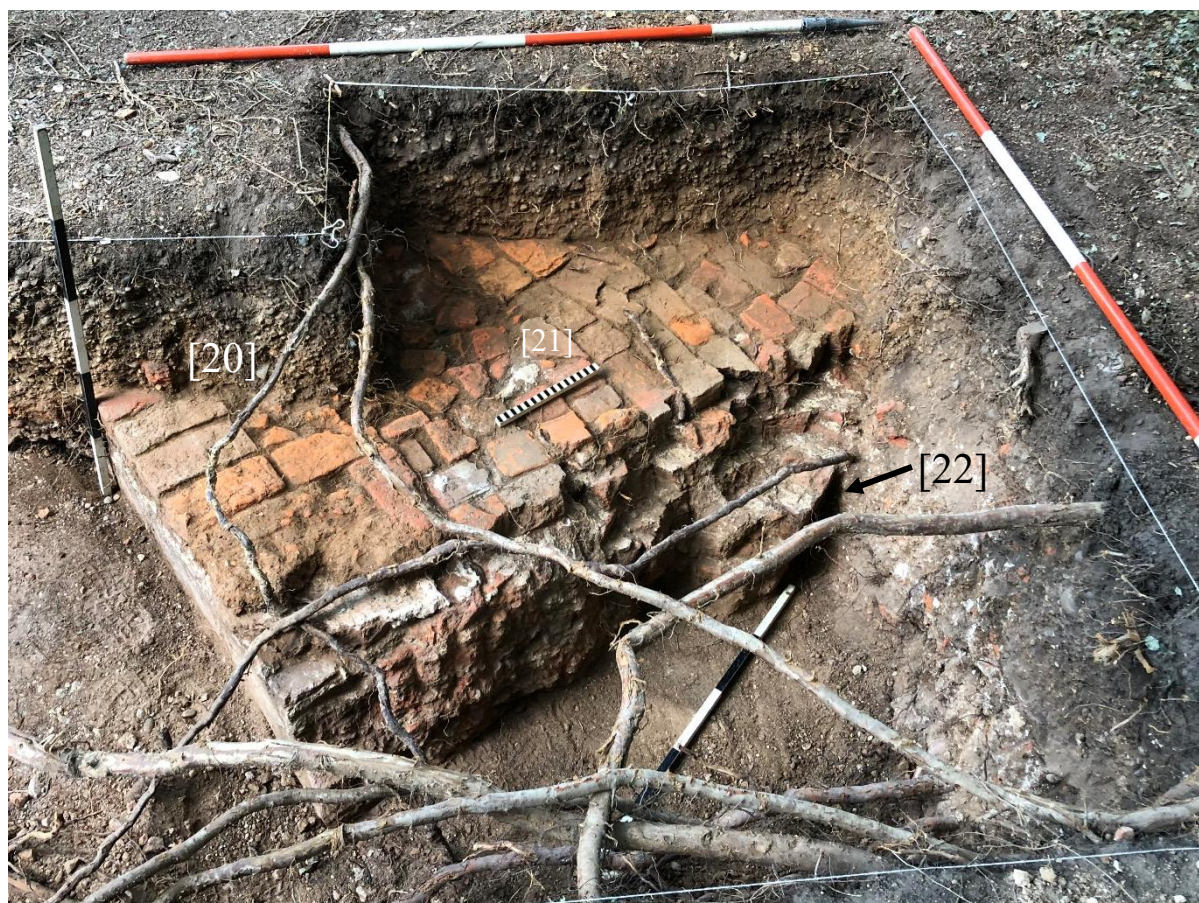
Pl. 10: Wall [20], ?Wall [22] and Brick ?Floor [21] Looking West (photo John Pinchbeck)

- If it was the case that walls [20] and [9] flanked a doorway it would provide a possible interpretation of another section of what appeared to be walling in Trench 5. This, [22], had probably, but not certainly, been truncated and overlain by a new structure perhaps at some point in Phases 2 - 4 (see below) and probably further damaged by Phase 5a demolition. Though its width could not be ascertained, one short section of its original fair but unrendered face survived to seven courses above the limit of excavation and indicated that it ran south east to north west. It could therefore have run on to meet wall [20] beyond the point where it was preserved, ?again to form one side of a doorway.

- However, [22], the small available exposure of which was far too damaged to assess in detail, was bonded with a different mortar to [20],<sup>3</sup> the angle at which they would have met appeared to be rather acute and, unlike [20], [22] did not have a rendered face. The area to the east of [22] in Trench 5 appears to have been sunken by over 0.52 m with respect to the ground floor level of the building (as represented by the level of [10] 2.50 m to the north east in Trench 2) so that, like [20], [22], if it was a wall, appeared to be one delimiting a cellared space and speculatively such a space might have been a corridor leading to the room of which [20] was the north west wall.

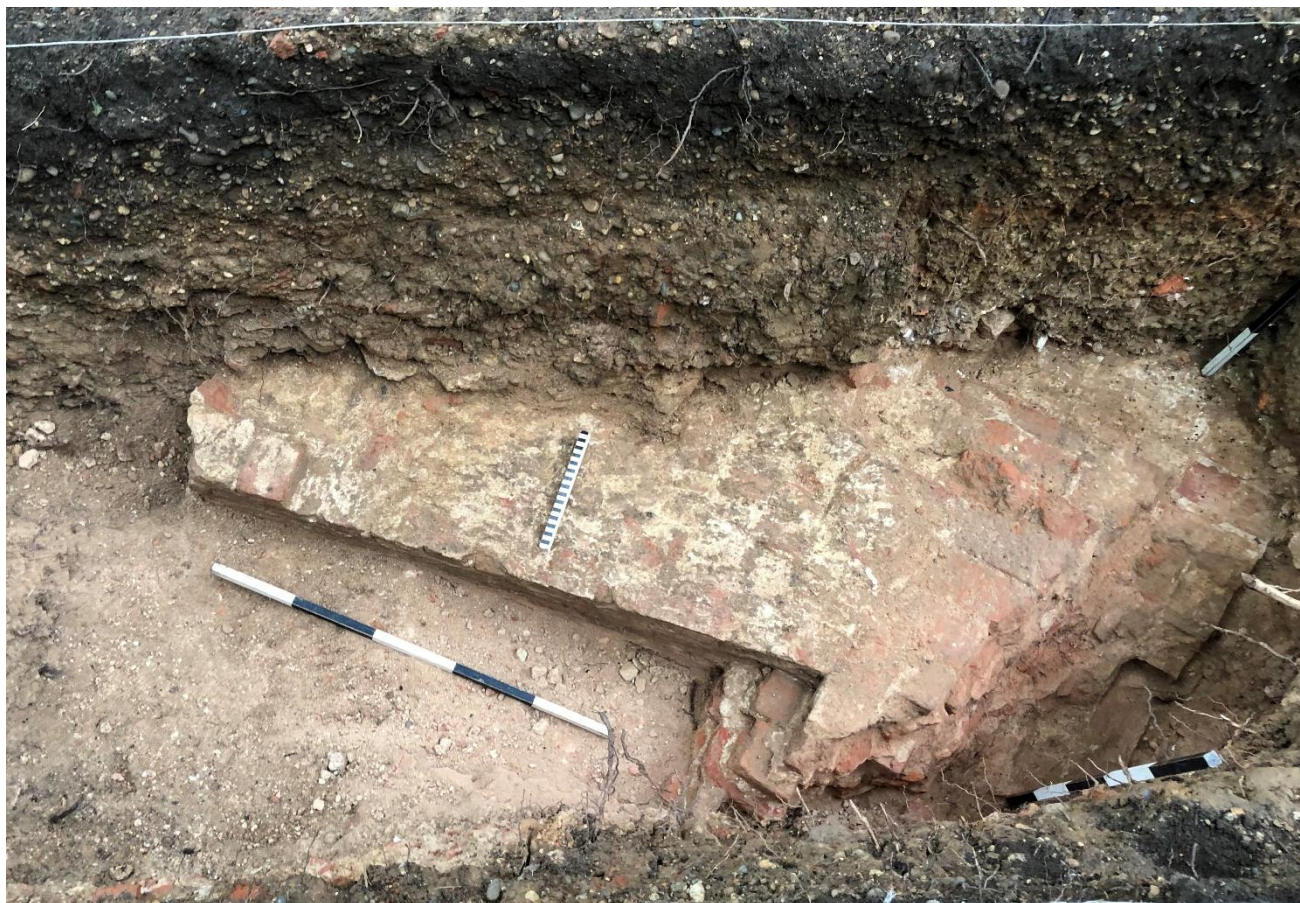
Pl. 11: Wall [19] Looking South (photo John Pinchbeck)

- Wall [19] had clearly been heavily demolished in Phase 5a, generating a deep deposit of rubble, [11], which lay above and around the remains of the wall and clearly continued below the level at which excavation ceased. It varied in composition, above the wall being a very compacted mass of blocks of hard white mortar, large brick fragments and large parts of peg tiles (as well as a single ridge tile fragment), while to its north it was much looser with frequent brick rubble (to 0.10 m), but in large part comprised crushed white mortar (so was somewhat similar to [5B] found in Trench 1).

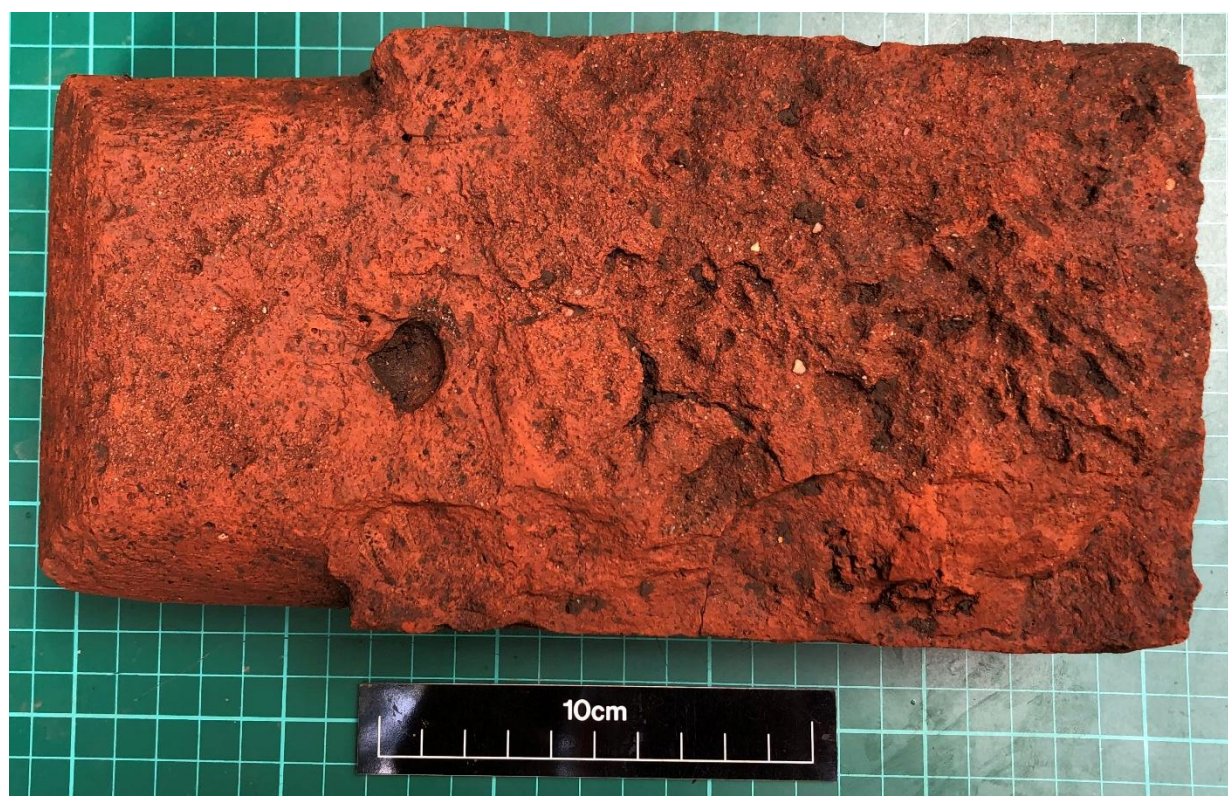
Pl. 12: Shaped Brick 2.2 (See Appendix 3) (photo John Pinchbeck)
