ENFIELD ARCHAEOLOGICAL SOCIETY (SECONDARY) ARCHIVE REPORT

EXCAVATIONS AND RECORDING IN AND SOUTH OF THE FORMER PALACE GARDENS AREA OF ENFIELD TOWN 1977 – 79

(SITE CODES PG77, PM78 and LY79)

**by
MARTIN J. DEARNE
partly based on an archive report by
JAMES DINN and †SUSAN REYNOLDS**

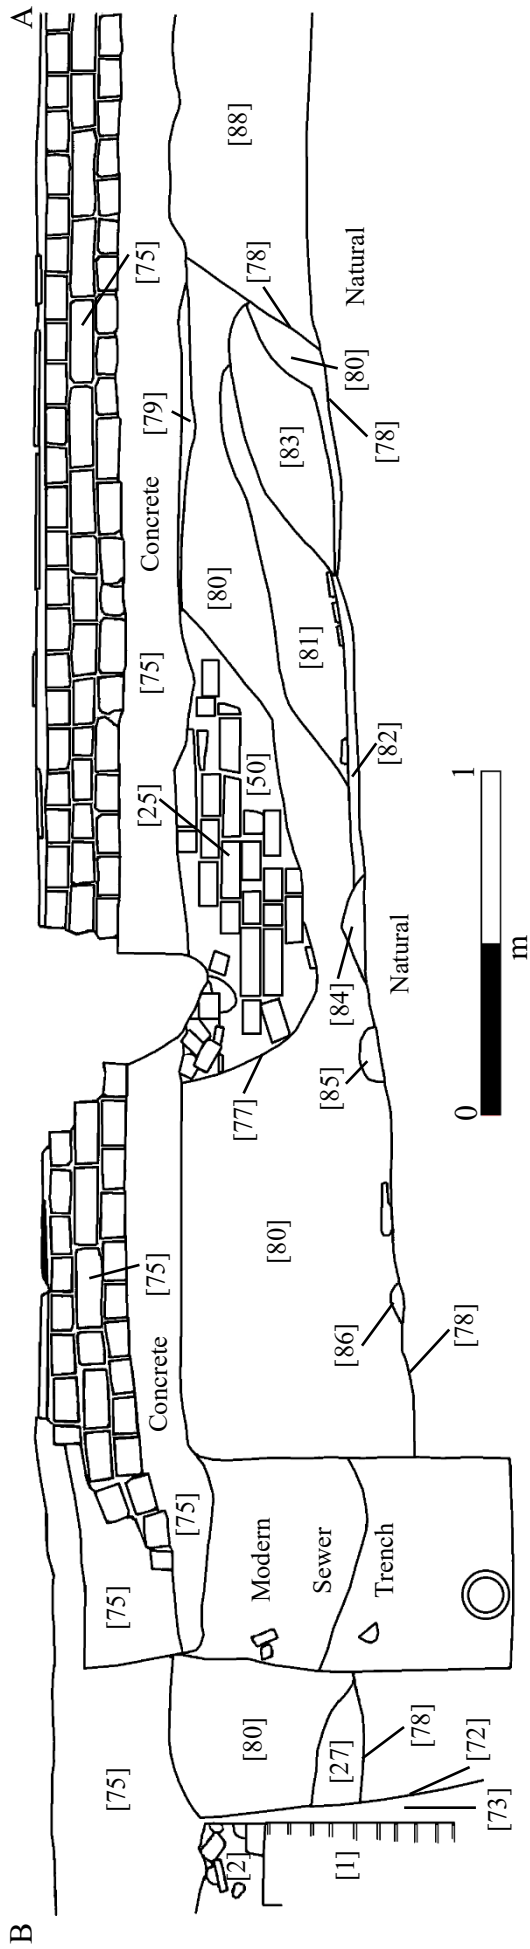
Fig. 5: PG77 Area I
South Section and Areas Excavated

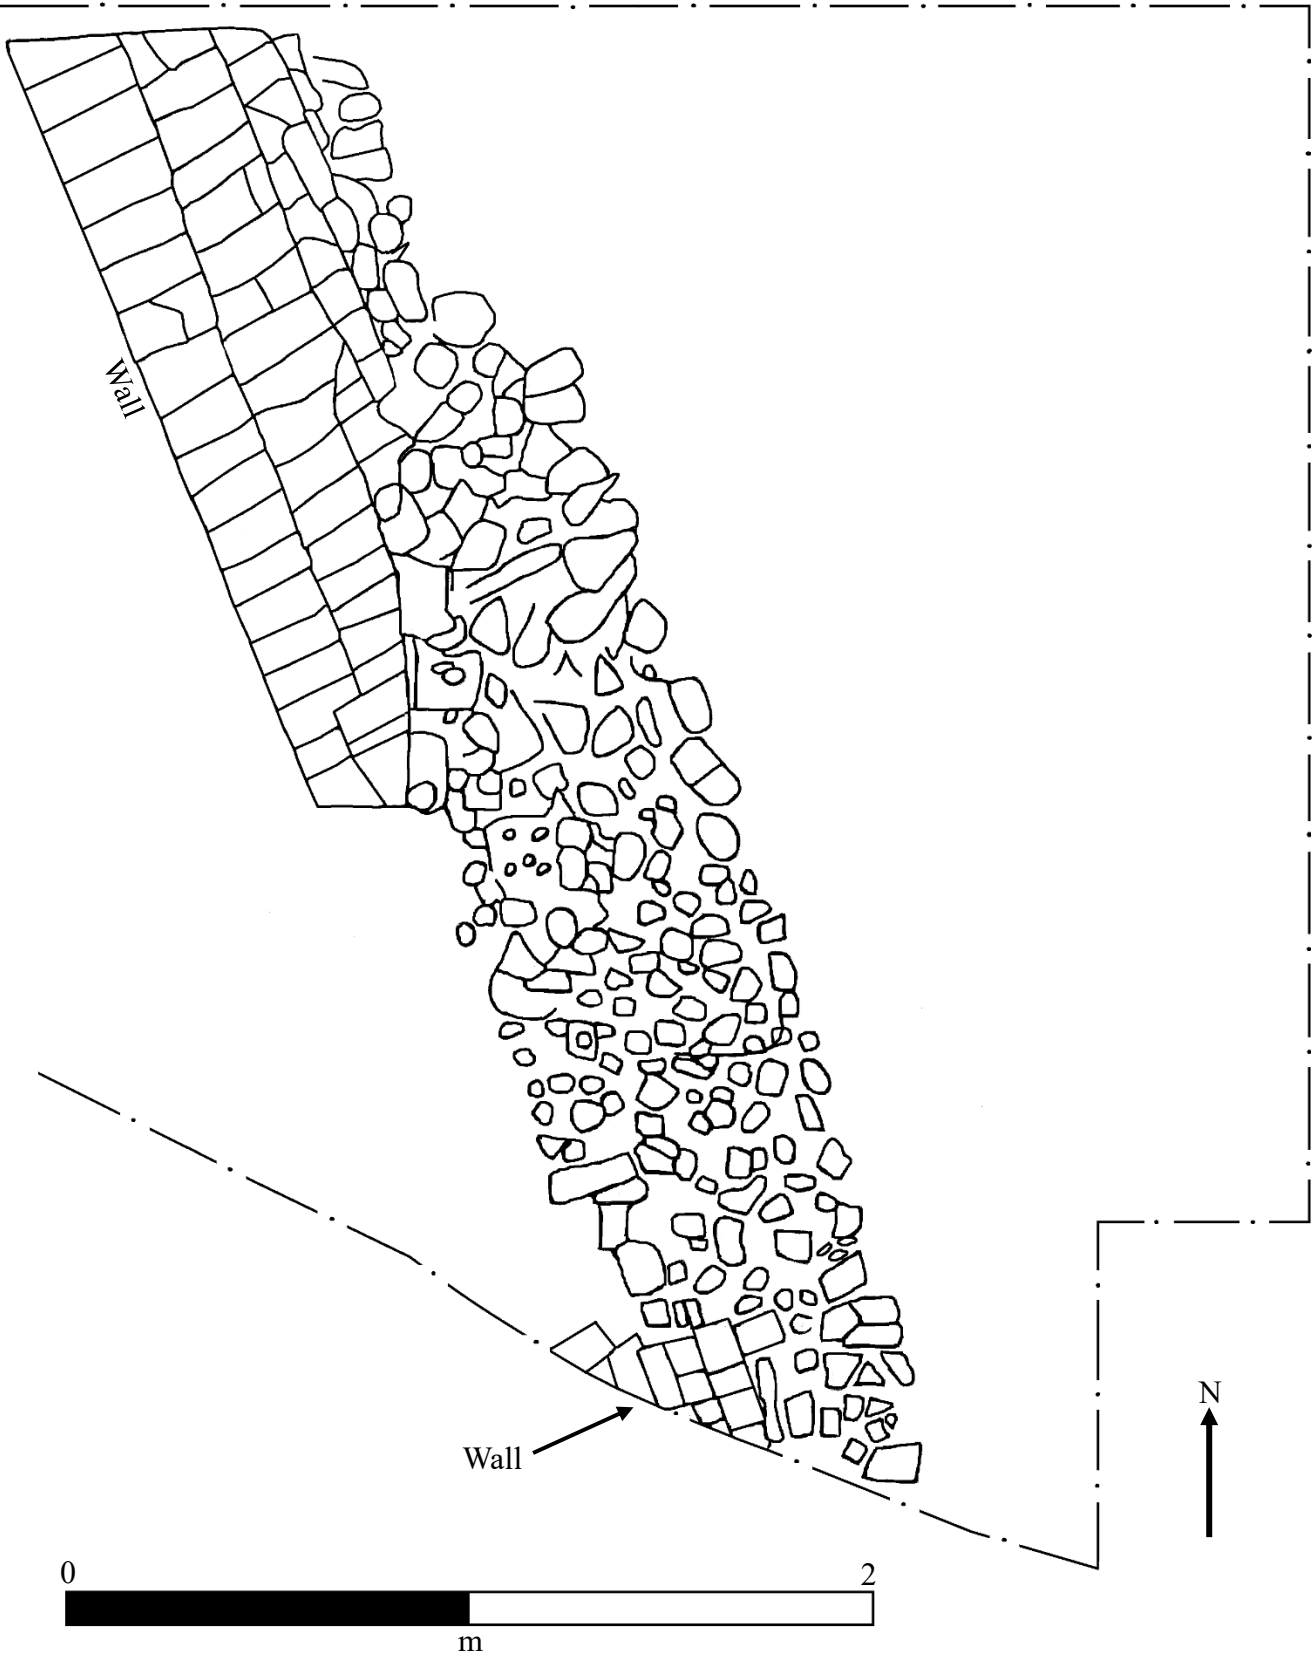
Fig. 6: PG77 Area I Wall [25] and Rubble Foundations (1:20)
(EAS plan)

- To the north of this section at least parts of wall [25] (F14) survived for a length of 3.90 m, but with a c. 1.40 m gap where it had evidently been demolished down to what was taken as being a foundation of (reasonably flatly lain) part bricks (though the professional team did not separately re-context this) (Fig. 6). The foundation is said (only in Armitage and Ivens 1978a; 1978b, 144) to have been 0.11 m thick and seems from plan and photographic (Pls 5 and 6) evidence to have been 0.80 m wide, projected often 0.40 m to the east of the wall, but not to have been present under the western 0.40 m of it. Together with the sectional evidence, it therefore seems likely that the wall line had been changed after the foundations had been lain. The wall itself was 0.61 m wide and survived to three courses. It looks to have been English bonded with white mortar using hand made unfrogged bricks, the top course at least on the west perhaps not fair faced and that course probably of two skins of headers and one on the west of ?part brick stretchers. The absence of much mortar on the top of the surviving section raises the possibility that it was in fact only a dwarf wall, though the carrying of the bricks filling the east side of the construction trench where seen in section to the top of the surviving wall probably argues against this and it is most likely to have been a free standing boundary wall. This wall, despite assumptions at the time that it was Tudor, is impossible to closely date, though the use of fully white mortar on other local sites appears to begin around the end of the fifteenth century so a sixteenth to seventeenth century date might be suspected.

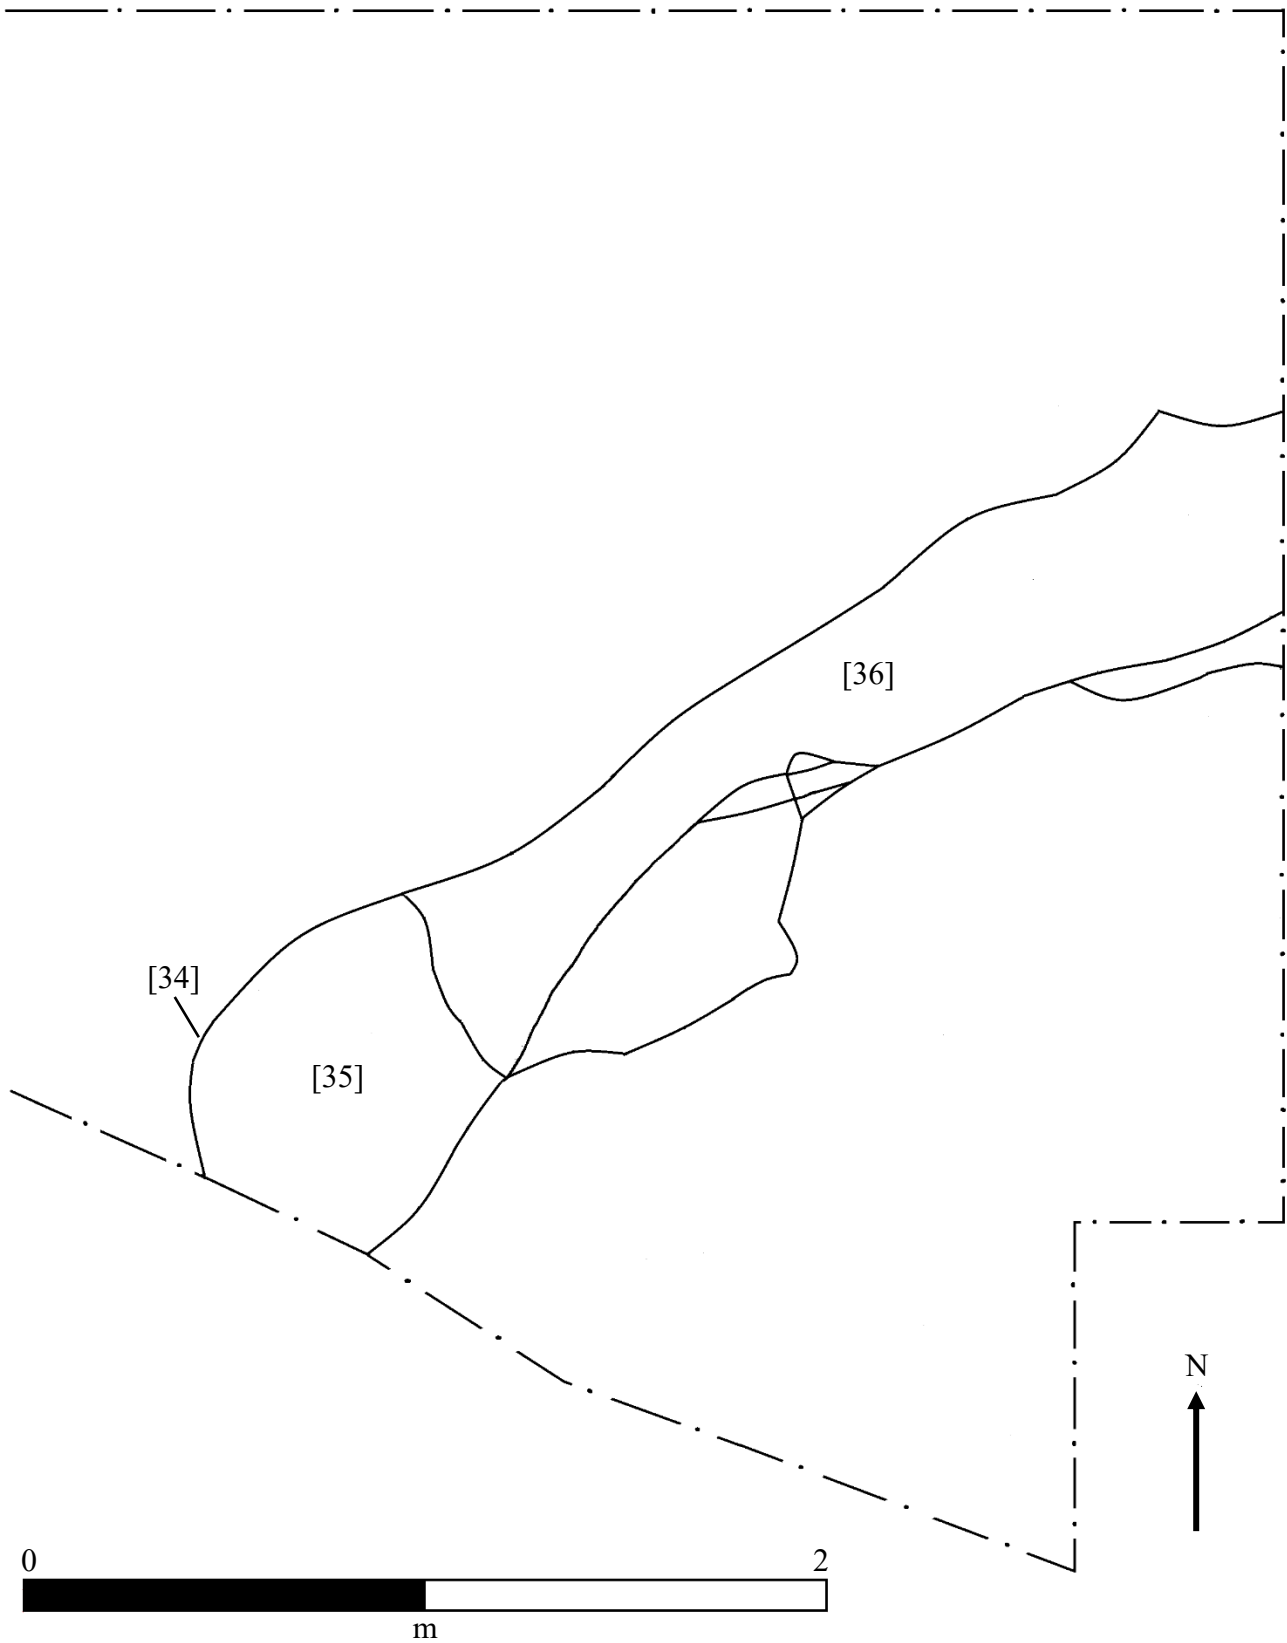
Fig. 7: PG77 Area I ?Gully [36] and ?Sump [34] (1:20)
(EAS plan – what some lines indicate is unknown)

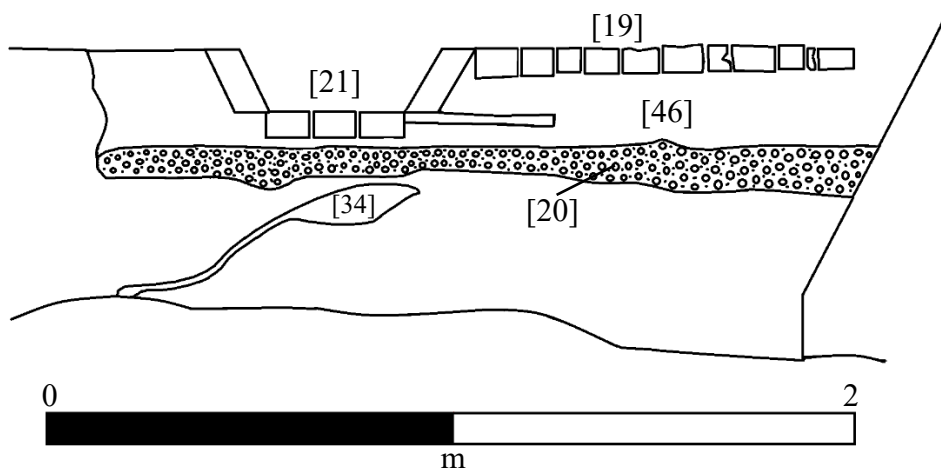
Fig. 8: PG77 Area I Section (1:20)
 (EAS drawing – line of section and what some lines indicate is unknown;
 possibly a composite/idealised section)

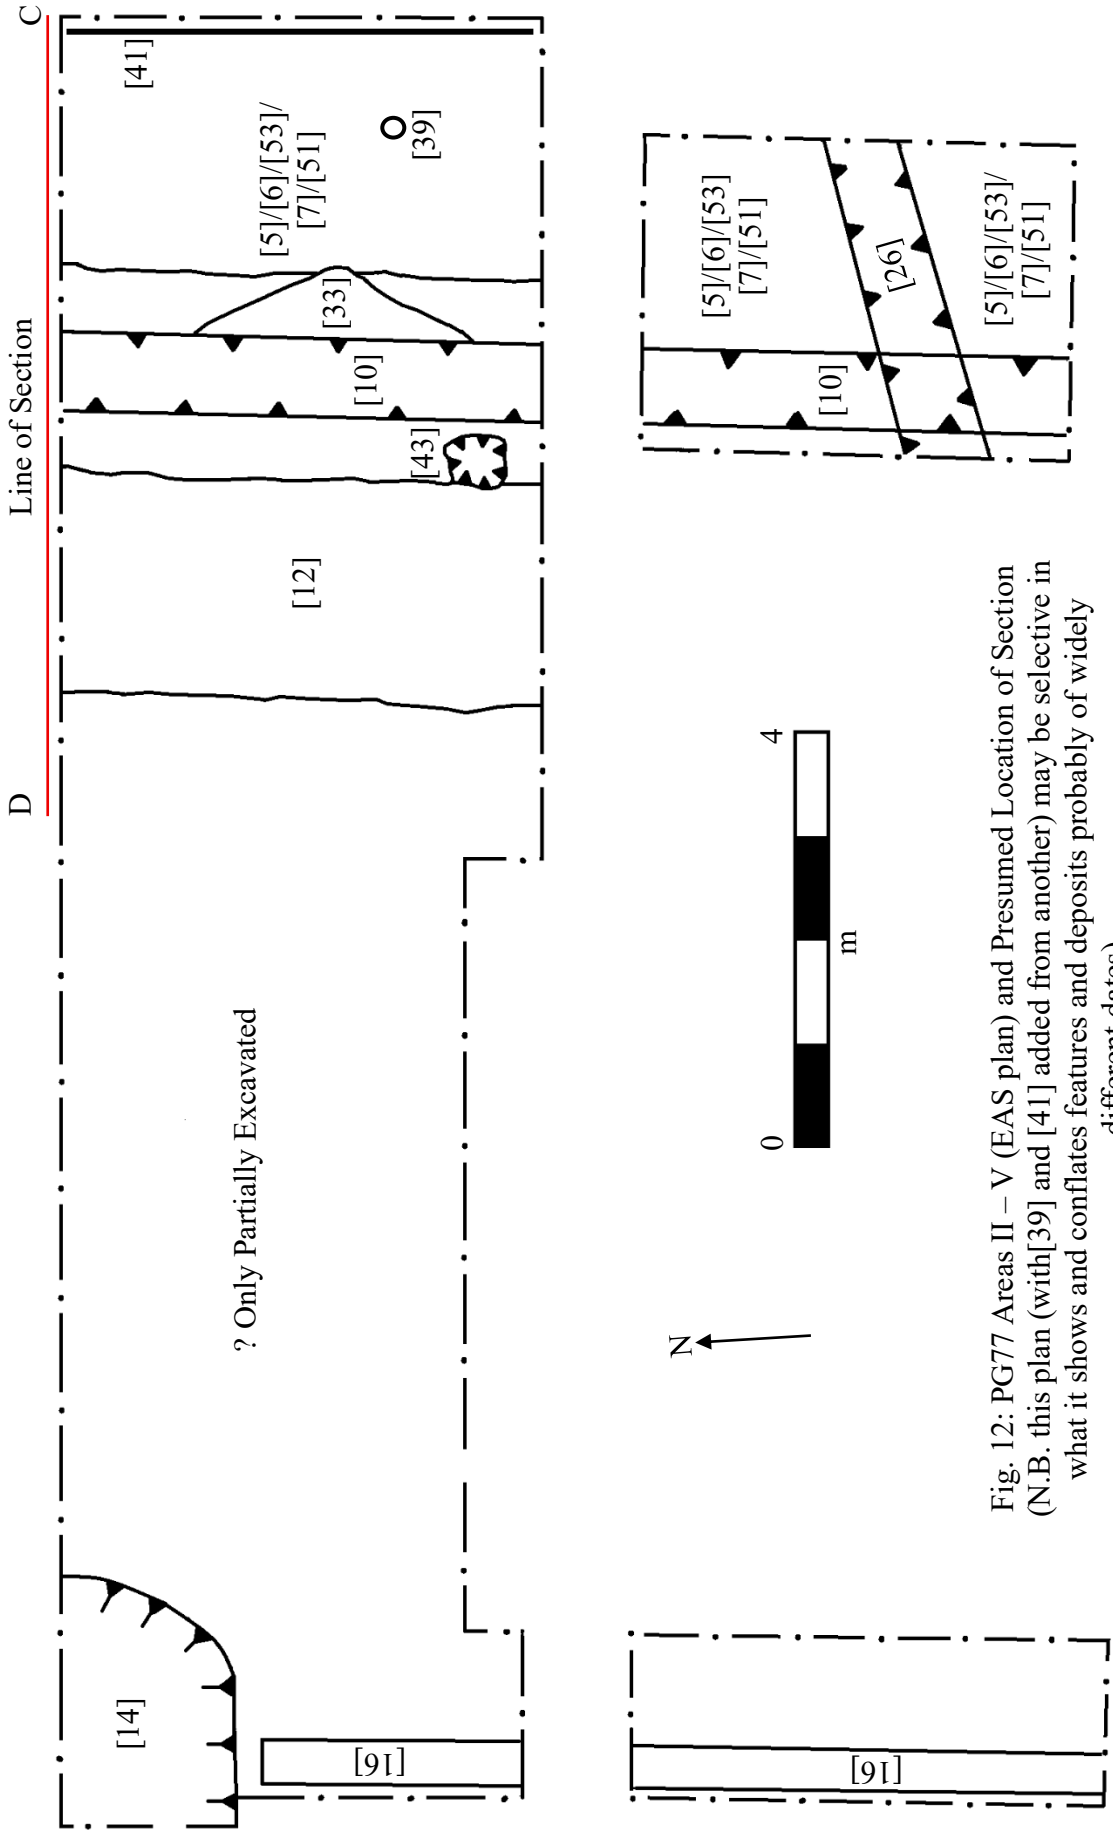
Fig. 12: PG77 Areas II – V (EAS plan) and Presumed Location of Section (N.B. this plan (with [39] and [41] added from another) may be selective in what it shows and conflates features and deposits probably of widely different dates)

- Areas II and III (Figs 2 and 3) can only be assessed from very limited plans (mainly just one overall site plan, Fig. 12), a single section drawing (Fig. 13) and some highly inadequate notes and photographs in an EAS site book, together with what the professional team could deduce, including from the finds. These records are entirely inadequate to make any reasonably reliable assessment of what was actually found beyond demonstrating that many of the interpretations in Armitage and Ivens (1978a; 1978b) are very problematic. What is attempted here then is just a basic description of what these records seem to document with the very significant caveat that even what is recorded may be suspected to be inaccurate as well as very incomplete.

- Partially overlaying and further east of [33] over the 'brown soil', a sequence of layers, shown in section as overall around 0.40 m thick but undifferentiated, appear to have been found at the east end of Areas II and III (Fig. 12) together with, at the north east corner of Area III, a pit shown in section (if this is the pit in question since it has no context designation) as cut into the 'brown soil', but in site records said to have been cut through the lowest of these layers.

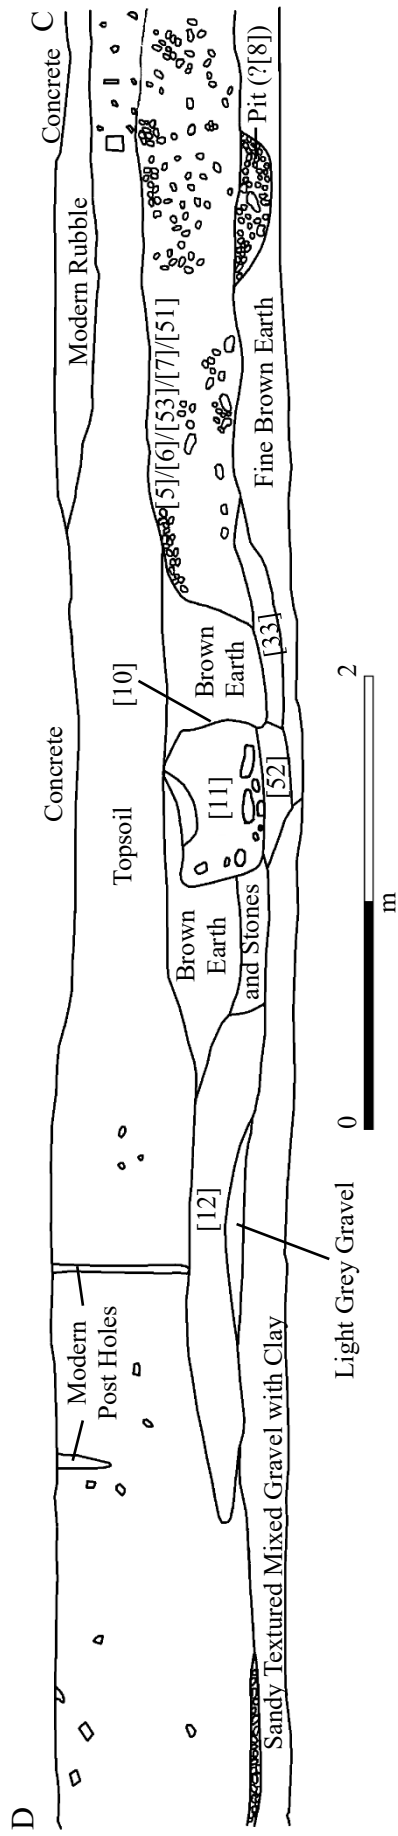
Fig. 13: PG77 Area III "Section North Face" (EAS drawing)

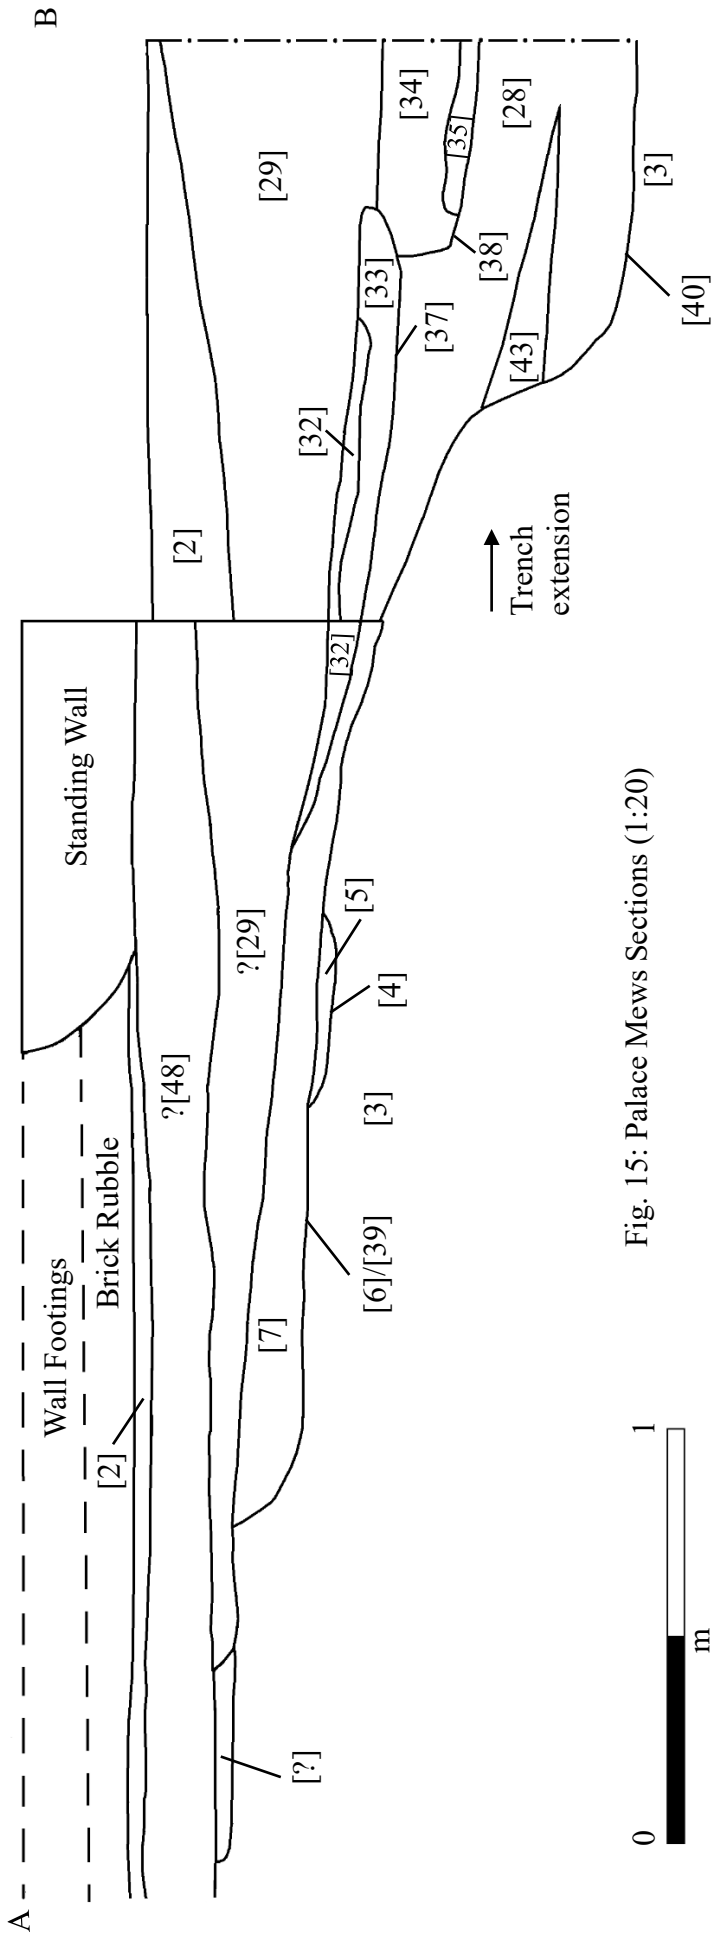
Fig. 15: Palace Mews Sections (1:20)

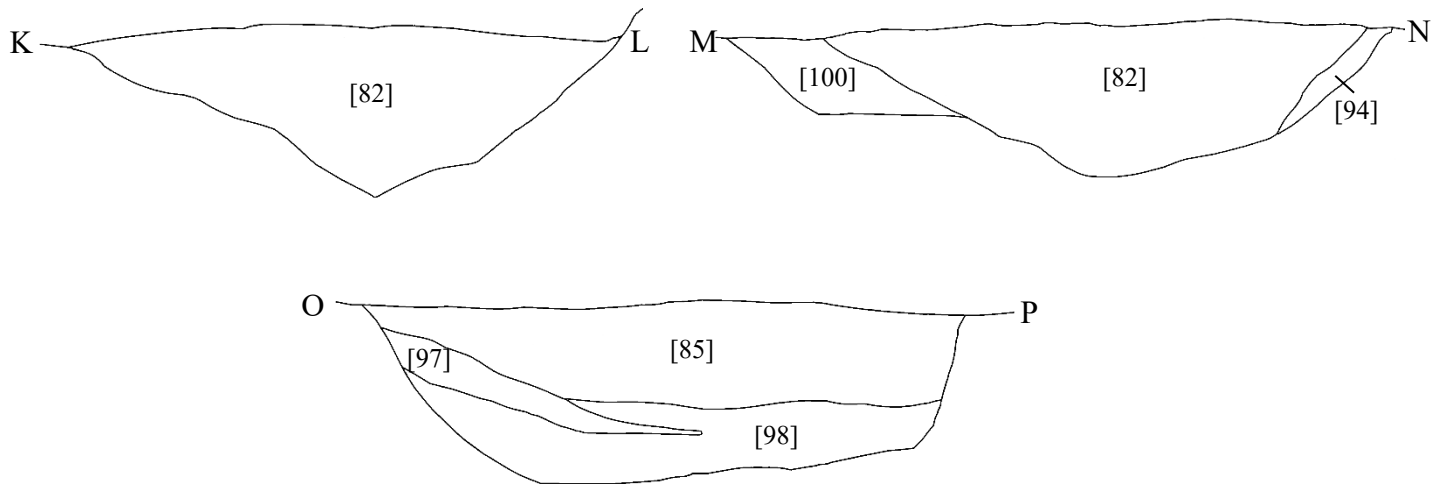
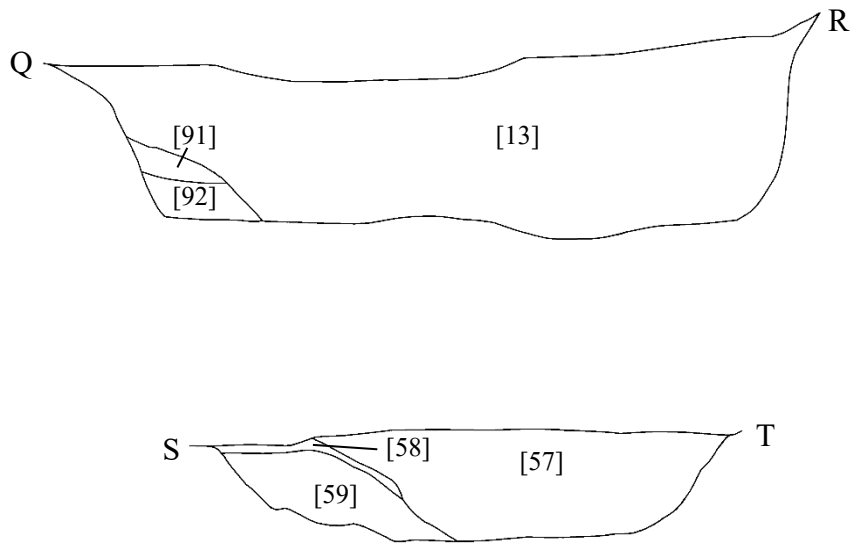
Fig. 18: Laing's Yard Sections (1:20)

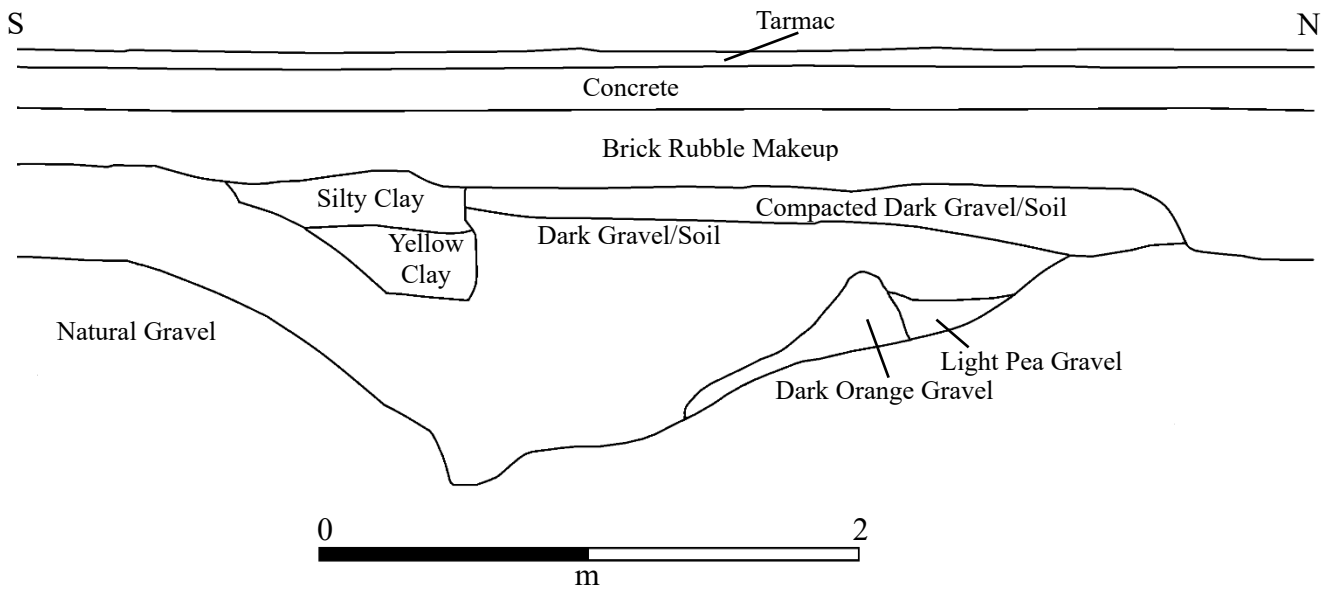
Fig. 19: Section of Ditch Recorded in Sewer Trench Watching Brief

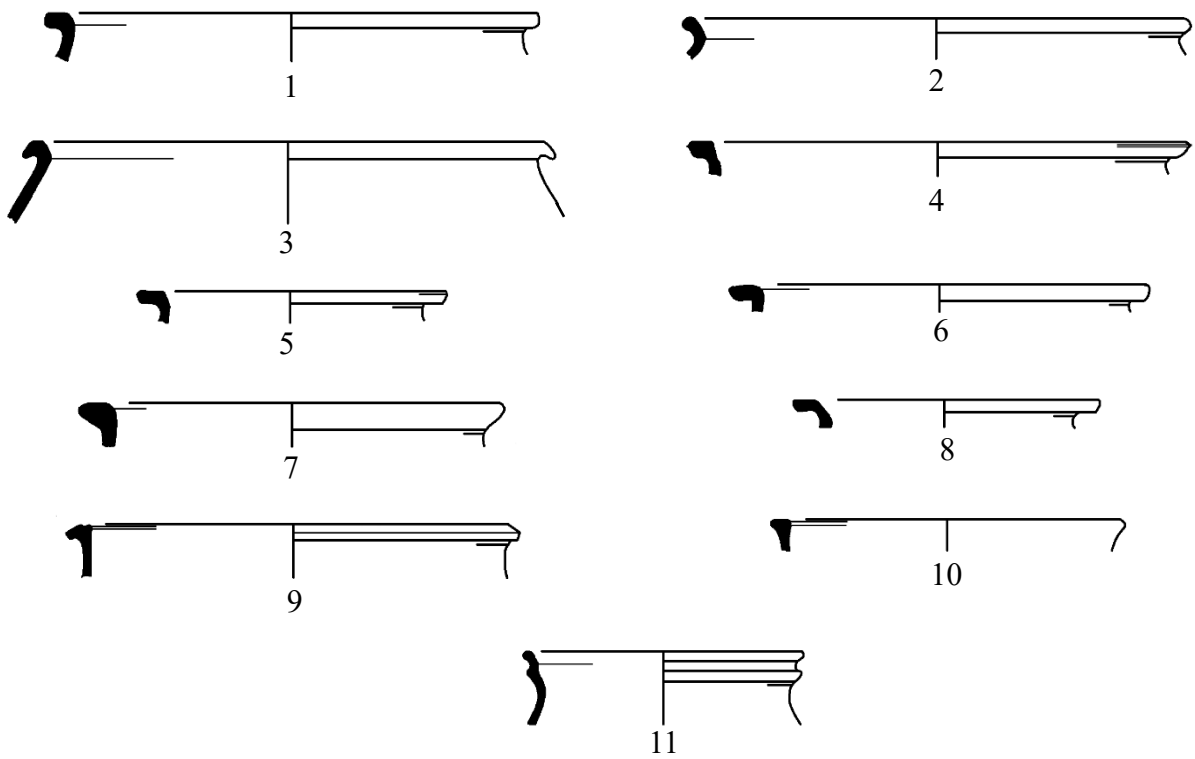
Fig. 20: Laing's Yard Pottery (1:4)

- Rims from at most 46 pots were found, nearly all simple everted forms. The main forms are shown on Fig. 20.
- [The order of Reynolds' list of these which follows has been changed to make it more comprehensible, but her terminology for rims is retained, even though some of it might now be seen as outdated. Note that she regarded all jars as cooking pots, but Nos 1 - 4 are towards the upper end of the diameter of medium sized jars (Blackmore and Pearce 2010, 136) so a function as storage jars probably cannot be ruled out. Rim forms are as Blackmore and Pearce (2010, 135ff) and the context numbers from which the vessels came have been added from archive drafts of the illustrations.]

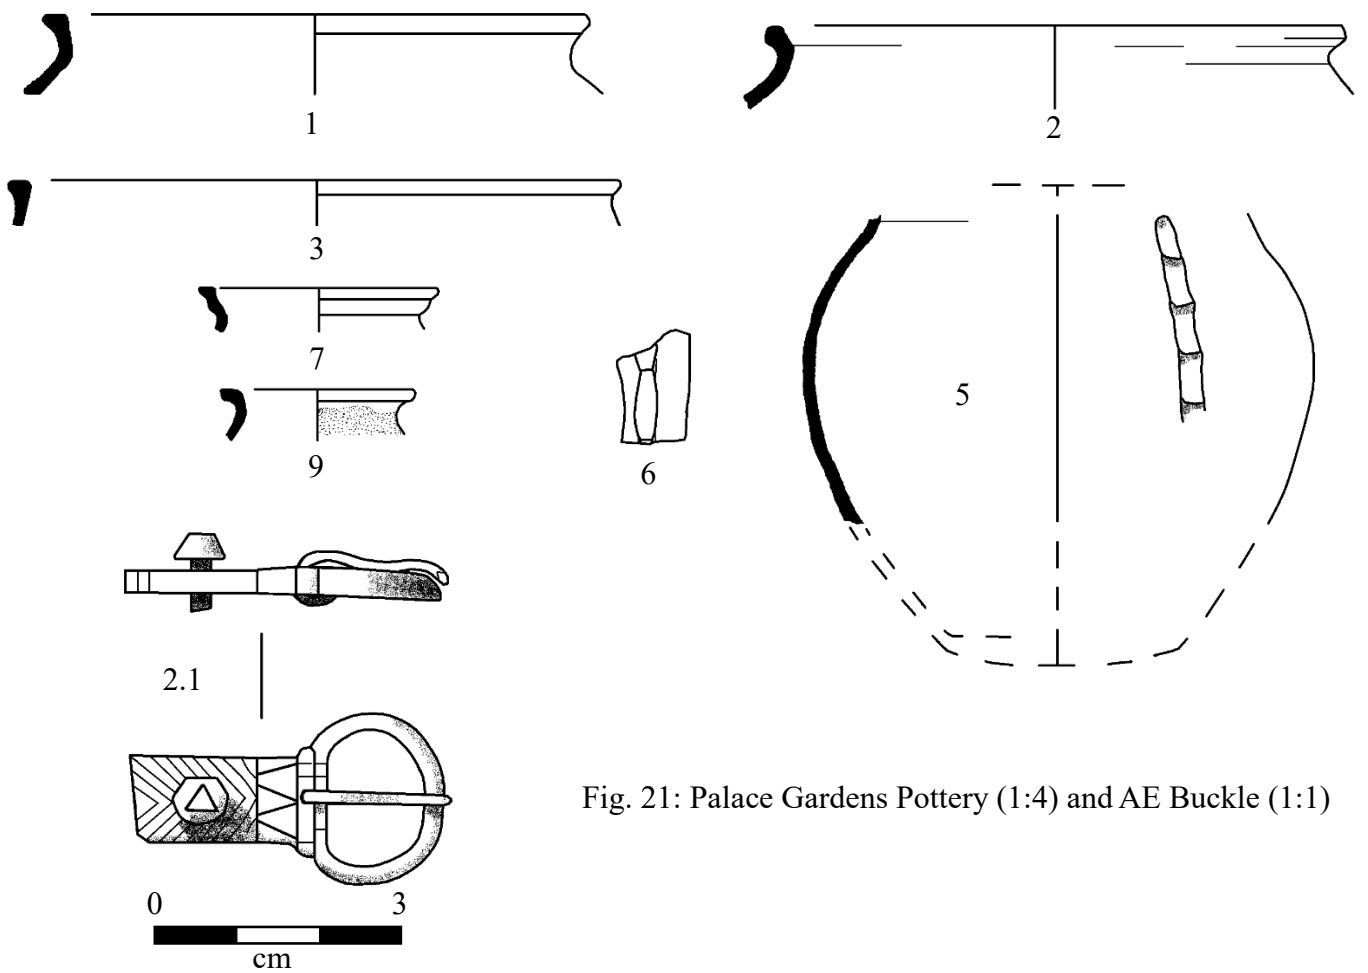
Fig. 21: Palace Gardens Pottery (1:4) and AE Buckle (1:1)

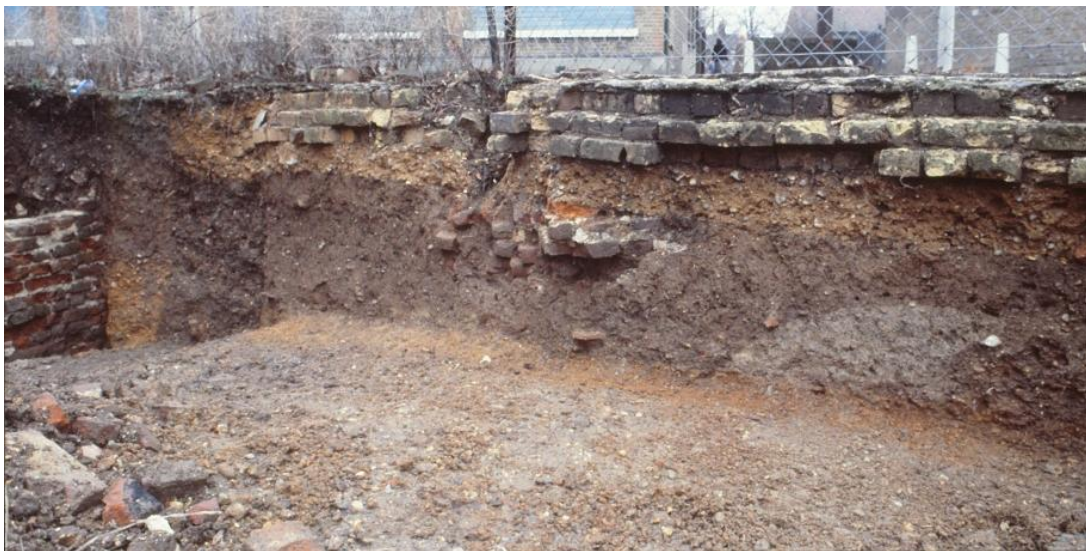
Pl. 4: PG77 Area I South Section (photo EAS/Enfield Local Studies Archive)

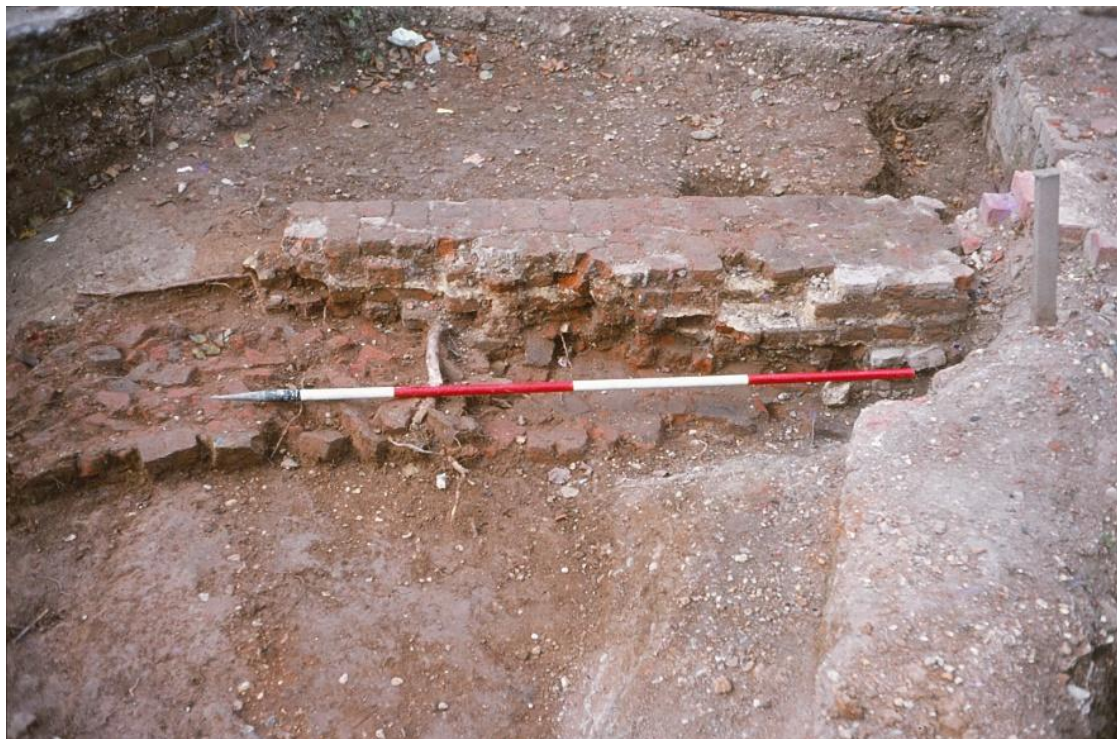
Pl. 5: PG77 Area I, Wall [25] Looking West (photo EAS/Enfield Local Studies Archive)

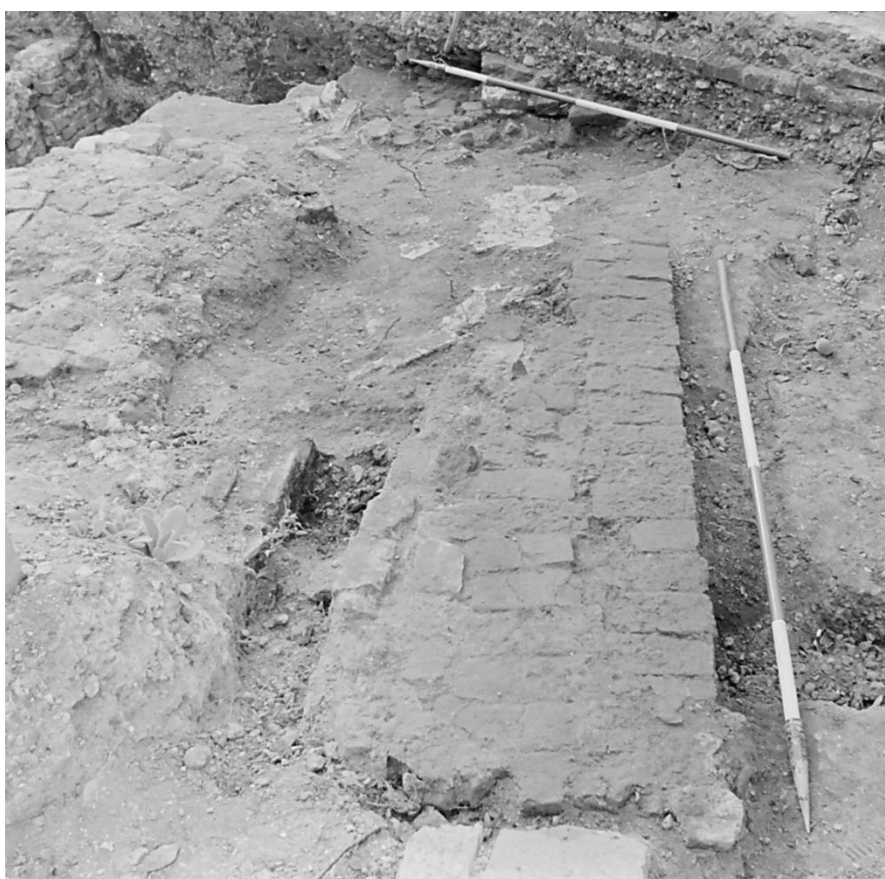
Pl. 6: PG77 Area I, Wall [25] Looking South (photo ?S. Somers/EAS archive)

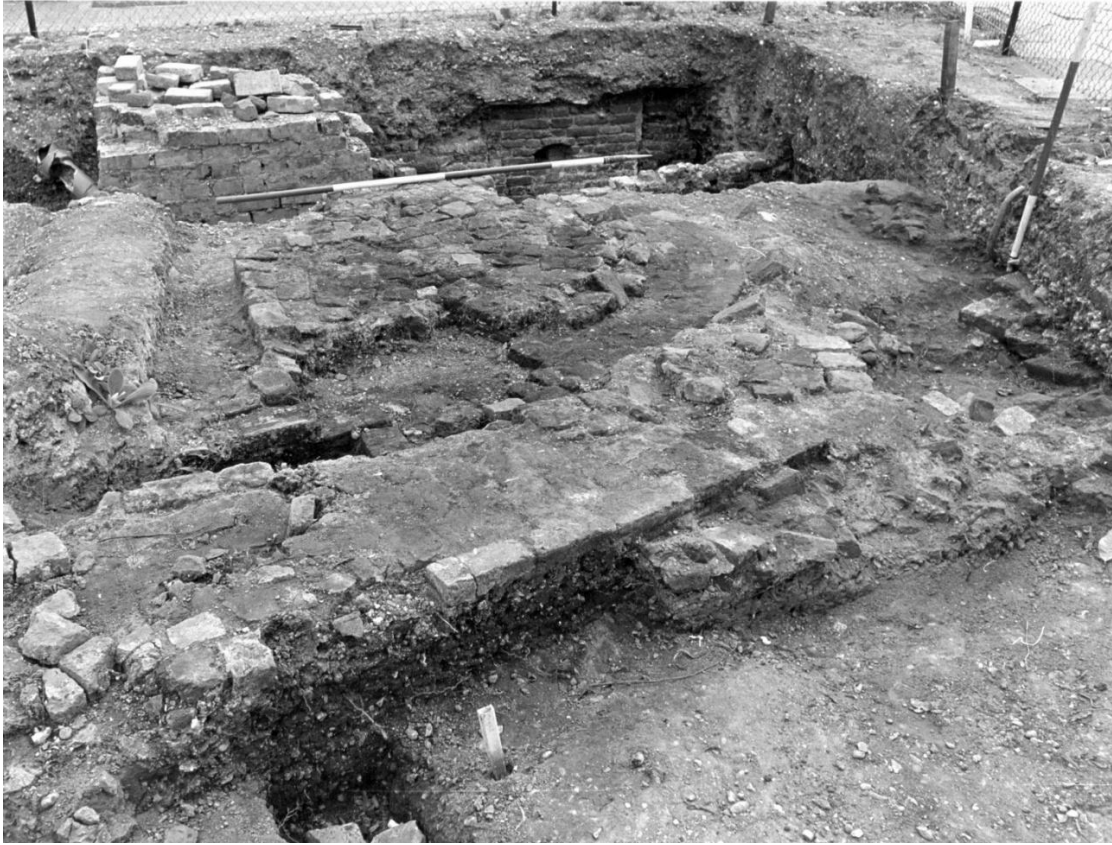
Pl. 7: PG77 Area I, Mid Ground Circular Structure [19]/[21] with Path [22] in the Foreground (to Left Beyond it Pit [23] to Right Wall [25] seen in Section and to Right in Front of [22] Brick ?Rubble) Looking East with [1] in the Background and to its Left a Modern Brick Built Sewer Chamber (photo S. Somers/EAS Archives = Armitage and Ivens (1978b) Fig. 1)

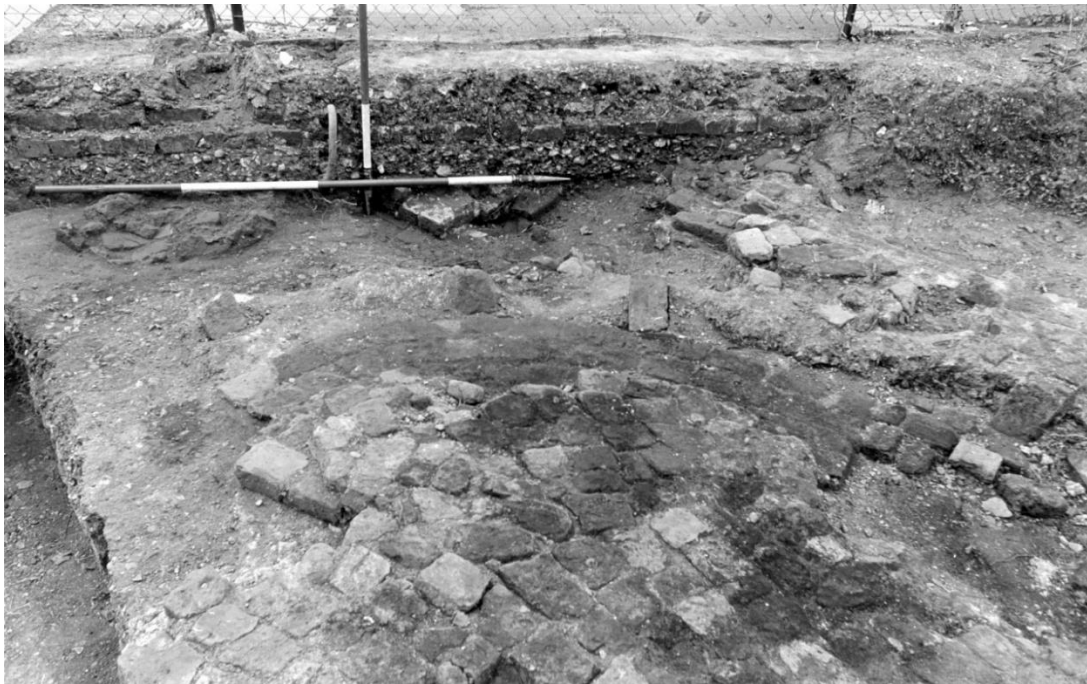
Pl. 8: PG77 Area I, Circular Structure [19]/[21] with Path [22] to the Right, Wall [25] in Section and Brick Rubble Dump [47] to its Left Looking South (photo ?S. Somers/EAS Archives)

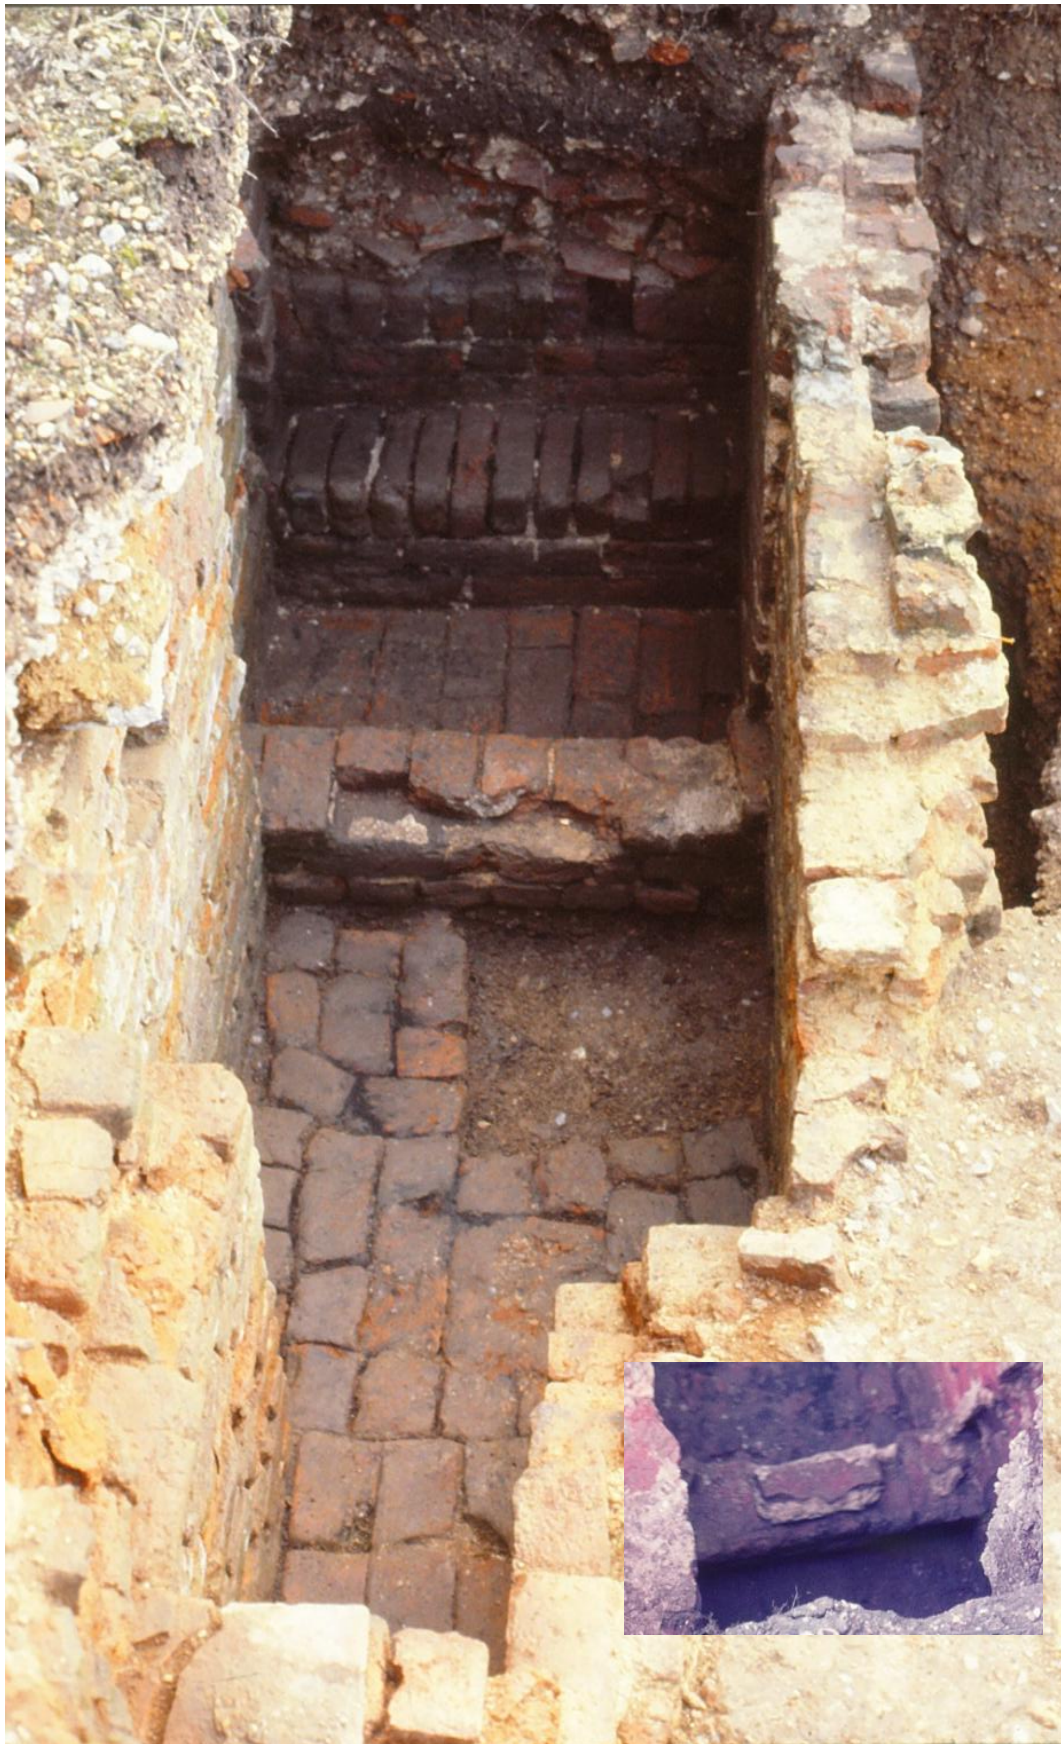
Pl. 9: PG77 Area I, South End of Structure [1] Looking South and Inset the Repair or Capping to Wall [57] Lost by the Time of the Professional Recording Looking North (photos EAS/Enfield Local Studies Archive)

- To the north of this area (Pls 9 - 12) a second larger compartment was 0.98 x 0.80 m with an unmortared brick floor ([55]), which was, however, missing in its south west quadrant, composed of whole and part bricks lain rather less regularly, particularly on the west, and was sunken by c. 0.06 m with respect to the first compartment (the 0.20 m high north face of wall [57] showing an extra basal course of brickwork). The upper part of the east wall of this compartment had 'a small hole near the top of [the wall which] was originally rectangular with chamfered edges' and seems to have been 0.20 x 0.27 m, but photographic evidence demonstrates that it was far better preserved when first excavated than when the professional team recorded it and had a probably cut brick arched top (Pl. 13).
