ENFIELD ARCHAEOLOGICAL SOCIETY (SECONDARY) ARCHIVE REPORT

EXCAVATIONS AND RECORDING IN AND SOUTH OF THE FORMER PALACE GARDENS AREA OF ENFIELD TOWN 1977 – 79

(SITE CODES PG77, PM78 and LY79)

**by
MARTIN J. DEARNE
partly based on an archive report by
JAMES DINN and †SUSAN REYNOLDS**

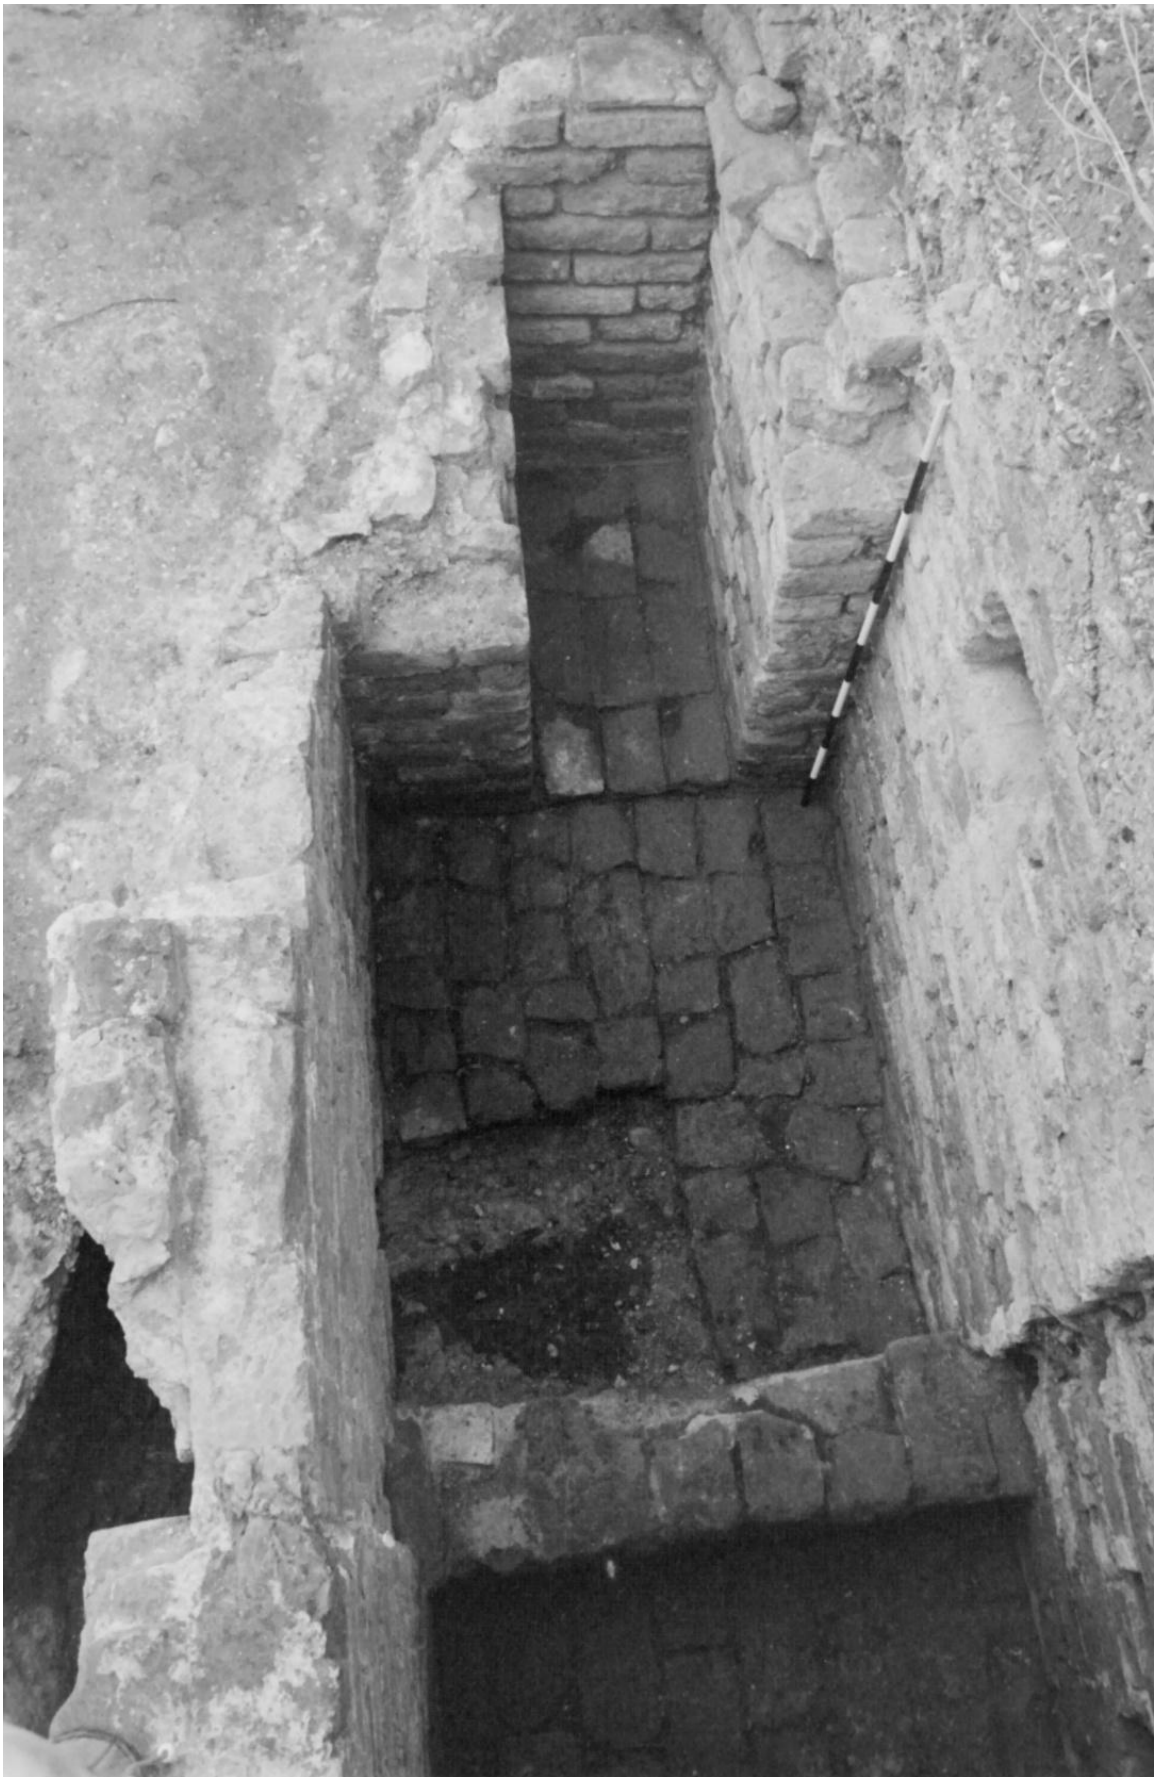
Pl. 10: PG77 Area I, North End of Structure [1] Looking North (photo G. Williams)

- To the north of this area (Pls 9 - 12) a second larger compartment was 0.98 x 0.80 m with an unmortared brick floor ([55]), which was, however, missing in its south west quadrant, composed of whole and part bricks lain rather less regularly, particularly on the west, and was sunken by c. 0.06 m with respect to the first compartment (the 0.20 m high north face of wall [57] showing an extra basal course of brickwork). The upper part of the east wall of this compartment had 'a small hole near the top of [the wall which] was originally rectangular with chamfered edges' and seems to have been 0.20 x 0.27 m, but photographic evidence demonstrates that it was far better preserved when first excavated than when the professional team recorded it and had a probably cut brick arched top (Pl. 13).

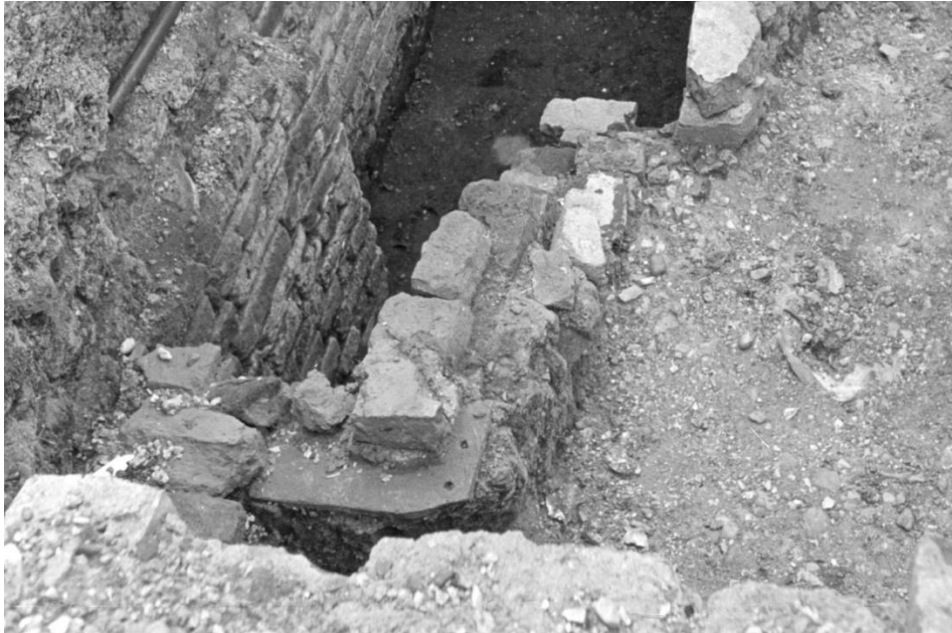
Pl. 11: PG77 Area I, Structure [1] Looking South Showing the Brickwork Above the Peg Tile at the North End Lost by the Time the Structure was Professionally Recorded (photo ?S. Somers/EAS Archives)

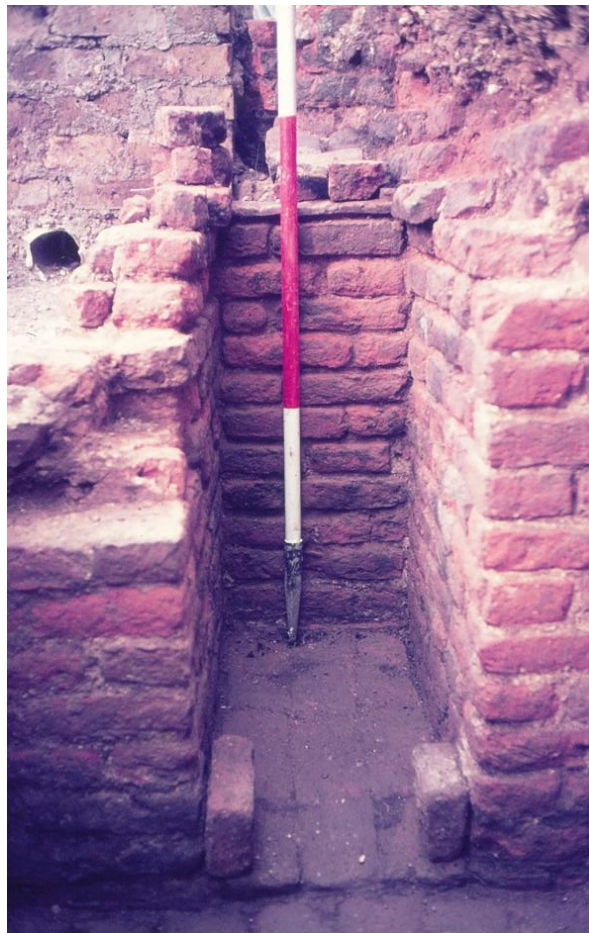
Pl. 12: PG77 Area I, Structure [1] Looking North Showing the Brickwork Above the Peg Tile at the North End and Bricks at the Entrance to the Northern Compartment Lost by the Time the Structure was Professionally Recorded (photo EAS/Enfield Local Studies Archive)

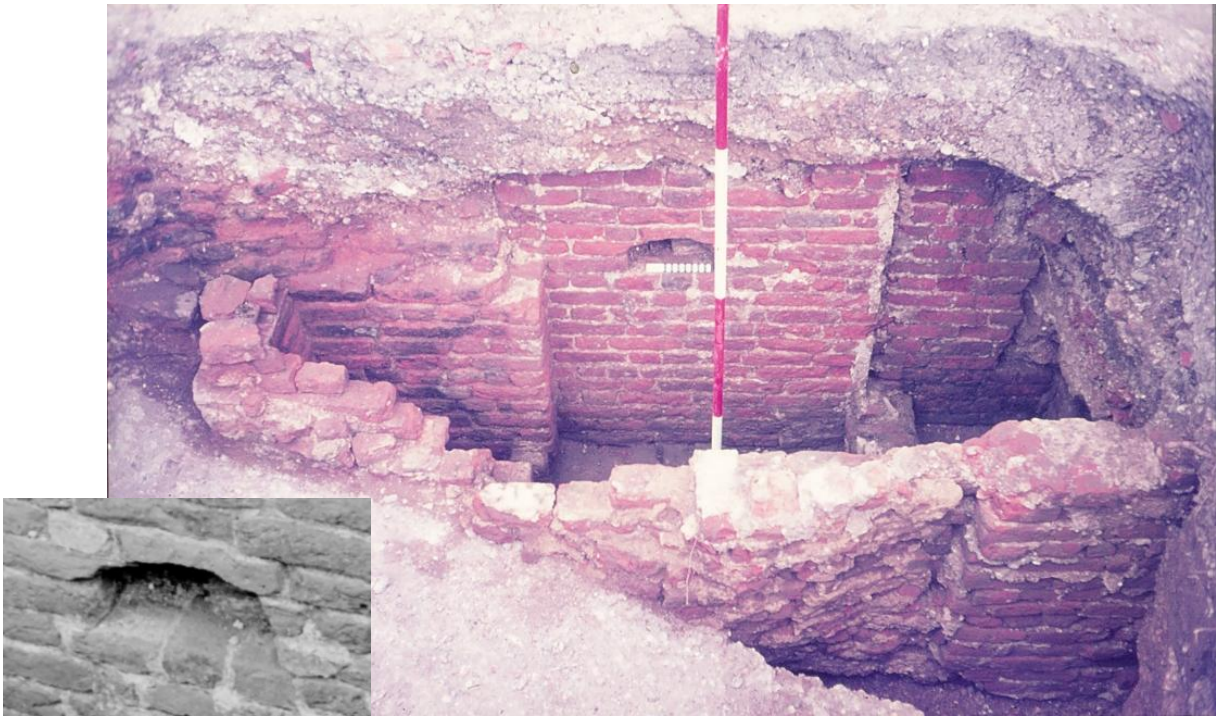
Pl. 13: PG77 Area I, East Wall of Structure [1] Looking East (photo EAS/Enfield Local Studies Archive) and Inset Detail of ?Flue (photo ?S. Somers/EAS Archives)

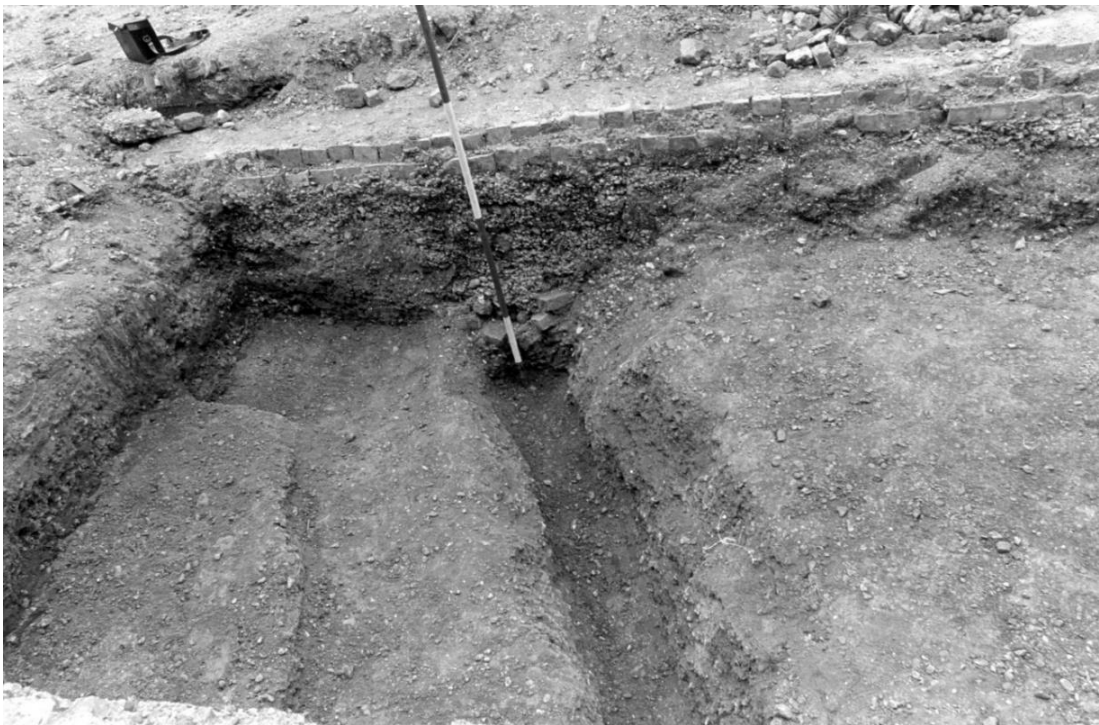
Pl. 14: PG77 Area II, Ditch or Gully [26] with Rubble [29] or [31] Filling Depression [28] or [30] Looking West (photo ?S. Somers/EAS Archives)

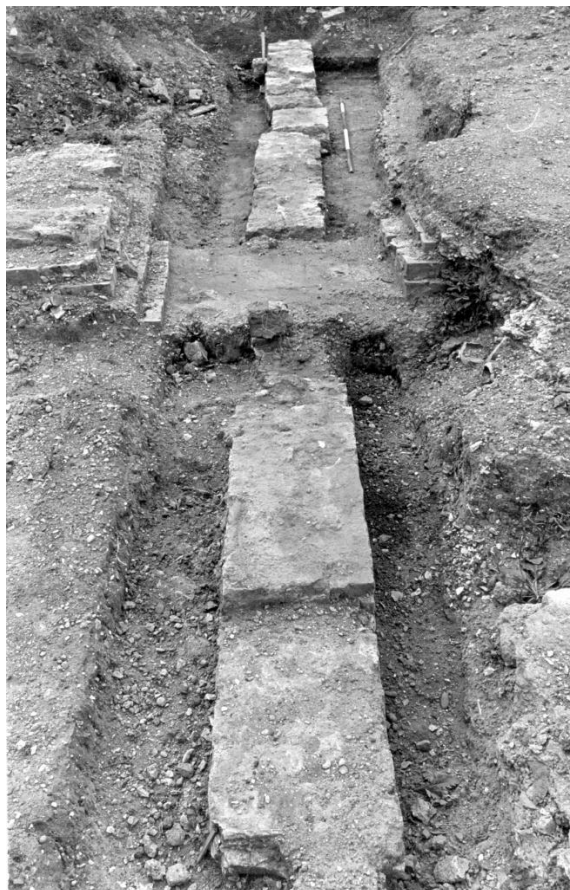
Pl. 15: PG77 Areas IV and V, Wall [16] Crossed by Demolished North Wall of No. 15 Palace Gardens (Road) Looking South (photo ?S. Somers/EAS Archives)

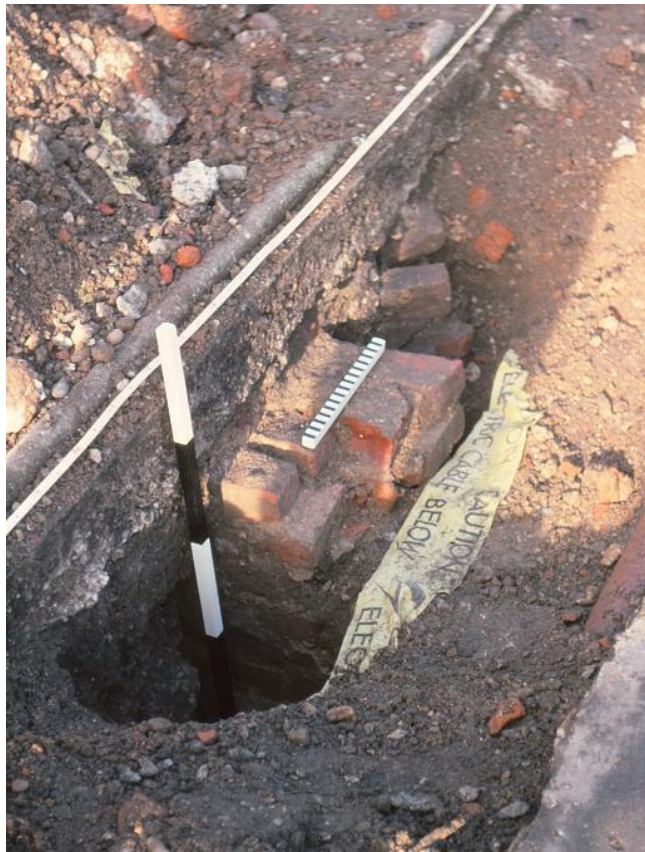
Pl. 17: Wall Exposure at Fig. 2 No. 4, Presumed to be Looking North (photo Ian K. Jones)

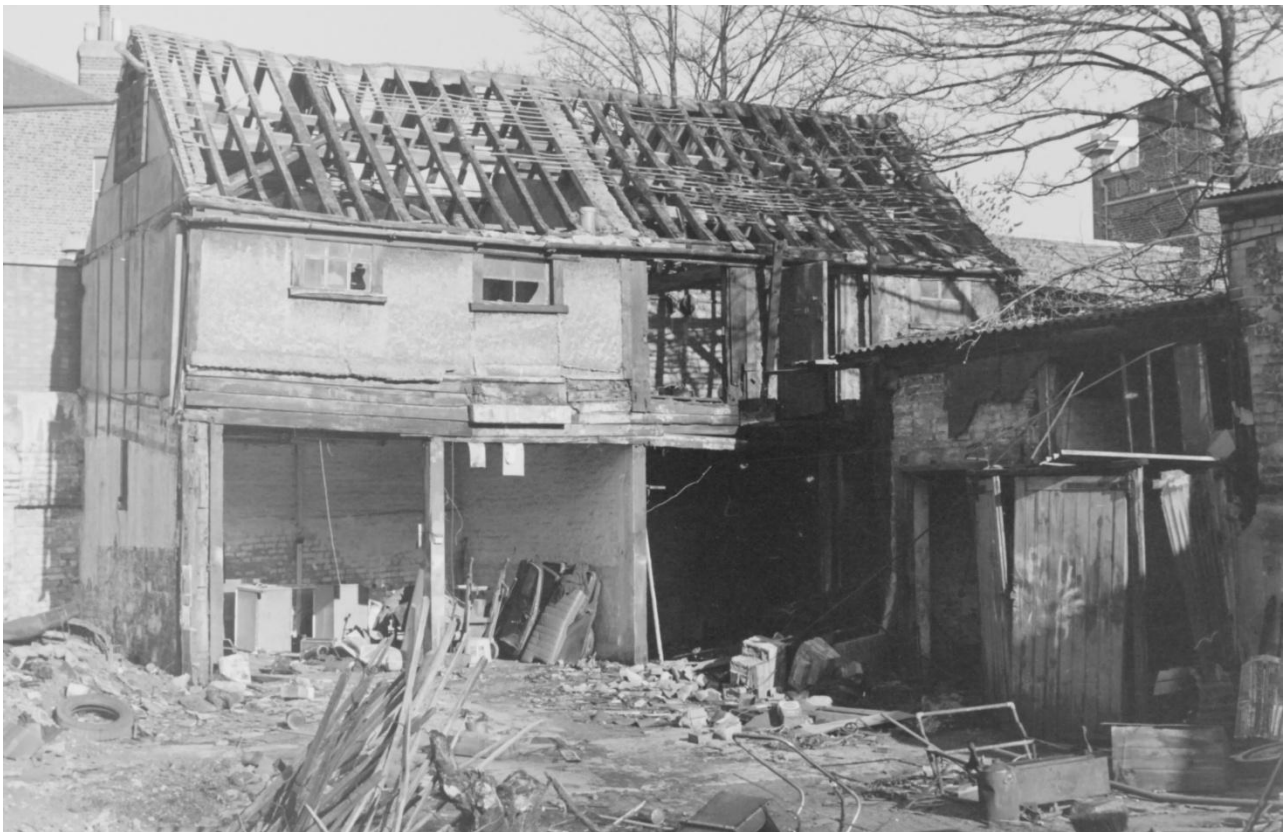
Pl. 20: Laing's Yard Barn Looking North During Demolition (photo G. Williams)

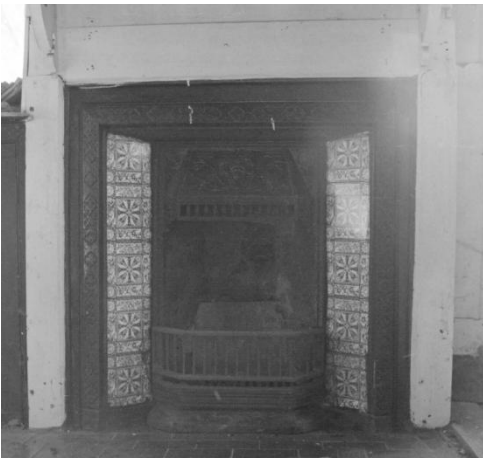
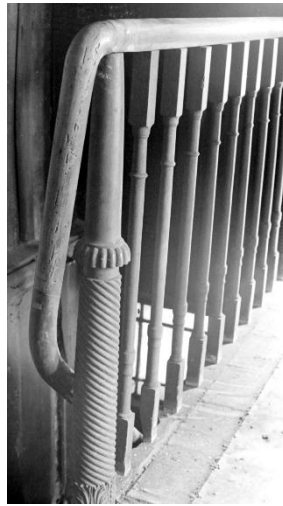
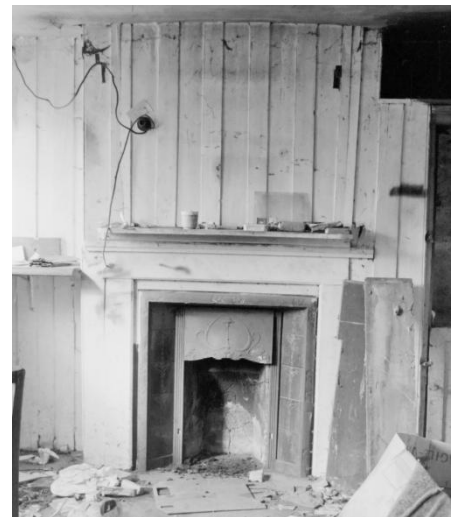
Pls 22 - 24: Laing's Yard Cottages Internal Details (photos G. Williams)

- The cottages were well fitted out with cupboards and shelves.
- It was unfortunately not possible for the writer to watch the actual demolition of these buildings, when much more of interest may have been revealed.
