ENFIELD ARCHAEOLOGICAL SOCIETY ARCHIVE REPORT

EXCAVATIONS AT ELSYNG PALACE, FORTY HALL, ENFIELD, JULY 2023

(SITE CODE FXV23)

by
MARTIN J. DEARNE

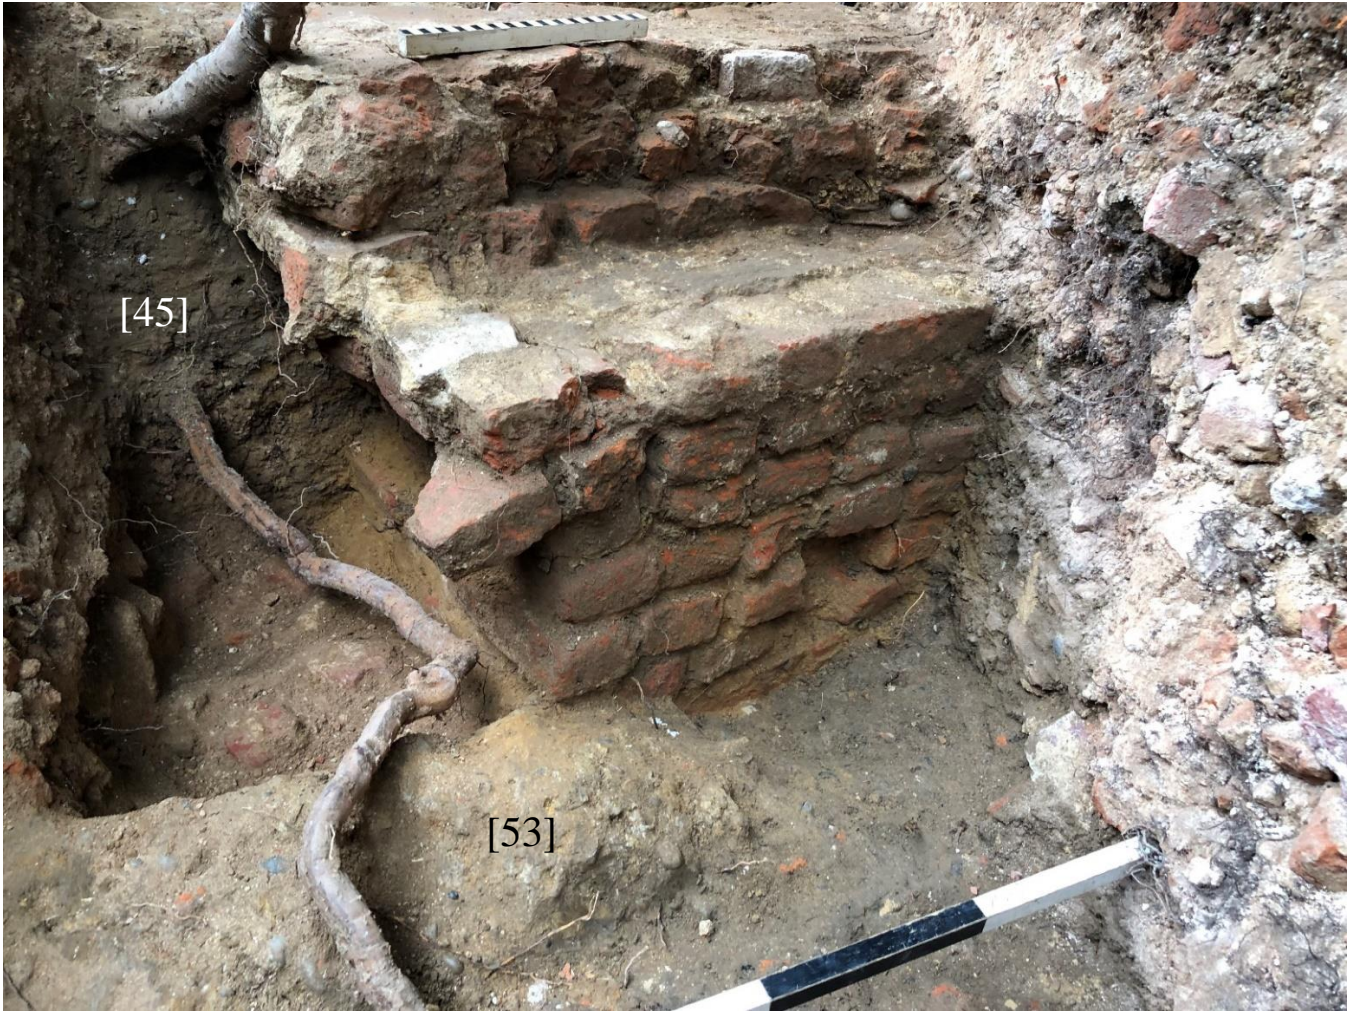
Pl. 3: Wall [43] Looking East with ?Packing [53] in the Foreground (Photo John Pinchbeck)

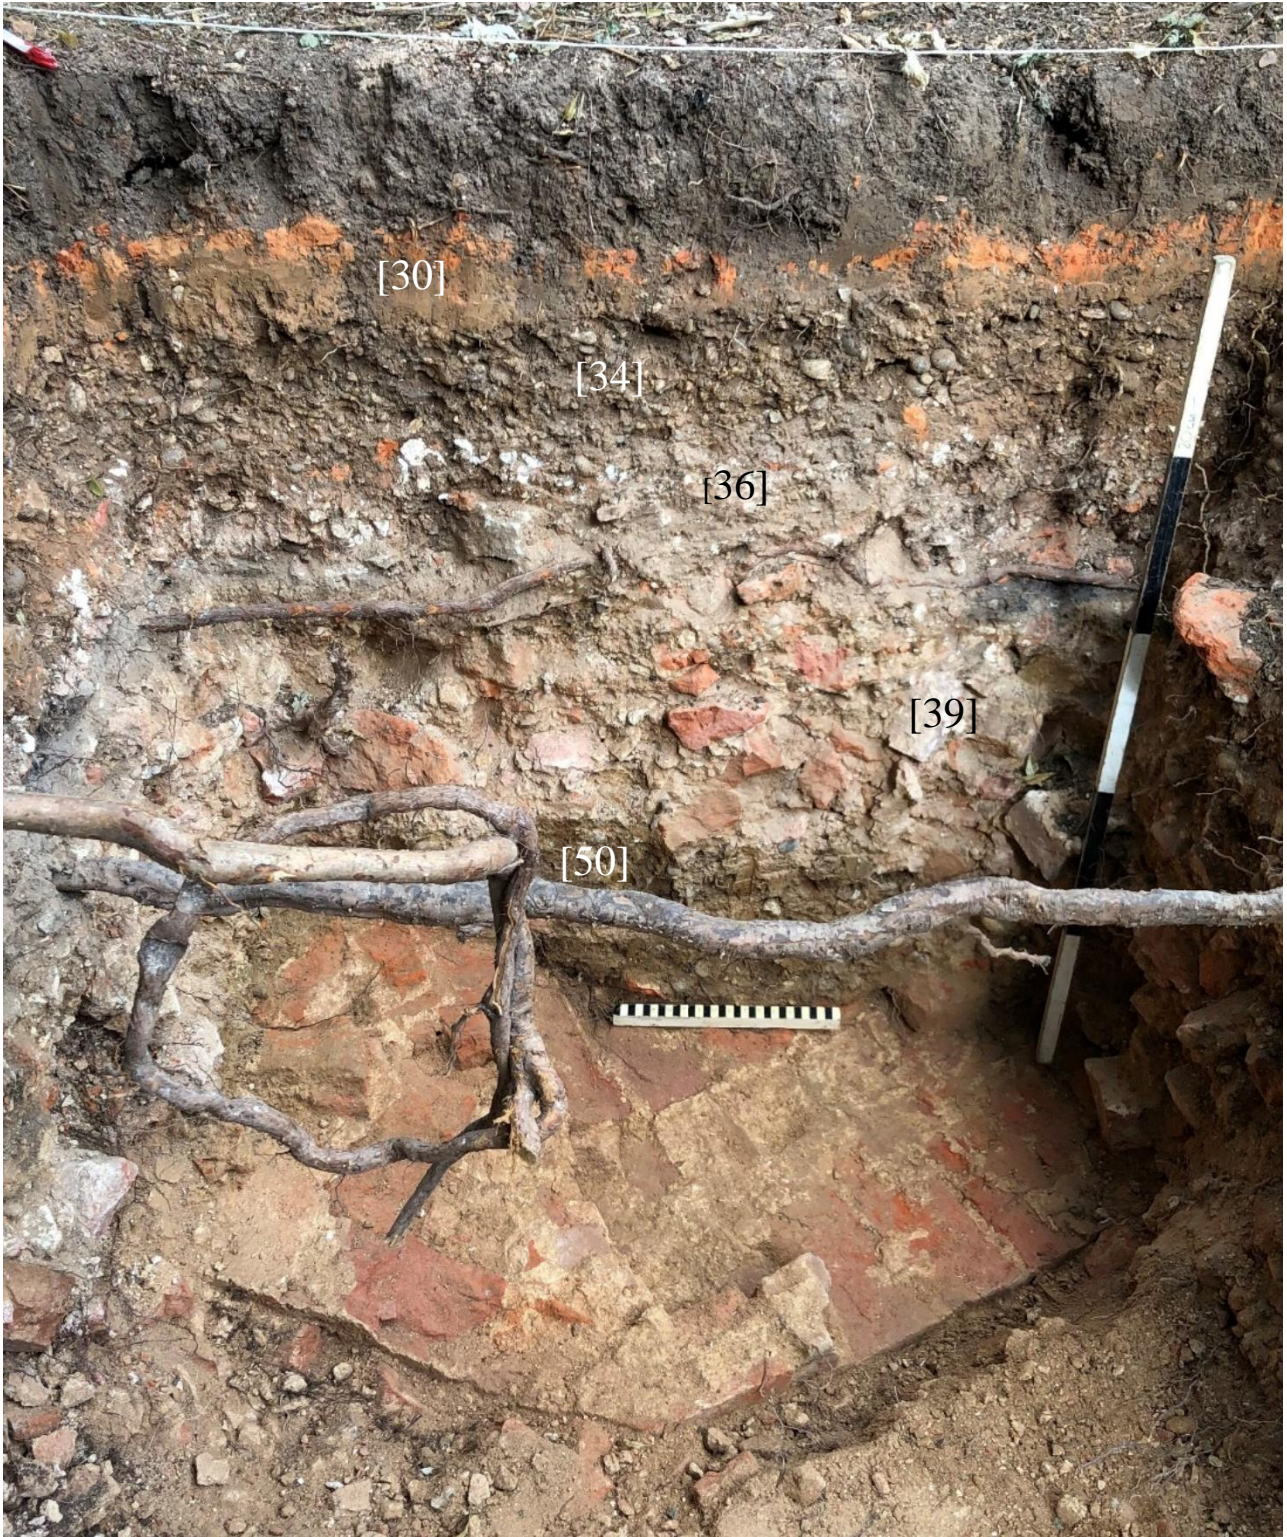
Pl. 4: Column [52] and Demolition Deposits Looking West (Photo John Pinchbeck)

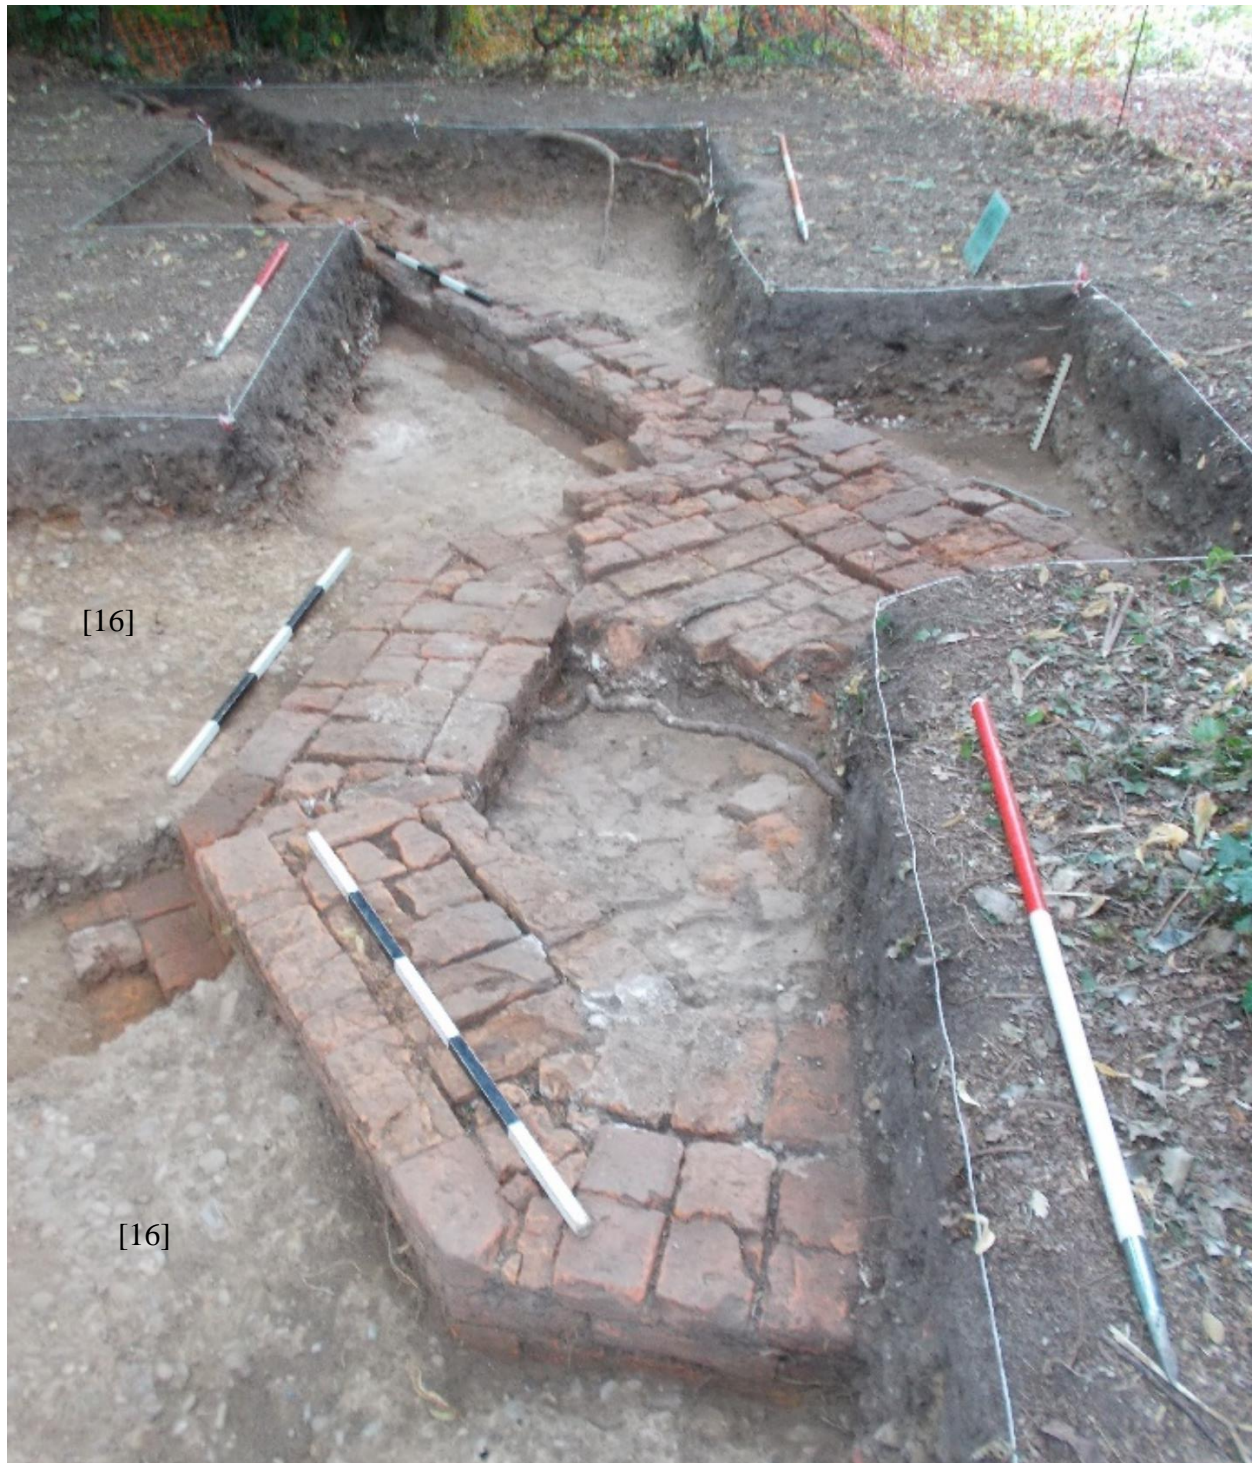
Pl. 5: Walls [17], [18] and [10] and Floor [19] Looking South (Photo MJD)

- Wall [17] (Fig. 8; Pls 5 and 6) was constructed on substantial foundations comprising (on the west where they were studied in Trench 4 Sondage B) an at least 0.14 m deep ?coursed brick and (obscuring) hard white mortar lower foundation, 0.025 m wider than the three course English bond upper foundation with a 0.06 m offset at the base of the 0.57 m wide actual wall, presumably also built in English bond (with the one surviving course using stretchers on the west to flank two (staggered) skins of headers).

- Integrally built, and also solidly founded, an eastern return of [17] continued as the southern arm of an externally 1.50 x 2.90 m, symmetrical, projecting pentagonal turret/tower, [18] (Fig. 8; Pls 5 and 6). Excavation of Trench 4 Sondage C showed that this projecting construction had been built in a trench

- (Presumably demolition) damage to the 1.80 by up to 1.00 m internal space created between the eastern side of [17] and [18] showed that it had been underlain by a foundation, [40], of horizontally lain peg tile fragments and a patch of rammed pebbles which had formed the base for [41], a bedding of hard white mortar lumps and soil for a partially surviving floor, [19], of whole and some cut bricks with possible traces of hard white mortar.

- Running south east from the south face of [18] in line with [17] was a further wall, [10] (Fig. 8; Pls 5 and 6). Once more it had been given significant foundations, probably built in a construction trench, [48], probably cut through [24], though only at the very southern end of the west side of the wall (in Trench 4 Sondage D) was this at all discernible as its fill, [47], was virtually indistinguishable from [24] (in fact it was probably redeposited [24]). The foundations overall were 0.70 m wide at the top, at least 0.30 m deep, comprised at least five courses of brickwork and (partly obscuring) hard white mortar and in some exposures at least appeared to have a 0.03 m wide broadening offset part way down them.

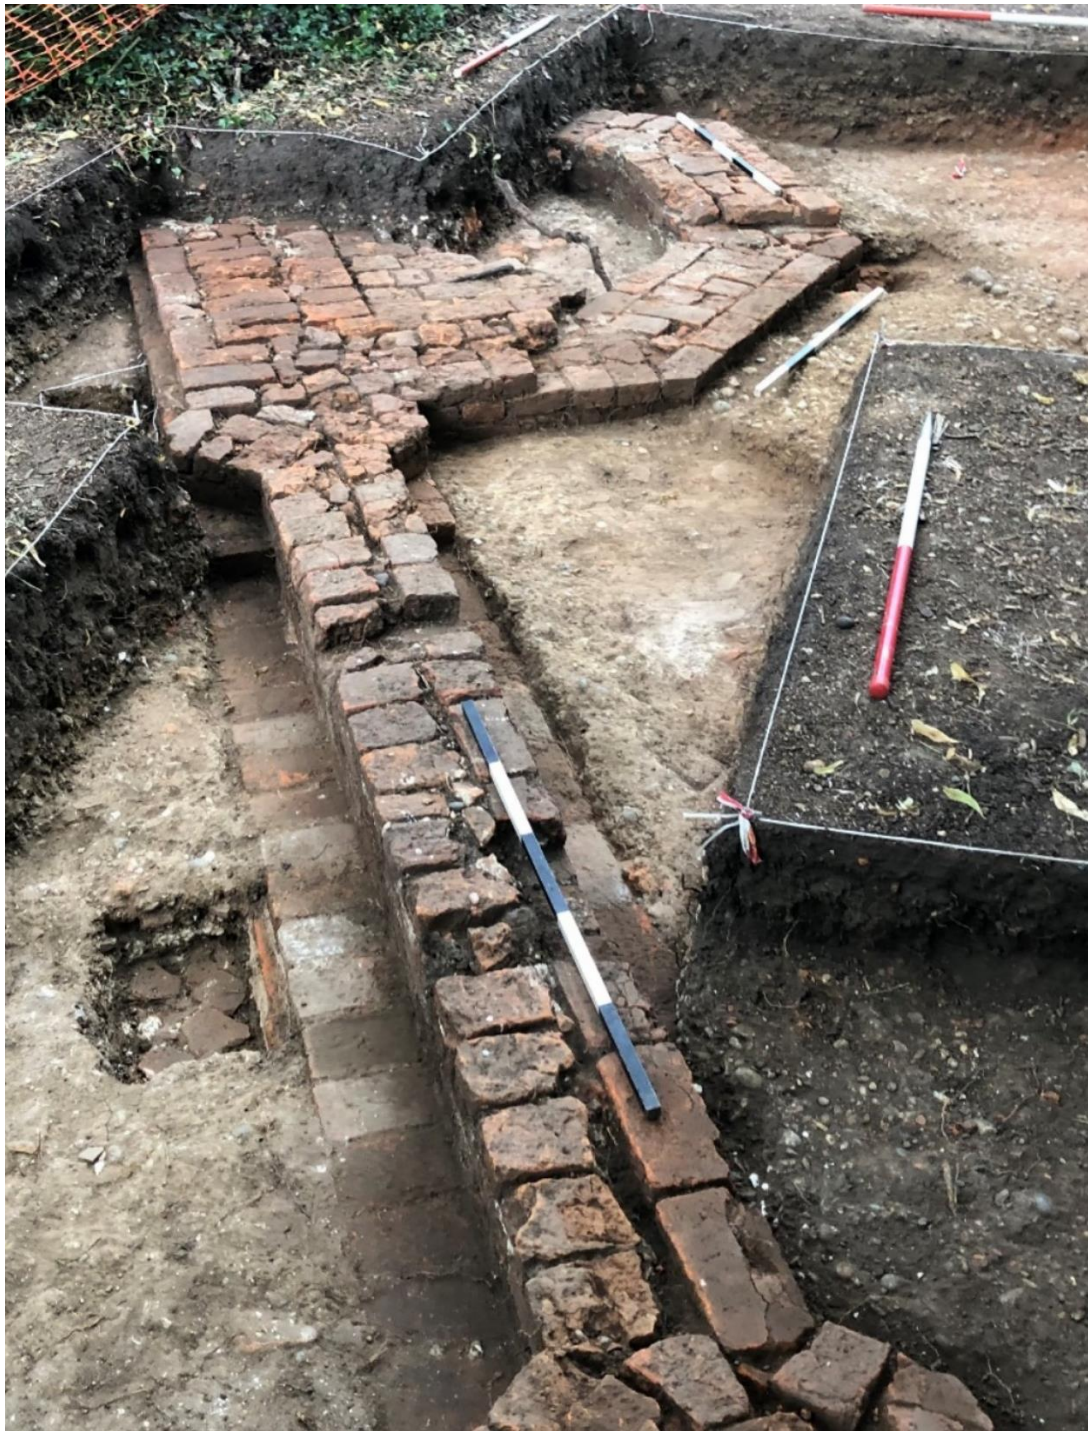
Pl. 6: Walls [17], [18] and [10] and Floor [19] Looking North (Photo John Pinchbeck)

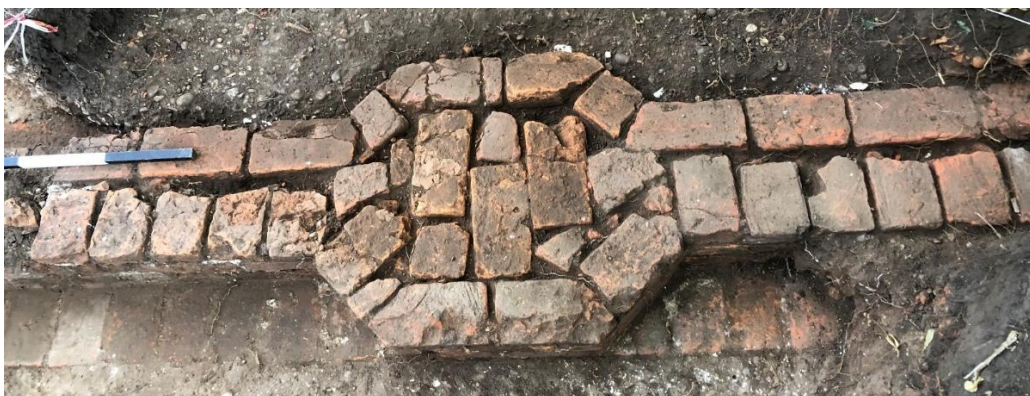
Pl. 7: Wall [10] Octagonal Column Base Looking East (Photo John Pinchbeck)

- The 0.30 m wide wall built on them survived to three courses of English bond brickwork, using whole (stretcher lain) and part (header lain) bricks with some paired header lain part bricks, probably to achieve the desired spacing between three broader bases for brick built columns that utilised the full width of the foundations. The southernmost base was very badly disrupted by an adjacent tree's roots and the northernmost was for a pentagonal column on a one course raised foundation and engaged with the south face of [18], but the well preserved central base showed that the column design was octagonal. This central base (Pl. 7) again survived to three courses and was constructed of whole and cut to fit part bricks, its 120° turns again achieved with brick axe cut and rubbed king closers, cut on opposite sides of one end (here asymmetrically).

- As in almost all work on the site, tree root disturbance of the archaeological resource was found, in this instance particularly illustrated by the complete breaking apart of the most southerly column base of wall [10] and damage to structure [26]. Though the rest of wall [10] and the sections of [17] and [18] within the excavated areas showed very good preservation, it must also be virtually certain that north of Trench 4 the continuation of these features will have been disrupted by the roots of a large tree and in particular are probably being adversely affected by the growth of two sizeable holly bushes, the removal (under archaeological supervision) of which is very strongly to be urged.

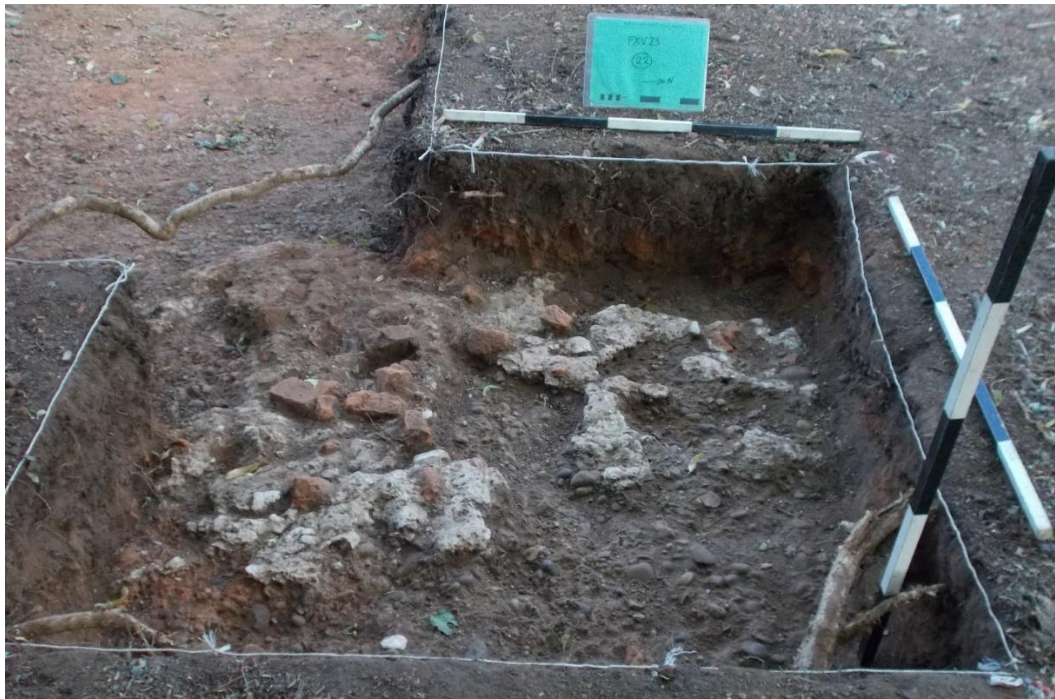
Pl. 8: Mortar Deposit [22] Over Surface [16] Looking West (Photo MJD)

- The one other Phase 2 – 4 feature in Trenches 4 – 6 was [22], an up to 1.60 x 1.90 m irregular spread of up to 0.10 m thick hard white mortar incorporating multiangularly laying 0.05 – 0.10 m part and fragmentary bricks (Fig. 9; Pl. 8). It overlay an area of pebble surface [16] and appeared to have hardened *in situ* rather than being a demolition phase dump, but it was quite irregular and became increasingly patchy as it ran north. Whether perhaps it was the remnant of the setting for a feature built onto the surface and without foundations was unclear.

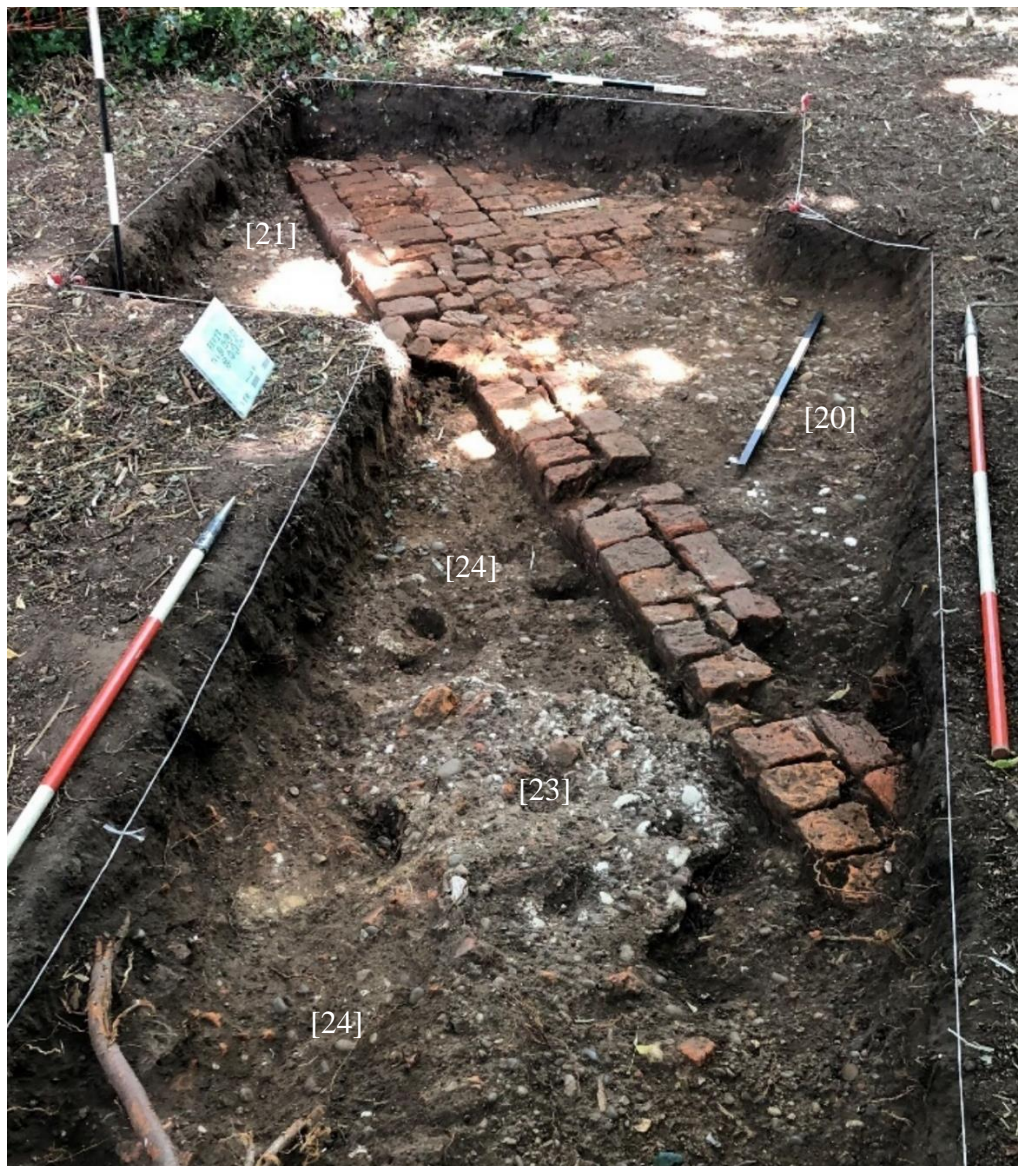
Pl. 9: Deposits Either Side of Walls [10] and [17]/[18] Looking North (Photo John Pinchbeck)

- Fairly similar rammed pebble deposits south of this, either side of wall [10] ([20] to its east and [21] to its west; Pl. 9) seemed most likely to be broadly contemporary with that wall (though all that was certain was that it, as surviving, existed when they were deposited). If contemporary with the wall, as preserved [20] lay c. 0.13 m higher than [16] so that there was probably a slope/step up in the surface in line with the south side of [18], even if perhaps [16] had seen more wear than [20]. However, [21] was absent over much of the area excavated and had presumably been damaged during or before Phase 5 while the small area of [20] seen was quite uneven and again likely damaged.
