# **The Archaeology of Forty Hall and its Estate**

Martin J. Dearne

Published 2025 by the Enfield Archaeological Society  
Copyright © Martin J. Dearne and the Enfield Archaeological Society 2025  
ISBN 978-0-9501877-4-7  
Designed by Martin J. Dearne and Printed by the Enfield Council Design and Print  
Service

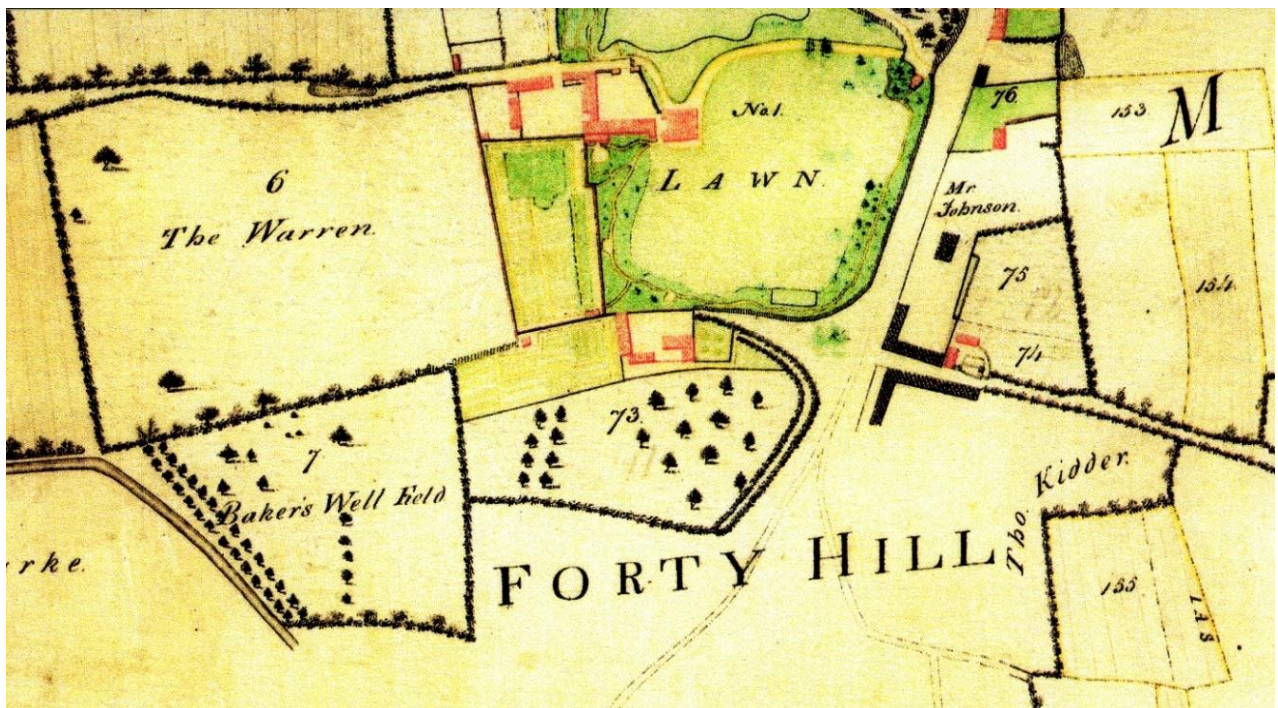
Pl. 4: Extract from the 1773 Sale Map (North at Top) (© Enfield Local Studies Library and Archive)

Norton.<sup>34</sup> However, he may have been responsible for some remodelling of the hall itself and for major remodelling of the estate, quite likely including the installation of cascades on Maidens Brook, and the redesign of the lake and area fronting the hall.<sup>35</sup> Breton presumably also had business interests and one house guest from Holland he entertained at Forty Hall in 1759 was Joan Loten, Governor of the East India Company, who was particularly taken with the Breton's daughter Mary (b. 1742) who he noted was educated in maths astronomy and experimental science.<sup>36</sup> Since her husband, John Hope, who she married in 1762, was a merchant working in Amsterdam<sup>37</sup> one then wonders whether Breton was in some way involved in international trade. However, his wealth was presumably mainly in his land holdings and he tried to sell the hall and estate in 1773, though exactly why is unclear. Gillam speculated that he might have wanted to move back permanently to the family seat at Norton and a letter of 1770 indicates that he was under doctor's orders to take a sea bathing cure at Margate or Bright Helmston (aka Brighton) which might be a hint that he was not in the best of health.<sup>38</sup> In any event he seems to have set his reserve price for most of the lots the sale was divided into too high so few sold and it appears that the aborted sale actually cost him a considerable sum (£1,200) in surveyor's fees,<sup>39</sup> but the estate sale map (Pl. 4) and survey so produced is the earliest detailed record of the hall and estate.

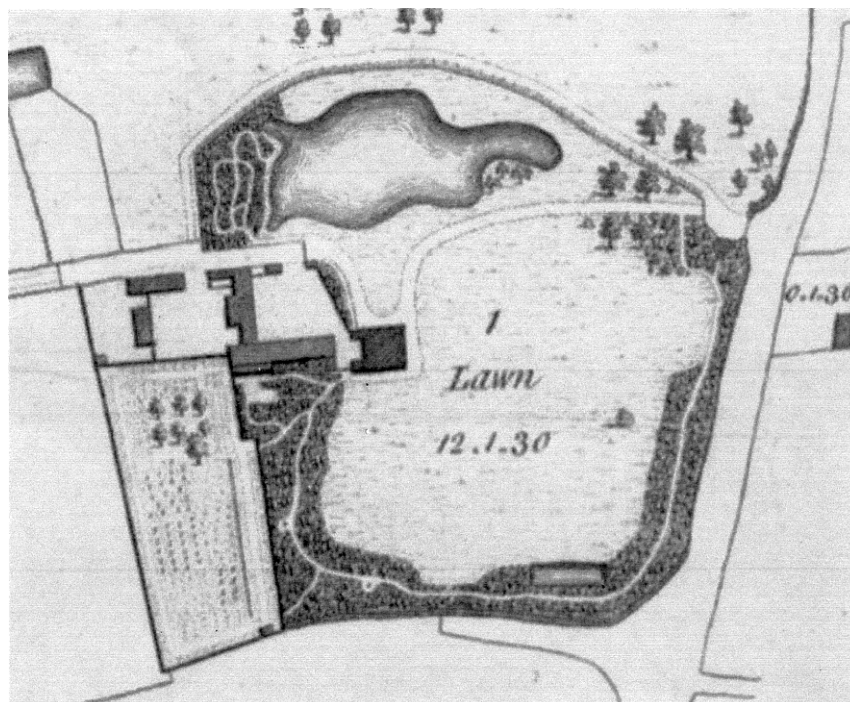
Pl. 5: Extract from the 1787 Sale Map (North at Top) (© Enfield Local Studies Library and Archive)

1787 they were forced, this time successfully, to put the estate up for sale, which led to the creation of a second sale map and survey of the estate (Pl. 5).

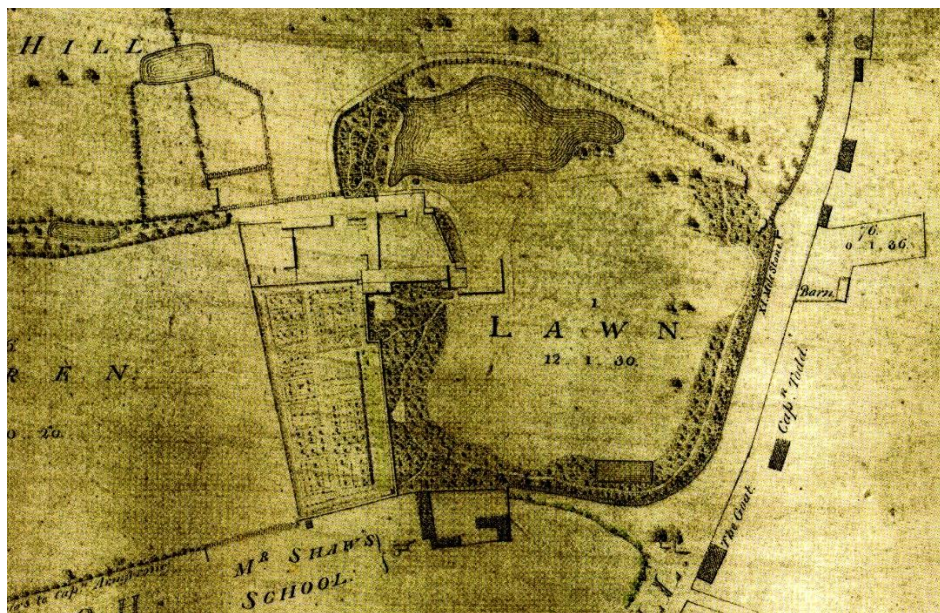
Pl. 6: Extract from the 1788 Map (North at Top) (© Enfield Museum Service Reg. No. Bc2239)

Presumably his (second) wife (Francis (Fanny)) and his children (William Archibald (b. 1770), George Andrew (b. 1771) and Harriet Anne)<sup>48</sup> also lived at the hall and, even if he was probably in London part of the time, he played some part in the life of the community, being co-opted onto a local committee for the defence of the constitution in 1794.<sup>49</sup> Robinson asserted that he had spent £4,000 on ‘repairs and alterations’ to the hall<sup>50</sup> and he did probably make numbers of changes to it and its environs, though they seem mostly have been subsequent to his producing a third extant plan of the estate in 1788 (Pl. 6).<sup>51</sup>

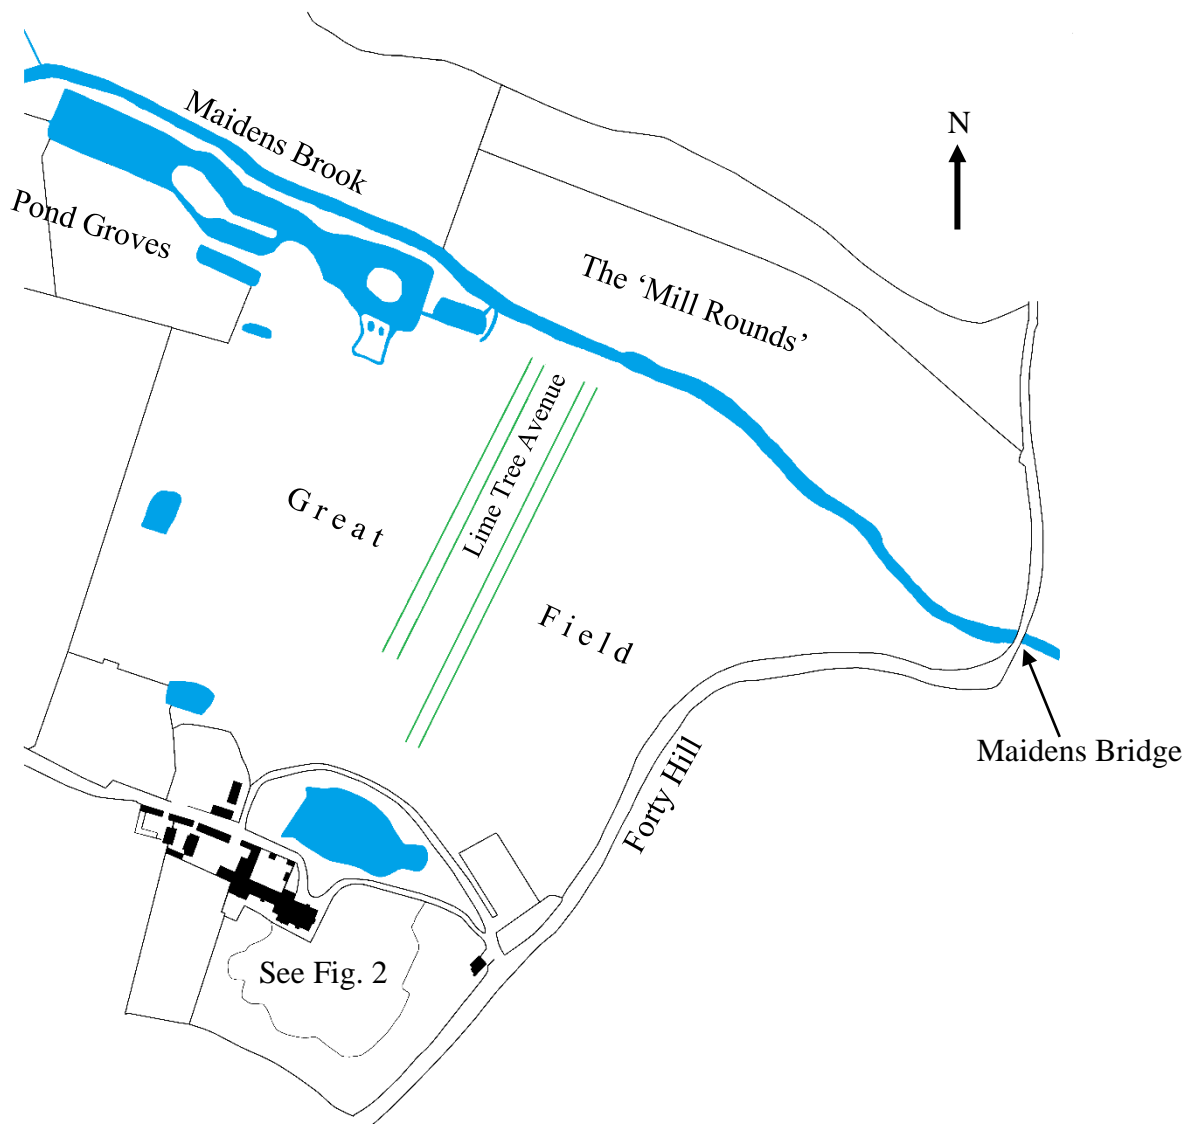
Fig. 1 The Core of the Forty Hall Estate (for the Wider Estate see Fig. 57)

This study is organised by area of the estate (Figs 1 and 2) being described and then by phase. Thus, it begins with the built environment representing the residential parts of the hall (and the Kitchen Courtyard immediately west of its original core), then the main Service Courtyard (to the west of the main hall), and the original Farm Courtyard and Rick Yard west of that, together with the later development of Forty Hall Farm. It then takes in turn the areas fronting the north, east and south facades of the residential block or its service buildings, and the grounds/gardens attached to each, followed by the walled kitchen garden and the wider grounds around the hall complex. It continues with the post 1660 development of the wider estate, covering the summerhouses in the grounds which formed part of a *Ferme Ornée*, the Great Field north of the hall, the development of Maidens Bridge and Maidens Brook including its system of cascades, a channel system in the 'Mill Rounds' linking the brook to the New River and the development of the Pond Groves. It concludes with an appendix which presents selected finds from all elements of the work, but particularly from a seventeenth century midden deposit.

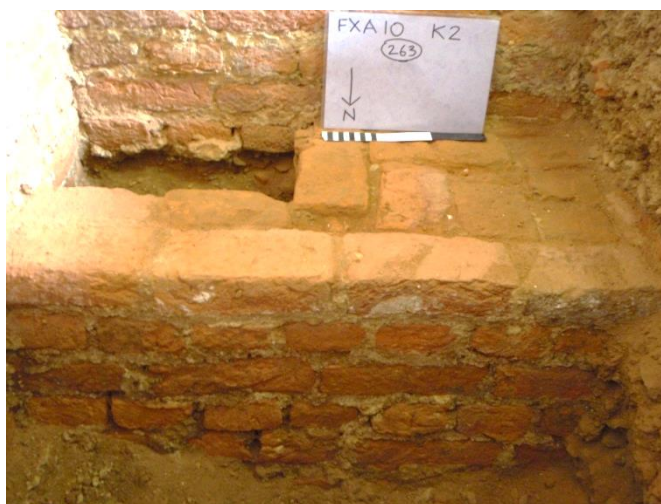
Pl. 15: Phase 1 Wall [10263]

The last fragment of the building was part of another internal east west wall, [10263], which was partly excavated in the south east corner of Area K2 (comprising room A0054). The available exposure (Fig. 7 and Pl. 15) was small and excavation constrained by adjacent Phase 2 walls which rested on it, but at

least five courses of the northern face of the 24 cm wide, English bonded, single skin wall were seen where some deeper excavation was possible. The wall expanded on the south to form an over 27 cm deep, over 58 cm wide integrally built probable chimney breast (unless what was represented was a wider wall into which a shaft had been incorporated on the south, which seemed far less likely). The three upper courses of the north face of the main wall were fair faced and the two lower rougher and probably originally within a large (unseen) construction trench. Only two courses of the south face of the wall and east face of the ?chimney breast were available for study, but both were fair faced and the latter built of coursed whole bricks. All parts of the structure seen were built of hand made, unfroged bricks, bonded with hard yellow mortar comparing well to that of the wall in area H1.

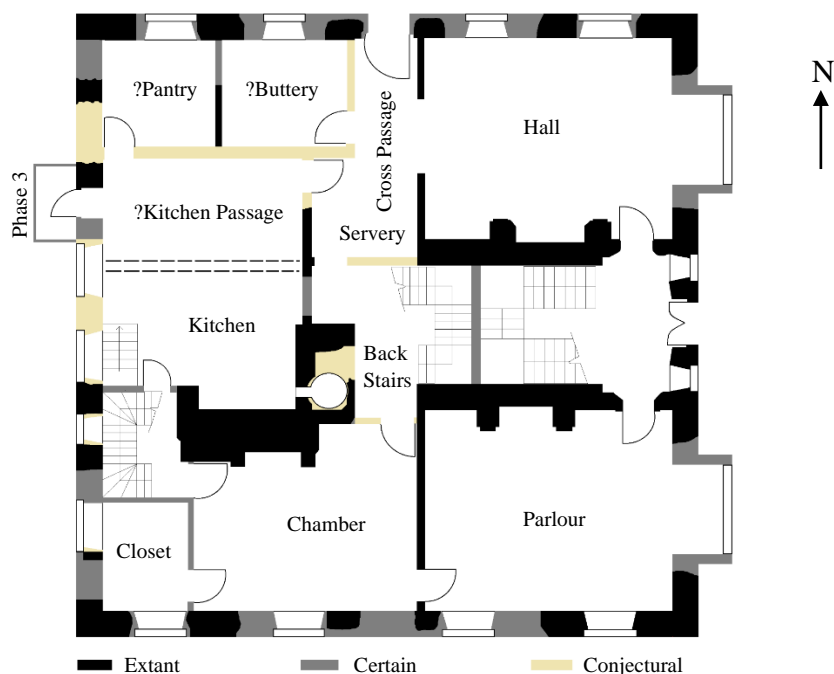
Fig. 8: The Ground Floor Plan of the Main Residential Block in Phase 2 (and 3) (After CMP Fig. 11)

The main residential part of the hall was built as a three storey square block which has been argued to have had a traditional plan, but classicising appearance (Peats 2008, 33ff). The ground floor plan (Fig. 8) then featured a main entrance in the northern facade (see p 78ff), accessing a cross passage and then stairwell, separating a hall on the east from a kitchen on the west, itself divided from a probable buttery and pantry to its north by a kitchen passage. To the south a parlour on the east adjoined another chamber and probable closet. Meanwhile at basement level below the east and south of the residential block there were four cellars (later – perhaps in Phase 5b - subdivided into rooms A002 – 8 by walls between rooms A003 and 004 and A007 and 008, with another basement added in Phase 8). Whilst much of this plan relies on standing buildings evaluation (Peats 2008; CMP), archaeological work has illuminated

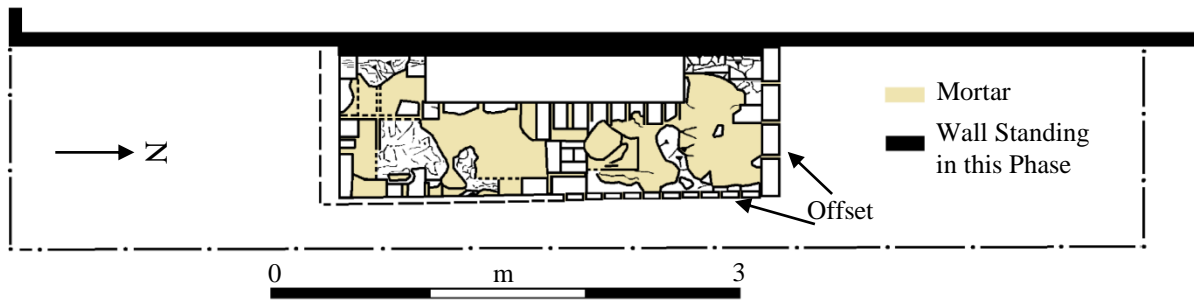
Fig. 11: The Demolished Projecting Bay Window in Trenches FYH05 and FYI06

Archaeological work has also demonstrated that the original form of the residential block included, subsequently demolished, projecting bay windows on the east facade. Excavation of one of these at the south end of the facade in 2005/6 (overlapping trenches FYH05 and FYI06; for location see Fig. 3) showed it to have been a 2.80 m long bay projecting 94 cm from the main facade wall of the hall (Fig. 11). At this point the facade wall, now buried to a depth of over 1.30 m, again demonstrated the variability of the bond used in the early stages of the construction of the hall. Though much of the construction was in English Bond, and from its well struck joints (like those of the bay) clearly intended to be seen, both below and above a 5 cm wide offset there were runs of irregular and stretcher bond brickwork from two to four courses high at different points south and north of the bay (while the offset itself was one course higher north of the bay than south of it).

The bay was built integrally with the facade wall, but may have been the first element to have been begun as, in contrast to the hard white mortar of the facade wall and some parts of the bay, its lower courses were bonded with a sandy yellow mortar. It had been built on a four plus course irregularly English bonded (but on the east Flemish below header bonded) plinth/broadened foundation probably

overall 3.02 x 0.99 m. Above a variable (3 – 10 cm wide) offset, its northern and southern arms were 51 cm wide and its east west side 58 cm, leaving a c. 30 cm wide gap between its inner face and the main facade wall.

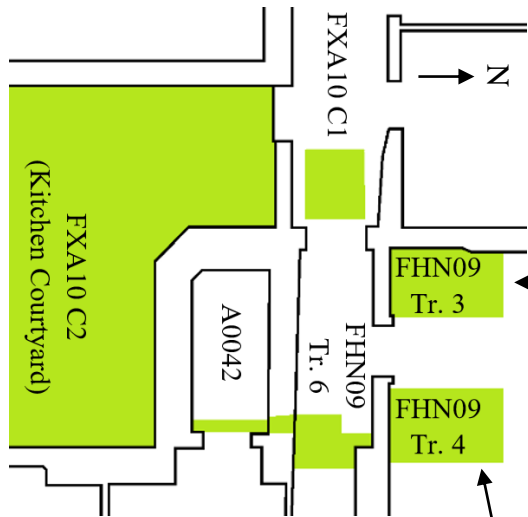
Fig. 13: Areas Excavated Just North of FXA10 C2

A third fragmentary brick structure, [1097], to the south east of [10132] was also presumably the remnant of another element of this first drainage system to be routed through the Kitchen Courtyard. It had again been heavily truncated and probably disrupted even where best preserved and no mortar remained bonding its bricks. It was represented by a short (70 cm) stretch of horizontally laid bricks forming a south east north west running floor that may have curved more to the east at the south east end, some stretcher laid horizontal bricks possibly representing the edges, and, elsewhere, some fragmentary vertically set bricks flanking the floor. In detail the remnants probably suggest a drain 26 cm wide internally that may have narrowed or slightly changed orientation again at the north west end where two further horizontal ?edge bricks appeared to be out of line with the rest of the feature. These drains (?and others) probably flowed into a larger drain excavated further north in FHN09 Trenches 3 and 4 (Figs 13 and 14; Pls 16 and 17).

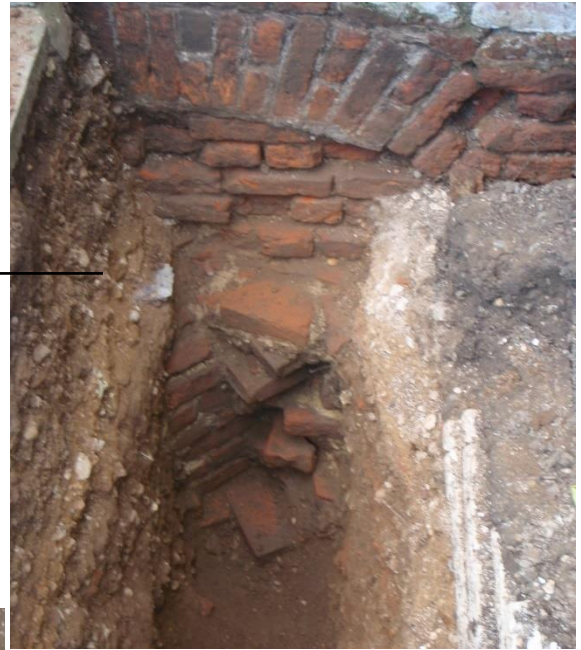
Pl. 16: FHN09 Trench 3, South Elevation of Standing Wall Showing the Phase 3 Relieving Arch and Drain [09113]/[09131]

Here, at the south end of Trench 3, a Phase 3 relieving arch (the edge of which had already been seen in earlier work in FHFL03 Trench 4) belonging to the northern boundary wall built in this phase (see below) survived (embedded in the Phase 5a extension to the residential block (below p 38)).

The relieving arch had been built to accommodate a south west to north east running vaulted drain, [09113]/[09131], which here was abutted and partly obscured by a rough mortared brick packing, at

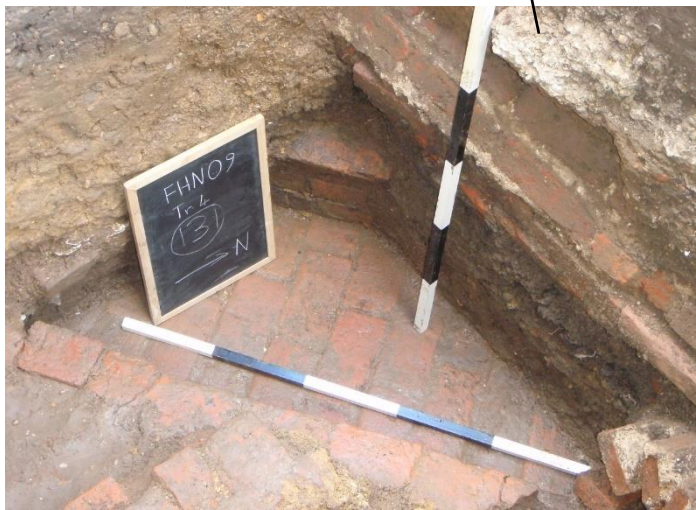
Pl. 17: FHN09 Trench 4, Phase 3 Drain [09113]/[09131] (Phase 7 Drain [09116] Forming the Section to the Right)

least seven or eight courses high, which could have been contemporary or conceivably have been a later construction. Only the extreme west end of the north side of the drain was seen here, but a second (partly demolished) section of it was also excavated in Trench 4. It was built of hand made, unfroged, bricks (and sometimes part bricks) and very pale brown mortar, was constructed in irregular stretcher bond to give a vertical side and a five course vaulted roof and had a floor of north south aligned stretcher bonded bricks/part bricks. In all it was over 72 cm high and internally 55.5 cm wide, its floor had only a very slight fall (c. 1 in 85) to the north east and it ran angularly through the relieving arch, the space between the top of the drain and the base of the relieving arch being infilled to a thickness of over 21 cm with similar bricks and mortar. Four courses/part courses of Flemish bond had been used here (but with stretchers replacing headers in the lowest of the courses above the apex of the drain) above a fifth offsetting course of headers, likely marking contemporary ground level.

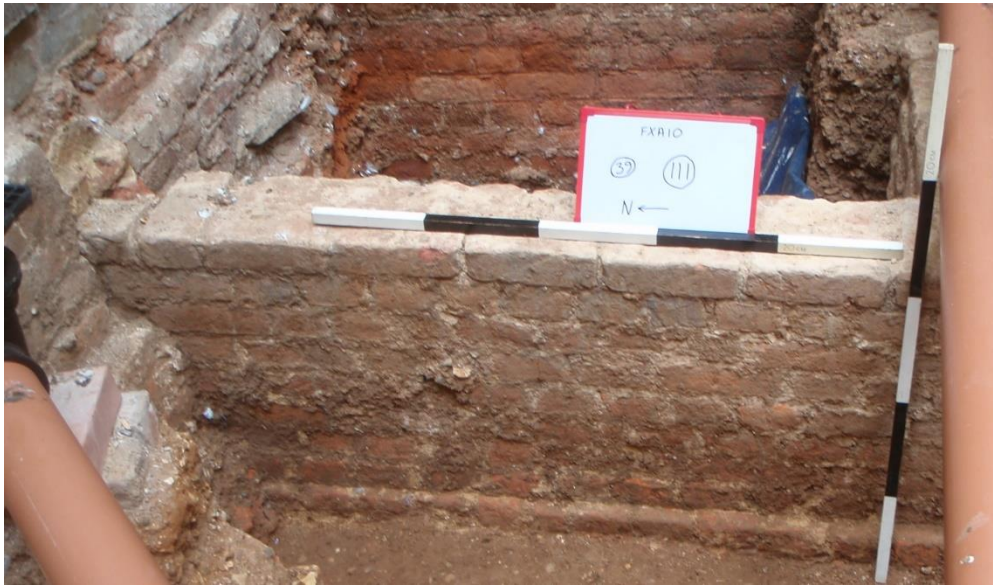
Pl. 18: Area C2 Looking East at the West Wall of Porch [1039]

In the north east of Area C2 though, and presenting far less interpretative problems, the southern side of a probable porch, [1039], was excavated in the 2009 – 11 work. It used mortar identical to that in the east wall of room A0035 and, as noted, it may well have replaced a wooden porch/stair of Phase 2 and must have had steps ?to its west or north which, if on the west, would have been removed by a Phase 5a extension. Though a Phase 8 cut had removed any construction cut on the south side of it and it had later subsided to the south from the weight of much later concrete work, the construction was well preserved (Pl. 18). Its building was represented by a 20 cm wide cut, [1099], through the earlier mortar surface [1090] to re-expose the offset of the west wall of room A0054 (so that the porch could

be built directly on to the top of the offset) and a construction cut for its west side. This, [10111], was a shallow (up to 18 cm), quite broad (at least 88 cm and perhaps 1.00 m wide), gently sloping cut, backfilled following construction with material including construction debris (unlike [1099] which was backfilled with gravel).

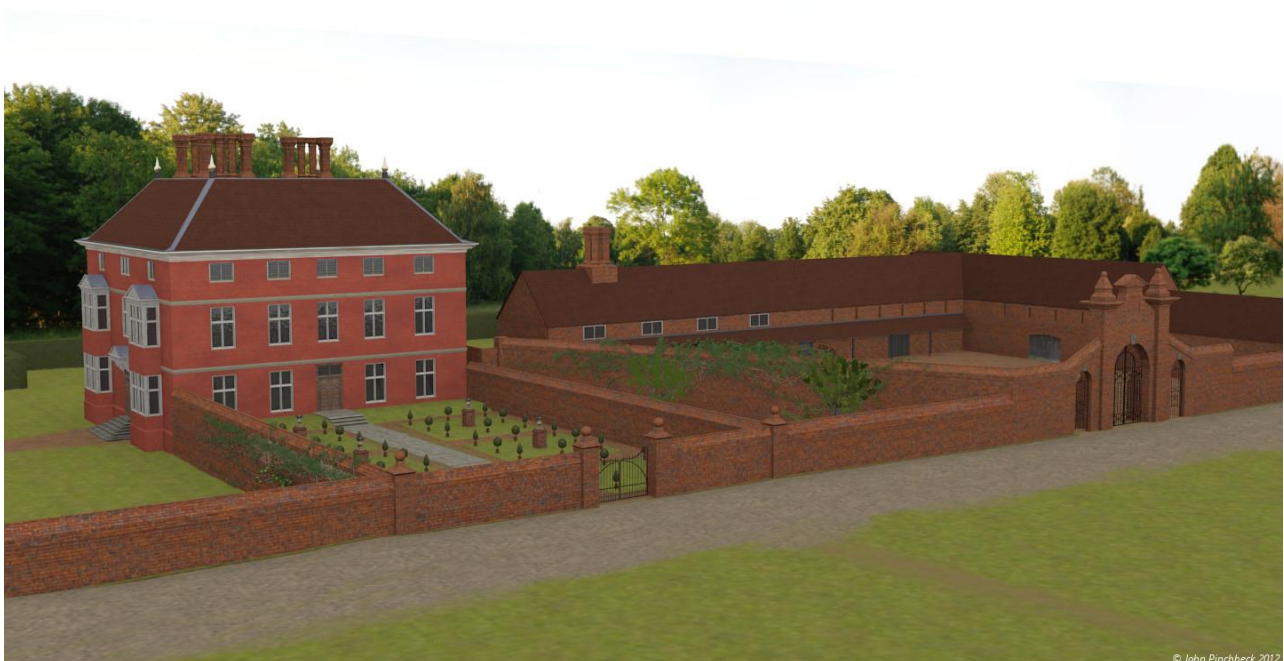
Pl. 20: Reconstruction of the Appearance of the North Façade of Forty Hall and its Service Courtyard c. 1660 by John Pinchbeck

For the first 60 years of its existence Forty Hall was occupied by the successive Rainton families. There are not believed to have been major changes to the residential block until early in the eighteenth century, even if the Service Courtyard may have been altered (p 56), thus producing the appearance shown in Pl. 20. There was though some evidence relating to the Phase 4 maintenance of the hall's basement in room A006 (FHN09 Trenches 1 and 2) and in Area C2 and FHN09 Trenches 3 and 4 there was evidence during the 2009 – 11 excavations for domestic activity and rubbish disposal as well as a phase of drain renewal succeeding Phase 3 in and just north of the Kitchen Courtyard. In particular here it was possible to excavate part of a midden that provided significant evidence for the material culture of Forty Hall in the later seventeenth century.

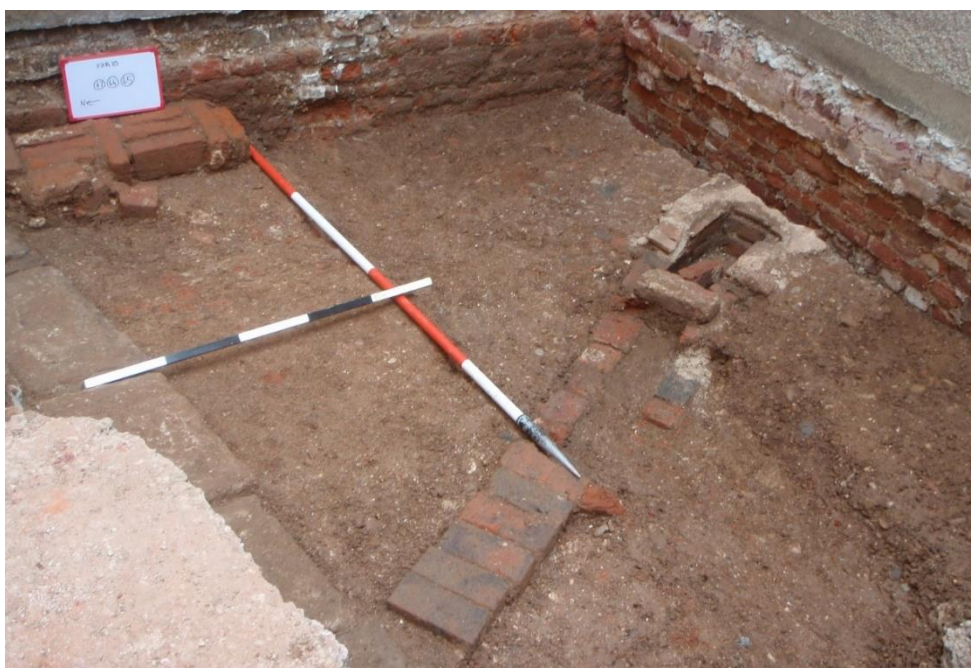
Pl. 21: Area C2 Showing the Phase 4 Drain [1047] and Brick Platform [1064] with Phase 8 Pipe Conduit [1065] on the Left

Presumably meeting [1063A] in a truncated area was [1047] (Pl. 21) which, despite further truncation, was traced running north west for 1.60 m from its point of origin as an open drain within an originally squared setting near the southern edge of excavation. Though it could not be isolated, it was evidently

built in a cut into the earlier general occupation/rubbish deposit [1049] and had a floor of peg tiles. Its sides were built on the tile edges and were two courses of edge lain bricks/part bricks high, supporting a roof of header lain bricks. Internally it was 17 x 20 cm and overall 34.5 cm wide, the bonding mortar not surviving, but the square terminal setting (in places on the east perhaps packed with reddish yellow silty clay) being of white mortar which also covered a capping of peg tile fragments around the opening. Also probably contemporary with this drain system, lain over [1049] and butted against the Phase 2 wall 1.50 m north east of the end of drain [1047], was a brick platform [1064] (Pl. 21). It consisted of single or paired unmortared edge set headers alternating with groups of three edge set stretchers (secured with pads of buff coloured mortar), between all of which gaps had been left. It was edged on the west by an only partly surviving ?single line of fully mortared stretchers horizontally lain on brick fragments to give the platform a more solid front edge. This flat platform, perhaps originally 1.00 x 0.50 m, was clearly not structural and probably formed the base for something such as a wooden water tank/barrel. If so, it is very tempting to functionally link it with the open drain and suggest that they were used for the open air emptying and rinsing of chamber pots in this Kitchen Courtyard.

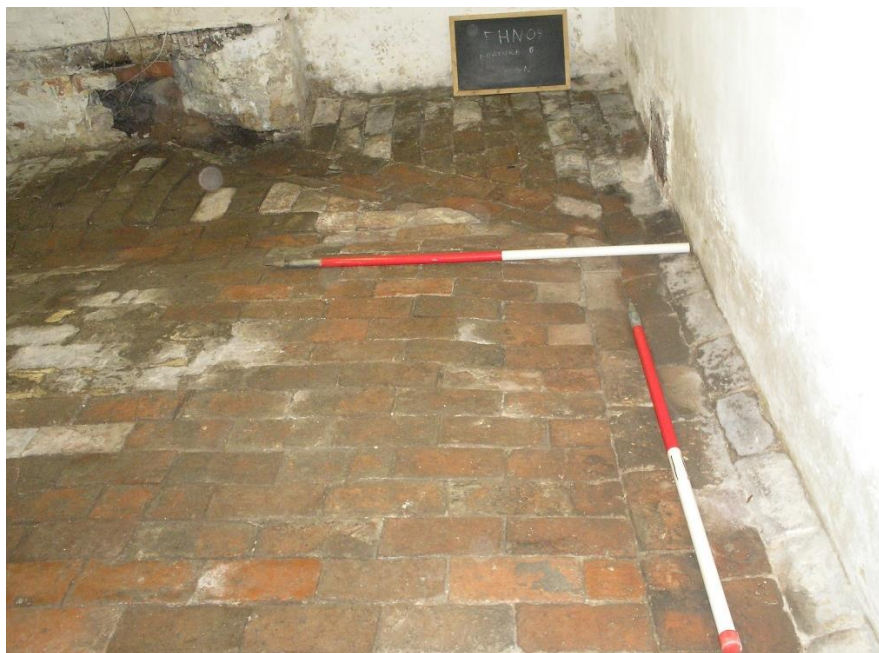
Pl. 22: Extant Brick Floor in Basement Room A006 Showing the Gutters Running into the Phase 4 Lead Channel Through the West Wall

Probably in Phase 5a (though it could have been late in Phase 4) all but fragments of the Phase 2 floor in basement room A006 (FHN09 Trenches 1 and 2; e.g. Fig. 9) were removed and it was replaced with the extant brick floor which lies at a slightly higher level and recreates the channel system of the earlier floor using integrally lain brick gutters and the Phase 4 lead channel entering the west wall of the room. Lain on a new, up to 10 cm thick bedding of crumbly pinkish grey sandy material (probably a decayed mortar), the floor shows some areas of later patching, one perhaps of eighteenth century date and others in connection with changes to the basement access arrangements and possibly (removed) nineteenth century features (not described in detail here).

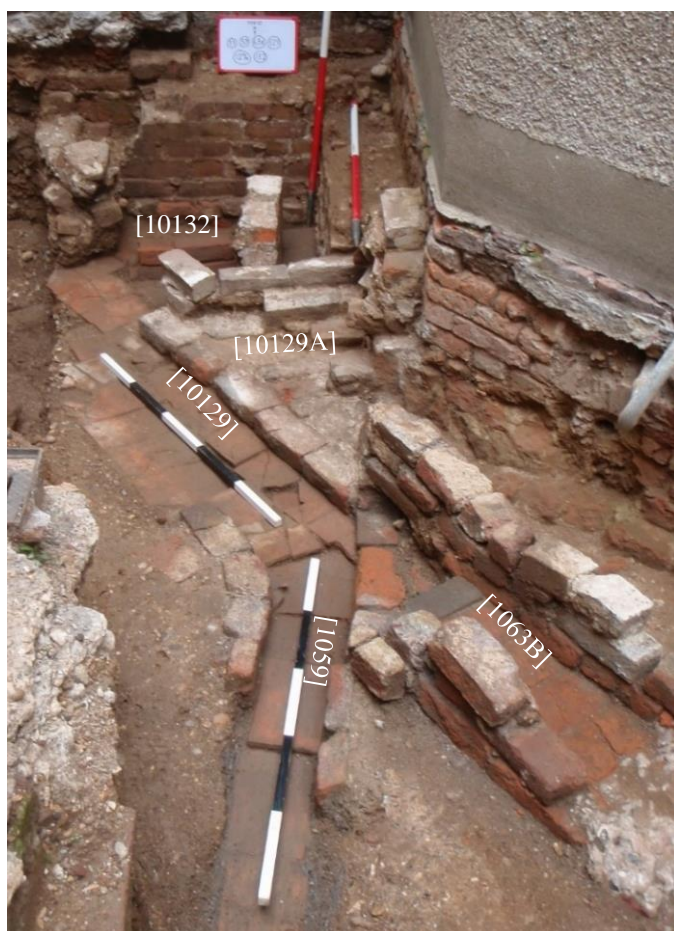
Pl. 26: FXA10 Area C2 (North West Corner, Looking North) Showing Phase 5 and 6 Drains [1063B], [1059], [10129] and [10129A] with Remnant Phase 2 Drain [10132] in Front of Phase 9 Wall [1033]

A sherd of English Saltglazed Stoneware directly below the new drain, [10129], might suggest that the new drain was built, and so the porch was constructed, before, or at least not greatly after, 1770 when new creamwares significantly decreased the popularity of saltglazed stoneware. Whilst then it would be unwise to rely just on this single sherd, which could anyway have been residual, to draw this conclusion and so to assign these changes to the tenure of the hall by Edmund Armstrong (1787 – 97), that would fit with other architectural evidence from it (CMP 6.2).

Though later truncation only left a 1.63 m length of the new drain even partly preserved it was 31 cm wide internally with a peg tile floor and single skin brick built sides. But it had been augmented, or later adapted, using a harder whiter mortar than the initial build did, with an additional skin of bricks to its east side and a two skin, two course high ‘wall’ and a brick blocking of the obsolete course of the drain, the latter two flanking a probable channel/pipe slot running into the new drain course from the Phase 5a extension. Though at some subsequent point this channel had in turn been blocked with bricks, it emphasises the Kitchen Courtyard’s function as a space through which to route the increasing number of services installed in the hall in the eighteenth and nineteenth centuries.

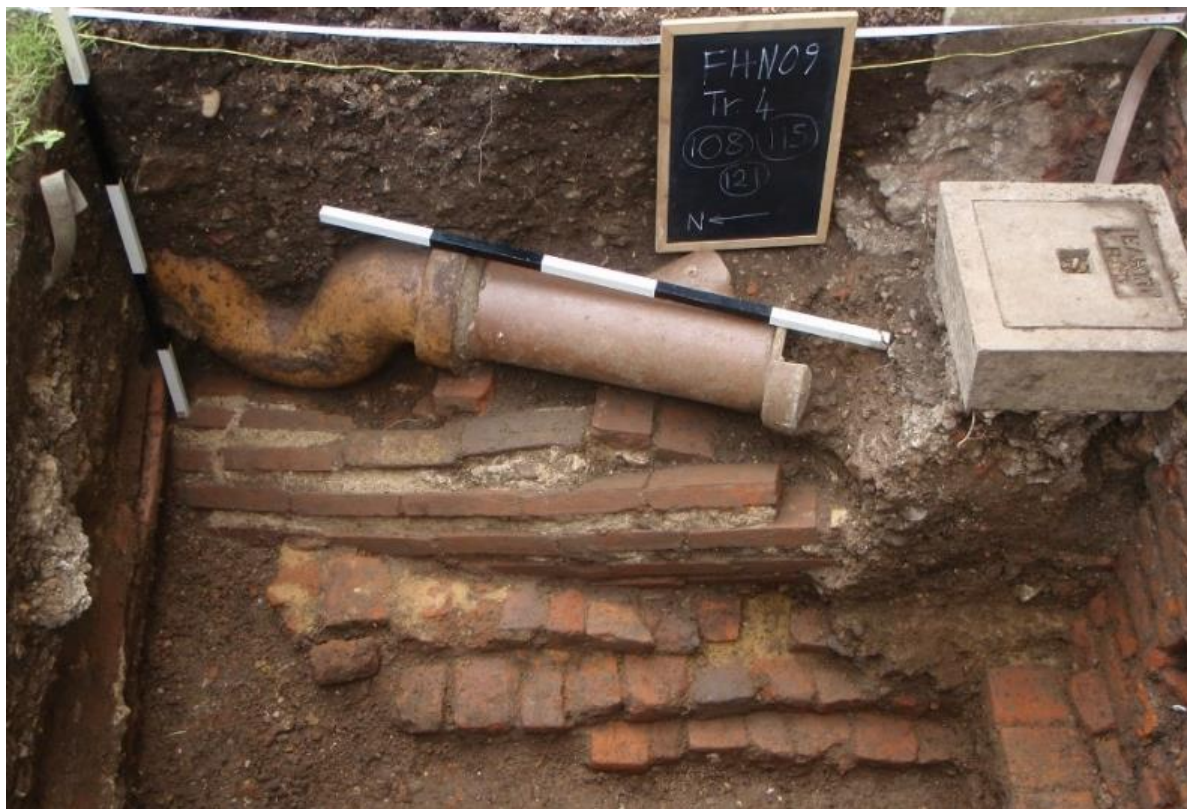
Pl. 27: FHN09 Trench 4 Showing Phase 6 Drain [09115] Over Phase 4 Wall [09121] and Under a Phase 8 or Later Drain (Phase 5a Wall [09122] to Bottom Right)

Indeed, the succession of services following similar routes was also shown just to the north where other Phase 6 features excavated included, in FHN09 Trench 4 (Pl. 27; for location see Fig. 20), a foul water drain, [09115], of the late eighteenth or more likely early nineteenth century, running north from a c. 30 cm wide circular hole in the north facade wall of the building (the egress also seen in FHN09 Trench 6 within the hall). Built above a Phase 4 forecourt wall (see p 76) out of hard fired, very slightly frogged, 4.5 cm thick pavers and hardish mortar in a rough stretcher bond, it was cylindrical, c. 40 cm in external and 25 cm in internal diameter, and showed a later repair, doubtless following forced access to clear a blockage, with two very hard fired, shallow frogged, bricks and creamy white cement.

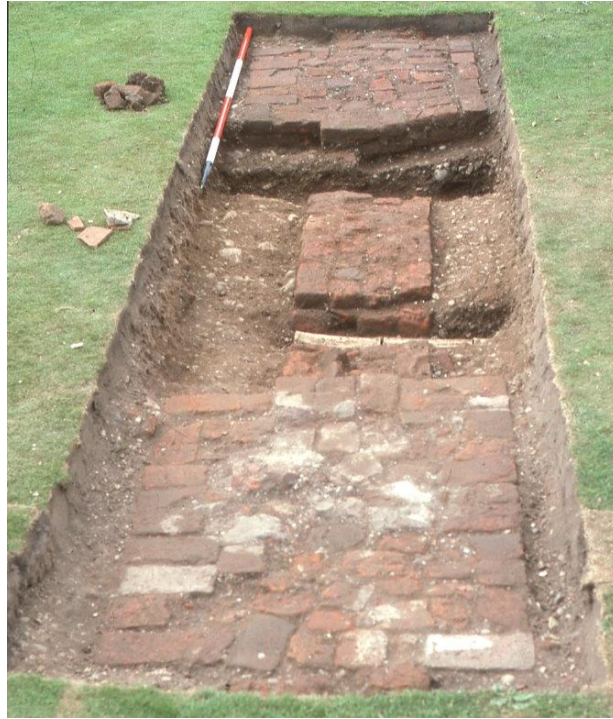
Pl. 38: FH93 Trench 4 Looking East (photo Geoffrey Gillam (© Enfield Local Studies Library and Archive))

The wall's central section though, which was revealed by topsoil clearance, but not fully excavated in FH93 Trench 4 (Fig. 37; Pls 38 and 39), appears to have been modified at some date to provide an entrance. The wall here (though interrupted by two later north south features including a sectional piped land drain) was of the same width, but without the southern reinforcement at least being noted. It only survived to three courses, and the structural relationships could not be established, but it appears that two rectangular pier bases had been built on the wall line. Described as 'of unmortared brick construction, with an irregular infill of incomplete bricks' (EAS archives), they were 50 cm wide, 2.50 m apart, the western 1.10 m long and the eastern 1.30 m long, each broadened by 10 cm along 34 cm of their inner faces coincident with the wall line.

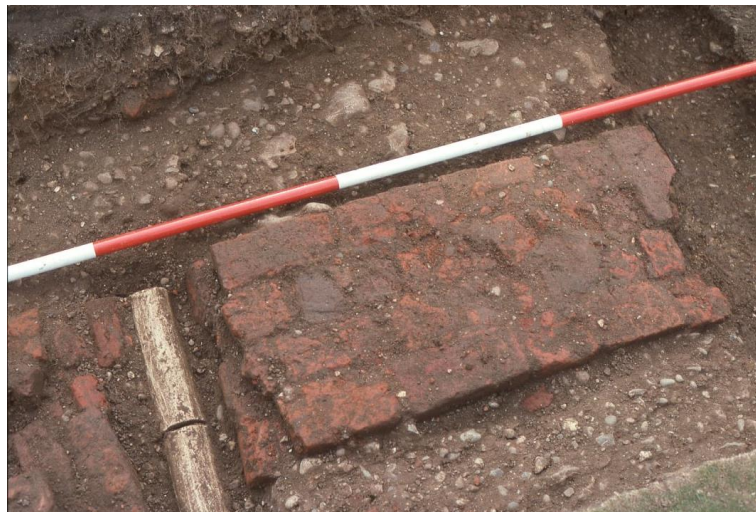
Pl. 39: FH93 Trench 4 Looking South Showing Wall [10250] Cut by Two Later Features Including a Land Drain (photo Geoffrey Gillam (© Enfield Local Studies Library and Archive))

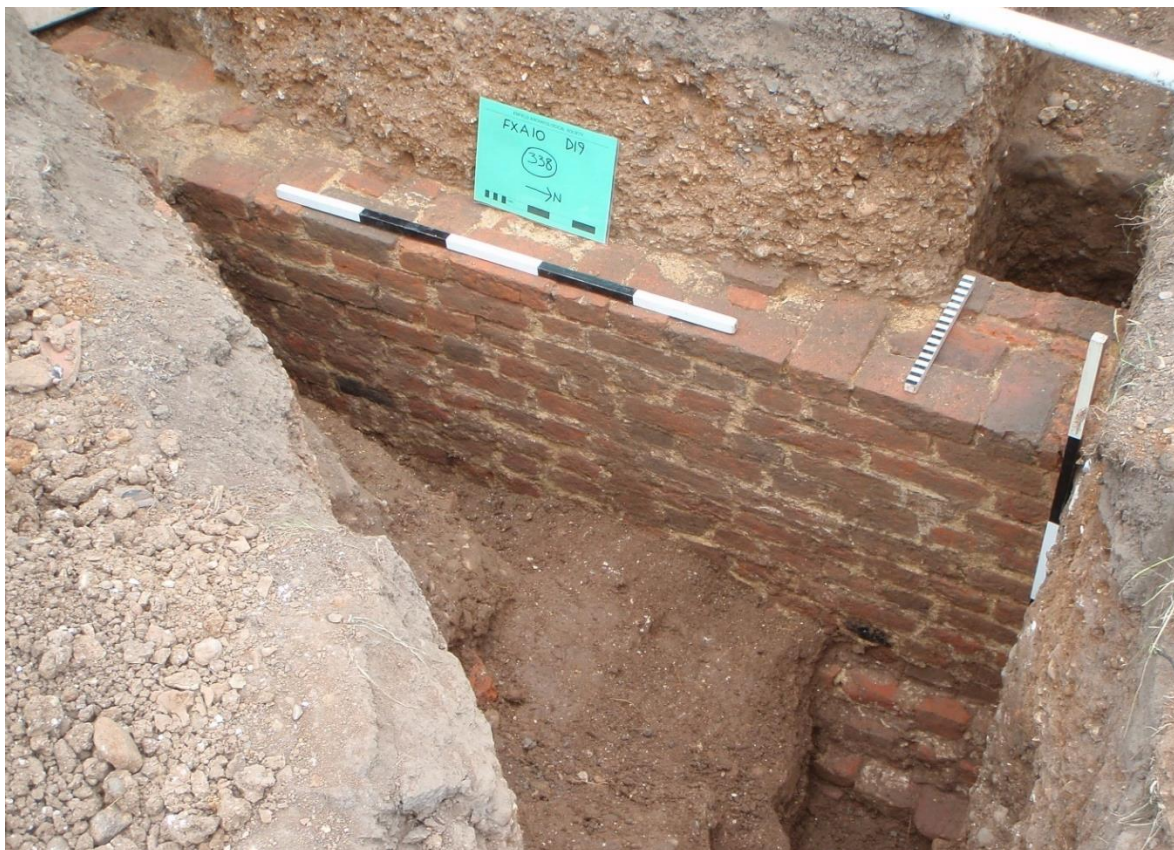
Pl. 40: Phase 4 Forecourt Wall [10338]/[13111] in FXA10 Area D19 Looking West

In any event a significant exposure of another wall, [10338]/[13111], defining the east side of the forecourt was excavated in FXA10 D19 near to the hall facade (with a further exposure in FXH13 Trench C, though it was not seen in the superficial and here much disturbed FHFL03 Trench 1; Figs 33 - 35; Pl. 40). The level which the wall survived to, combined with the level down to which its mortar joints had been fully struck, probably suggests a ground level here at the east side of this facade at the time of the wall's construction of around +46.236 m OD or a little higher. As this was approximately 30 cm lower than the level of the Phase 1 ground surface in the Kitchen Courtyard area, either a natural slope existed or more likely cuts in connection with the Phase 2 construction of the hall (and or its Phase 1 predecessor) and e.g. installation of a drain ([10212]) seen nearby in FXA10 D1 (see p 89) were already present here.

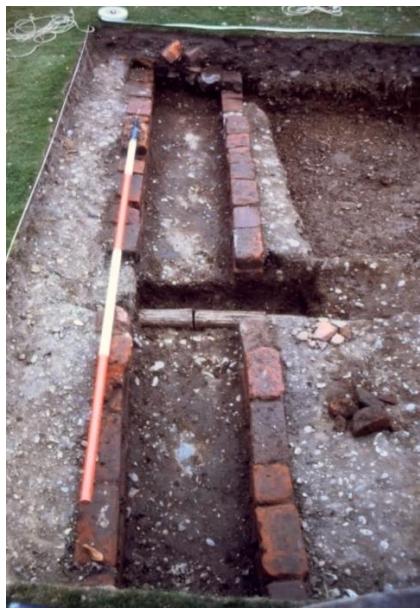
Pl. 41: FH93 Trench 1 Looking West at the Drain (Bisected by a Later Land Drain)  
(photo EAS Archive)

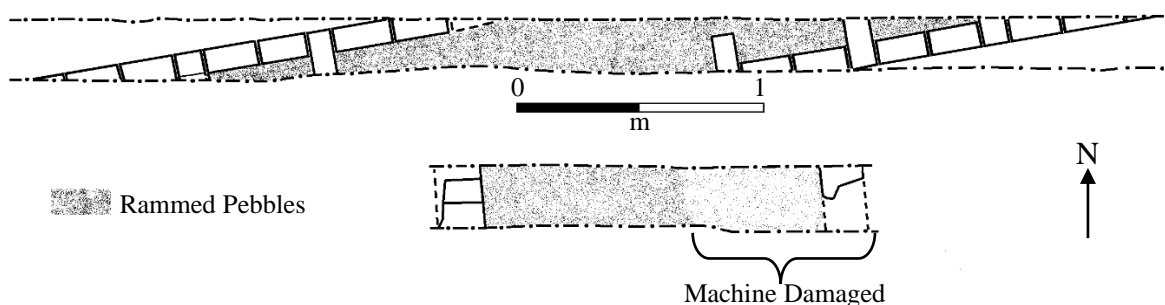
Fig. 38: FHFL03 Trench 1 Exposures of Path [03T1F1] (below) and Feature [03T1F2] (above)

Relatively little is known of the interior of the Phase 2/3 or 4 forecourt, however, a basically axial path to its full length must be presumed and probable or certain evidence for one has been excavated at two points (Figs 35 and 38). FHFL03 Trench 1 encountered [03T1F1], a 1.72 m wide north south rammed pebble path edged, where seen, with header lain bricks and aligned on the (east side of the) north entrance of the hall, even if not exactly on the northern entrance to the forecourt (suggesting that internally the forecourt was not exactly symmetrical). Whilst undated, this path seems likely to have belonged to Phase 2/3 or 4.

FHFL03 Trench 1 also, and in an area that must have been within the forecourt, showed that at some point a feature, [03T1F2], had been created running east west across its western part at least (Figs 33, 35 and 38). Linear and c. 50 cm wide, it appeared, though the exposure was very limited, to comprise edges formed by at least three courses of brickwork infilled with rammed pebbles, the edging brickwork (though no mortar was preserved at least) comprising stretcher lain bricks, but with every third one replaced by a header. Though presumably intended as well to be decorative, this construction may suggest that it was a small terrace retaining ‘wall’. Unfortunately the intersection of the probable axial path and this feature was not within the monitored trenches and again no dating is available for it, but if it belonged to Phases 2/3 or 4, and especially if it was continued on the other side of the axial path (where monitoring could only record possible disturbed dumping further north and in adverse conditions), the forecourt may have been on two levels. That immediately north of the possible retaining ‘wall’ a compacted layer of pebbles, but containing some tile and brick fragments, was present might hint at the presence of a path following the wall line and reinforces the possibility that the forecourt could have been subdivided by paths into ?unequal ?quadrants, perhaps on different levels. However, the difficulties of interpreting features only seen in narrow machine cut trenches means that this must remain hypothetical.

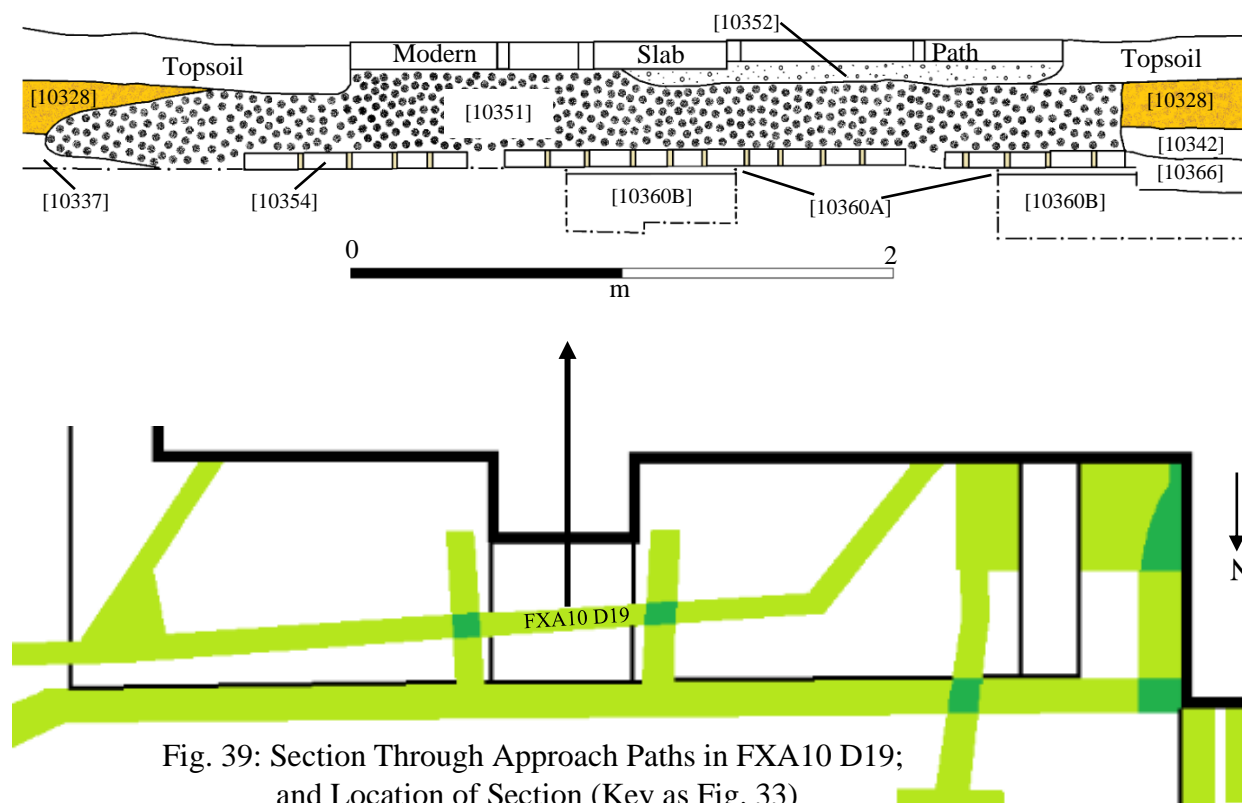
Fig. 39: Section Through Approach Paths in FXA10 D19; and Location of Section (Key as Fig. 33)

There is also evidence for extensive dumping, perhaps not all at the same time, in front of the residential block facade either side of the axial path and the most likely interpretation of what were multiple layers forming different sequences (including [10366], [10337] and [10342]; Fig. 39) is that much of the dumping belonged at least to Phase 2/3 or 4 (though it is possible that some or all of it was introduced in Phase 5 and the only direct dating evidence was a partial clay pipe bowl of c. 1640 – 60 from [10342]). Repeated disturbances here associated with many changes to the approach to the residential block's main entrance and services works as well as the small areas available for examination mean that interpretation is problematic, but at some point the dumping probably again served to create a terrace fronting the facade of the hall or at least raised the general forecourt area above its surrounds. Whether in these phase(s) any more formal surface(s) or more likely gardens existed in front of the house where these dumps occurred either side of the approach path to the entrance is unknown, but must be likely. (How areas just east of the forecourt were treated is unclear, though FXA10 D19 did record a sandy, stony clay probably deposited soon after the construction of its eastern boundary wall which might have represented a contemporary surface.)

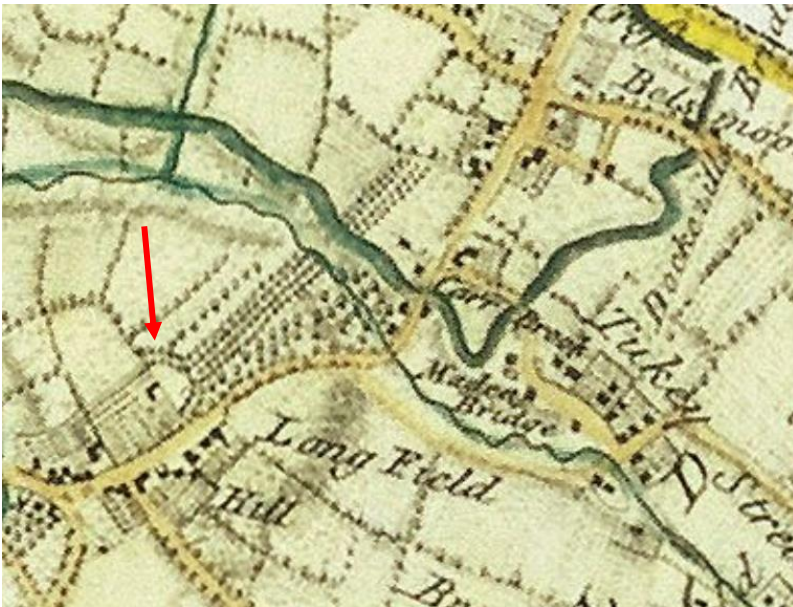
Pl. 42: Extract from Rocque's 1754 Map of Middlesex Showing the Tree Avenue Curving Round the Pond (and Continuing North of Both Maidens Brook and the New River)
