# **The Archaeology of Forty Hall and its Estate**

Martin J. Dearne

Published 2025 by the Enfield Archaeological Society  
Copyright © Martin J. Dearne and the Enfield Archaeological Society 2025  
ISBN 978-0-9501877-4-7  
Designed by Martin J. Dearne and Printed by the Enfield Council Design and Print  
Service

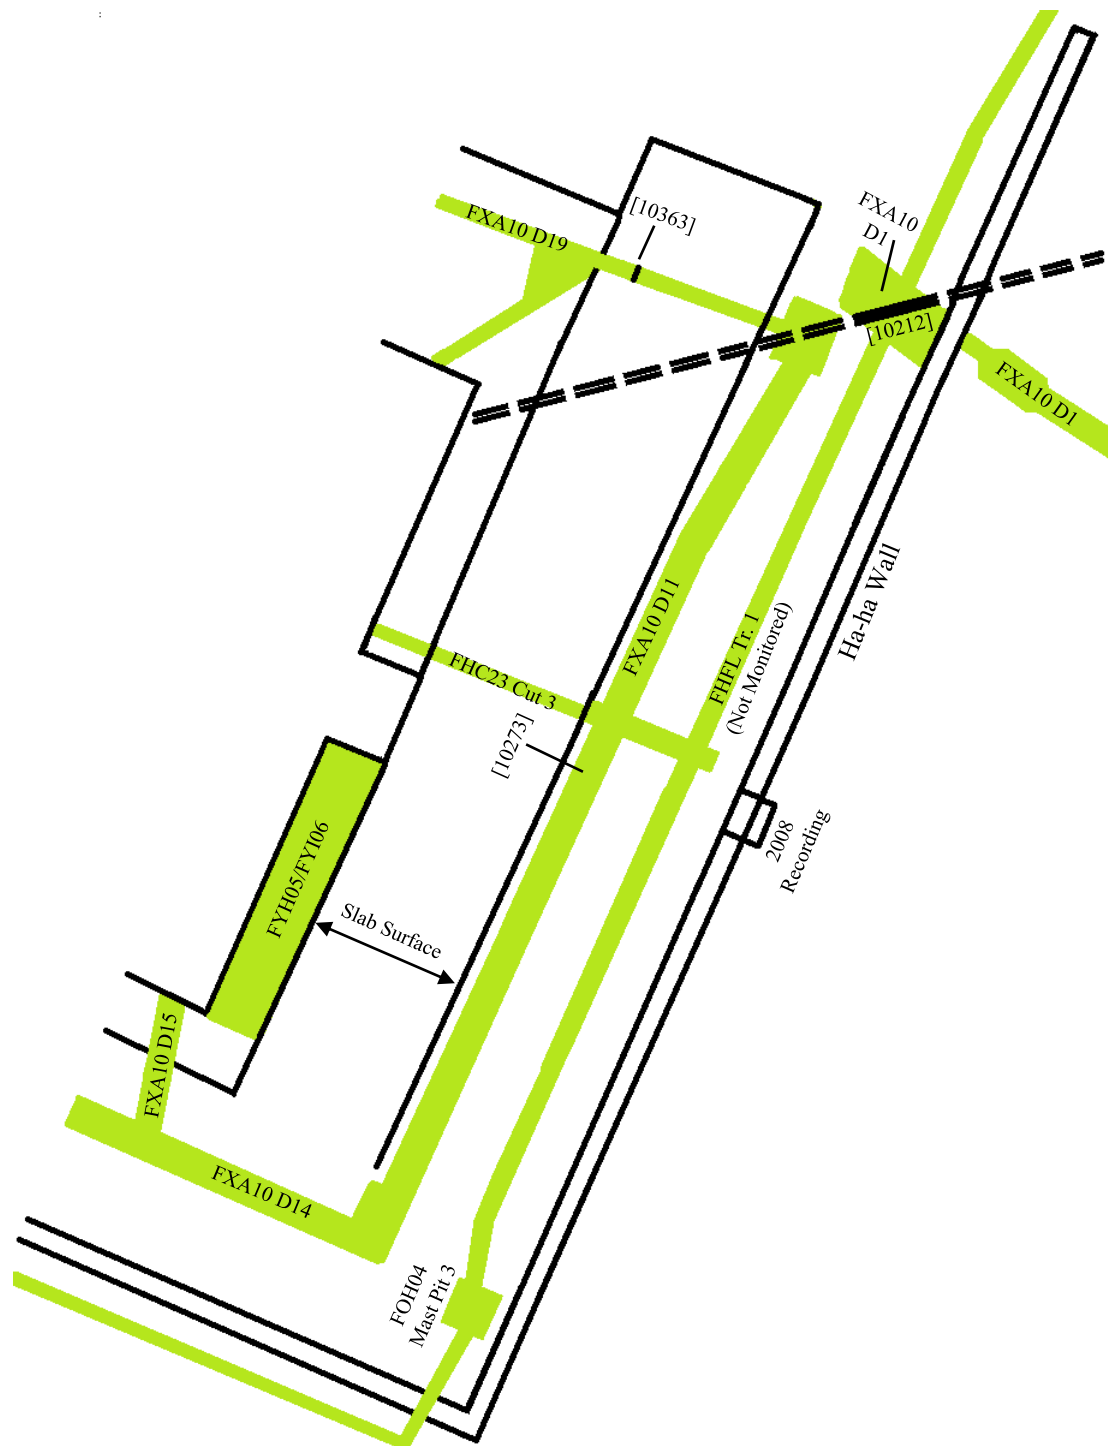
Fig. 45: Excavations and Monitoring Immediately East of the Main Residential Block  
(Key as Fig. 44)

Further possible evidence for terrace creation was recovered a little further north in FXA10 D19, but its dating is equivocal. Thus, 2.90 m east of the Phase 2/3 east wall of the forecourt (see p 75) was another north south wall, [10363] (Fig. 45), built from a higher level than it in a 60 cm wide, perhaps U-shaped construction cut. It had been almost completely demolished, leaving only parts of three courses of a 30 cm wide, irregularly bonded foundation of hand made, unfrogged bricks and thick mortar joints. It clearly pre-dated a widespread Phase 7 surface, while the mortar used was reminiscent of that used in the privy block to the south of the hall built in Phase 6 (see p 96f) and the bricks (though they could have been reused) would be consistent with a seventeenth or earlier eighteenth century date. However, it is possible that it might have belonged to the widespread changes to the hall made by

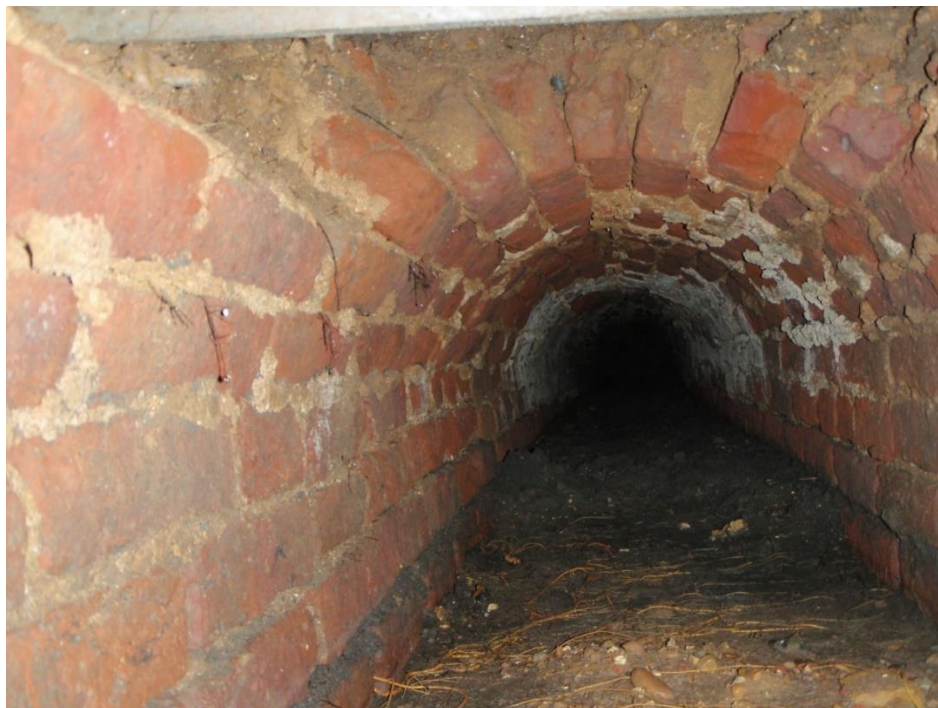
Pl. 46: FXA10 D1; Internal View South West Along Phase 2/3 Drain [10212]

corner of the Phase 2 residential block. Its floor at +45.165 m OD, compared to that of the original floor of the Phase 2 hall's basement excavated in room A006 at c. +45.270 m OD, makes it virtually certain that it was a main drain for the original basement, presumably serving the north east corner of room A003.

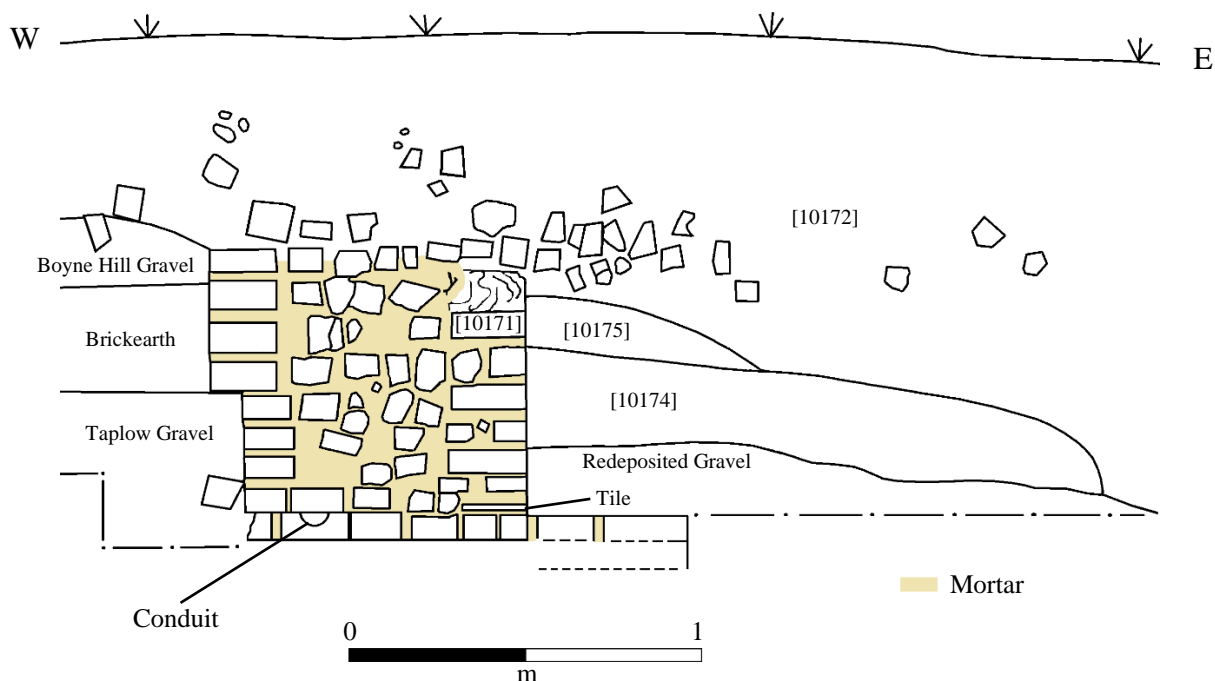
Fig. 46: FXA10 D1, Section Through Wall [10171] and Flanking Deposits

Evidence for this probably Phase 5 landscape modification initially came from FXA10 D1 which showed that a boundary wall, [10171] (Figs 44 and 46), had been built along the west side of a major natural-truncating cut running approximately north south 72 m east of the modern ha-ha wall to define the re-landscaped area.

The lower part of the boundary wall, 90 cm thick, survived to nine courses (85 cm) of part, and at least in one course on the east face whole, bricks, comprising a fairly roughly built/coursed core with rather tidier (?English bond) faces. The five lowest courses appeared to have been stepped back around 8 cm from the line of the west face above them and probing suggested that the lowest, laying at the top of the water table at the time of excavation, had been stepped back again on the west. Excavation showed that this basal course had incorporated a constructed water conduit running along the line of the wall, while on the east the wall had been broadened by a further 45 cm at this level into an offset overlain by redeposited gravel. The broadening continued down for at least one further probed course below the eastern half of the wall and used, at least in its top course, a skin of part brick headers faced with a skin of whole brick headers.

The conduit was constructed of a line of north south lain, hand made bricks moulded with a longitudinal 5 cm deep, 7.7 cm wide U-shaped channel in their upper surface, covered by a second line of hand made, unfrosted, bricks, at the level of which to the east, but separated from them by a gap, were a line of whole, unpierced, (roofing) tiles which would have marked the level of the channel on the east face of the wall.

The landscaping cut, into the west side of which the wall had been built, had removed a considerable depth of the natural Boyne Hill Gravel and underlying Brickearth and Taplow Gravel, the cut having thus left a raised platform at least c. 70 cm, and probably, given that dumping took place west of it (below), nearer to 1.00 – 1.20 m, above the level east of the wall. The function of the wall must, in part at least, have therefore been to retain the platform, as emphasised by its broadened foundation to the east, but how far it was only a retaining wall and how far a boundary wall of some height is problematic as the depth of its foundations may well have been as much due to a desire to tap ground water by use of the conduit as for structural reasons. The presence of the conduit built into the wall indeed suggests that part of its function could have been, depending on how far south it ran, to feed one or more pools at the south end of the gardens on the east side of the hall, possibly the pond in the south east corner of the pleasure grounds discussed below (p 107f).

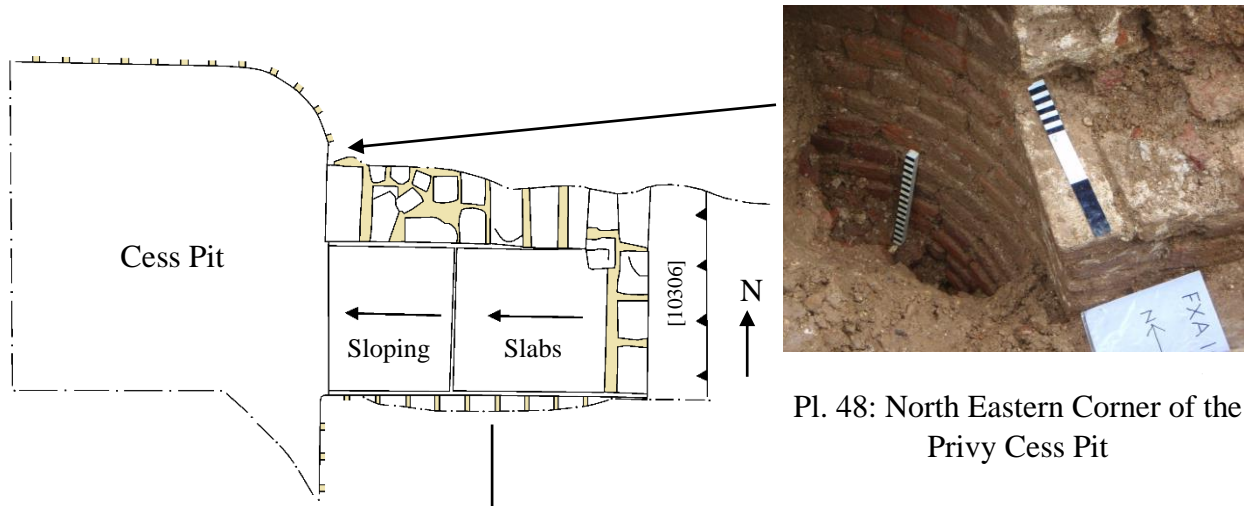
Pl. 48: North Eastern Corner of the Privy Cess Pit

It was possible to entirely excavate the northern privy, (of almost certainly a line of two and perhaps three) and to clear to a significant depth the eastern part of the adjacent cess pit to its west. The cess pit was rectangular with rounded corners, over 1.20 m east west (but almost certainly under 1.70 m) and over 1.50 m north south, with vertical header bonded brickwork walls changing to English bond for the east wall adjacent to the privies and some slight suggestion of corbelling to the upper of the 15 or 16 courses seen in detail so that it perhaps had a gently arched roof. Its north east corner probably survived to near its entire height so that it was seen to be over 1.14 m deep, probed to 1.44 m and minidigger working of its basal rubble fill suggested (though this could not be confirmed) that it might have been in all c. 2.00 m deep with a slightly dished floor.

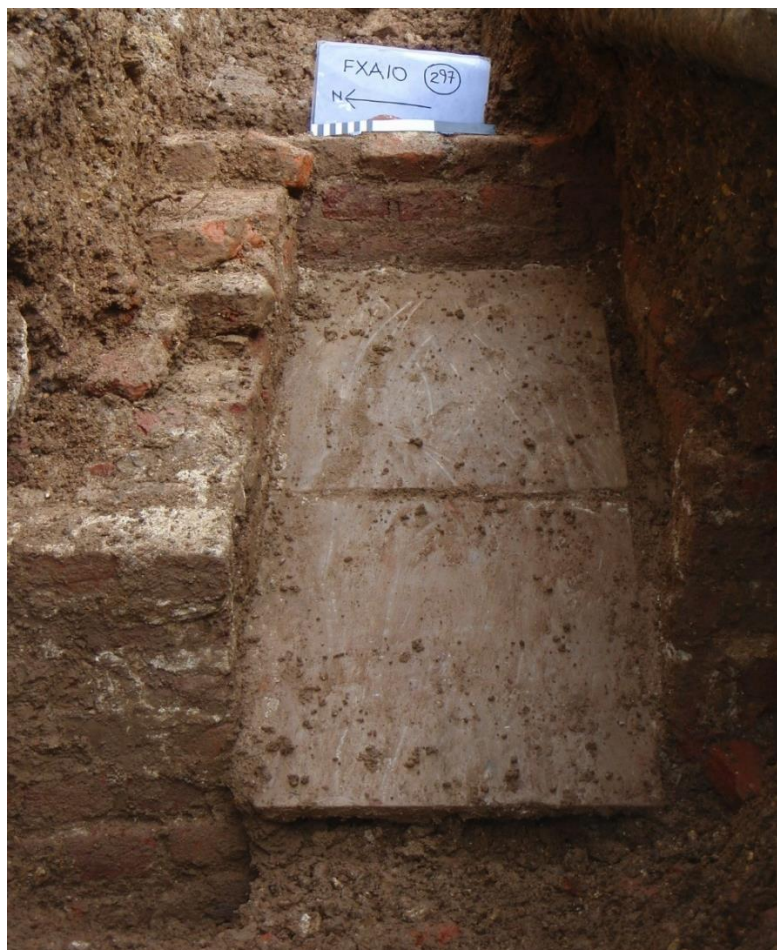
Pl. 49: Sloping Slabs in Privy [10297], Looking East

Whatever they represented though once the main surface, [10300] (surviving to up to 28 cm thick and of gravel in a matrix of sterile, strong brown very gritty/sandy clayey silt), was laid the building of the privy block resumed. It was represented by the east wall, [10314], of the block, built in a 54 cm wide, 20 cm deep construction trench, [10316], which lay c. 1.60 m east of the wall for the privy seat (probably suggesting open privies ranged along the west side of a corridor). The wall, using whole and part bricks, only survived to a maximum of three courses above a mortar raft and was 26 cm wide. Demolition rubble in the cess pit included brick, peg and ridge tile as well as (less) roofing slate and some (?whitewashed) plaster, suggesting something of the superstructure of the privy block.

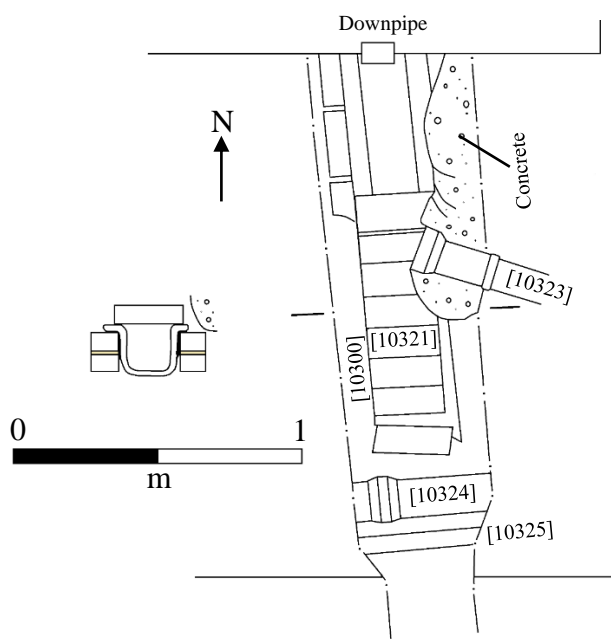
Fig. 50: Drain [10321] in FXA10 D15 (for Other Numbered Features see Below)

It was impossible to be sure at what date this occurred, but the roof drain system was replaced in 1800 (Phase 6b) by James Meyer, extant lead hoppers monogrammed JM bearing that date, and in Area D15 one of the drains, [10321], serving the down pipes installed at this time and cut into surface [10300] survived largely intact for 1.40 m out from the facade wall (though comparison with a second seen in D19 (p 85) probably suggests that it may have been a slightly later replacement for the original). It (Fig. 50) comprised a 20 cm wide, 14 cm deep rectangular gully, with sides of two courses of hand made, very shallowly frogged, stretcher bond lain bricks, lined with lead sheet. Its partially surviving roof was of similar, header lain, bricks.

Subsequent features (Figs 50 - 51) were all related to later services replacement and included a Phase 9 or 10 (post 1897) concrete encased sectional terracotta pipe drain, [10323], in Area D15 and a probably Phase 10 east west salt glazed sectional piped drain, [10324], running roughly parallel to the facade of the hall seen in D15, D16 and D18. Another lead water main, [10325], may also have been of either Phase 8 or Phase 9 and the final change was the laying of the modern slab surface to the terrace.

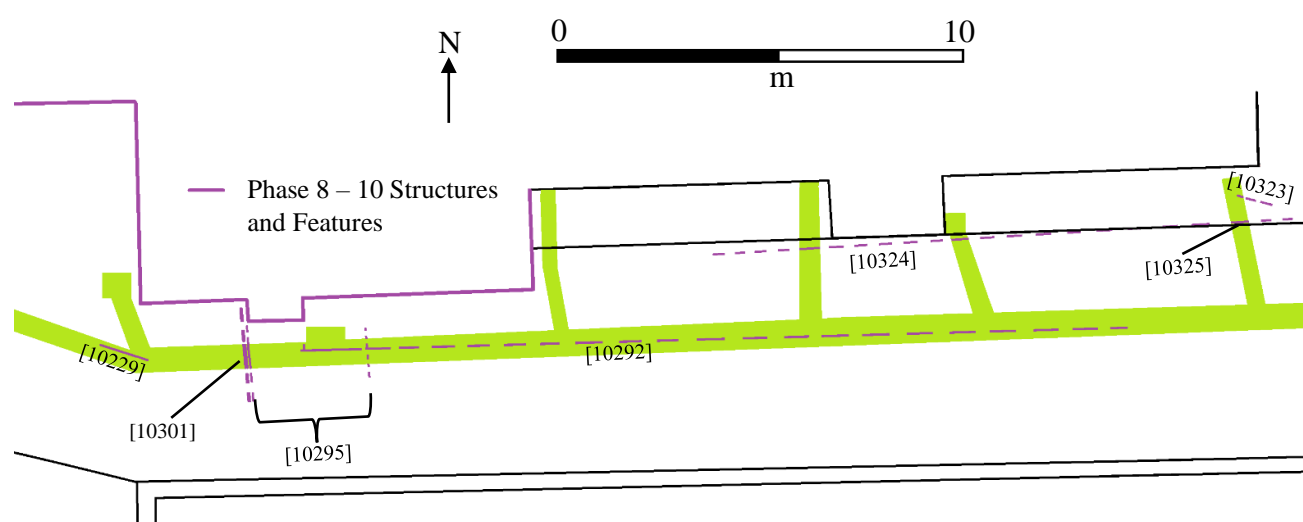
Fig. 51: Phase 8 – 10 Extensions and Features South of the Main Hall Complex

In areas monitored in 2009 – 2011 in front of the Phase 2 residential block and Phase 8 extensions (Fig. 51) services changes were represented by a major north south cut, [10295], in line with the entrance into the new extension at least partly to take new water mains leading into the hall at this point. Overall as much as 4 m wide and opposite the porch perhaps 90 cm deep, it ran in part across the unexcavated western side of the former privy cess pit and held three lead water supply pipes running towards the porch and a capped off gas main, [10292], ran into it from the east with a capped off gas supply pipe running towards the porch from that ([10292] was also seen much further east and probably ran the length of the south facade of the hall). Never the less, cut [10295] opposite the porch was much larger than necessary for all these and one suspects that major piped drainage also ran north south within it, but below the level exposed during the monitoring (and a later trench probably from the removal of another drain was recorded in Area D8). Just to the west of [10295] another parallel 40 cm wide, 47 cm deep cut, [10301], held another (Phase 8 or 9) water supply pipe while a concrete encased foul drain [10229] was recorded in D9 and D14.

Evidently following the completion of the new extension a c. 6 - 10 cm thick grey flint pebble concrete surface had been laid right along the south facade of the hall, projecting 1.4 m south of the facade of the new extension and 3 m or more (probably widening as it ran east) from the facade of the original (Phase 2) build. An over 1.30 m wide, 10 cm thick path of compacted very dark grey cinders was also laid from the south west corner of the newly extended section of the hall, likely to give access to the tree belt surrounding the lawns to the south and east of the hall.

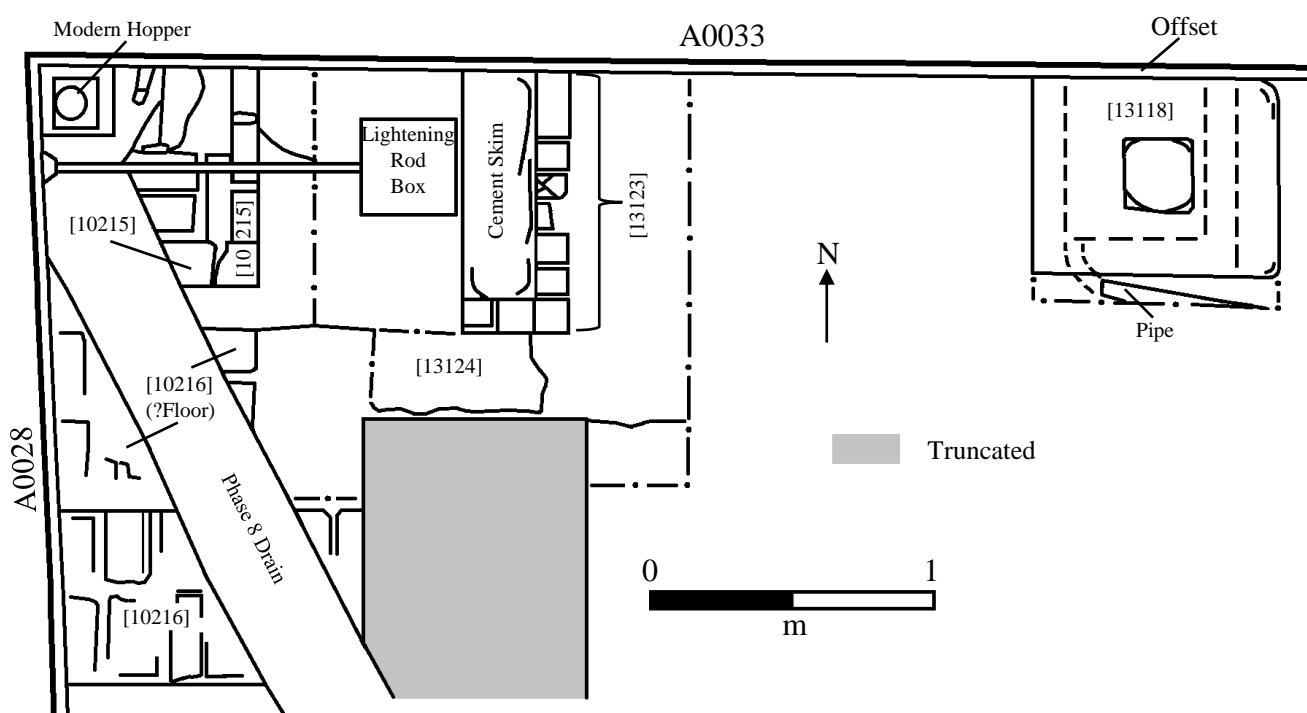
Fig. 52: ?Phase 7 Features in FXA10 D3 and Adjacent FXH13 Areas

Further west there had clearly been repeated use of the space in the angle between the south wall of the Phase 3 brewhouse/bakehouse and stables (rooms A0035 and A0033) and the east wall of the orangery (room A0028) for drainage features as well possibly as small structure(s), maybe such as a gardeners' tool shed or e.g. water tanks, probably from Phase 7 onwards (Fig. 52). But the presence of modern features including a drain hopper, lightning rod box and electricity supply cable further complicated interpretation of the disparate elements seen in both FXA10 D3 and the FXH13 monitoring. Of them [10216], a 1.04+ m east west run of 62 cm wide cement bonded brickwork using a variety of (re-used) bricks and including yellow stocks was presumably a ?Phase 7 ?wall foundation and a continuation of

the brickwork to the north could have represented a brick floor. Slightly further east [13123], a c. 23 cm wide, at least as surviving, 90 cm long north south dwarf wall comprised three courses of Flemish bond brickwork with struck joints, (conceivably re-) using shallow frogged brindled stock bricks, above a fourth offset course which projected 8 – 12 cm and re-used some older, softer fired red bricks. The top of the ‘wall’ had been given a cement render skim and at the level of the offset an over 10 cm thick light grey concrete raft, [13124], continued over 30 cm further south of it and over 80 cm to the west. However, the phase of these features and what, if any, relationship they had to [10216] was unclear. Maybe later than one or both of these a brick built drain gully, [10215], presumably for an adjacent roof downpipe, had been built in the corner of the area, then blocked with part bricks when it went out of use. Subsequently it and [10216] had been truncated by the installation of a presumably Phase 8, active, concrete encased salt glazed stoneware drain serving the downpipe via a new smaller gully/trap. Meanwhile, maybe in Phase 7 and 1.6 m east of [13123], a brick built presumed soakaway/sump, [13118], internally c. 55 x 48 cm and 53 cm deep, had been built abutting the south wall of the Phase 3 stables (room A0033). It comprised a single skin of brindled, shallow frogged stock bricks seven courses high, capped with an 86 x 66 cm, 4 cm thick stone slab. The slab was almost certainly re-used

and had a central, 23.5 cm square hole cut into it and a small (c. 5 cm diameter) iron pipe appeared at some point to have been fed into the top of the south west corner of the sump/soakaway from the east, but had been cut off before reaching it. One suspects that it was originally intended for limited quantities of waste ?water from some outside activity (probably at least latterly carried in the iron pipe from further east) rather than roof drainage as its position would obviously have presented a damp problem for the standing building if it had been for the latter.

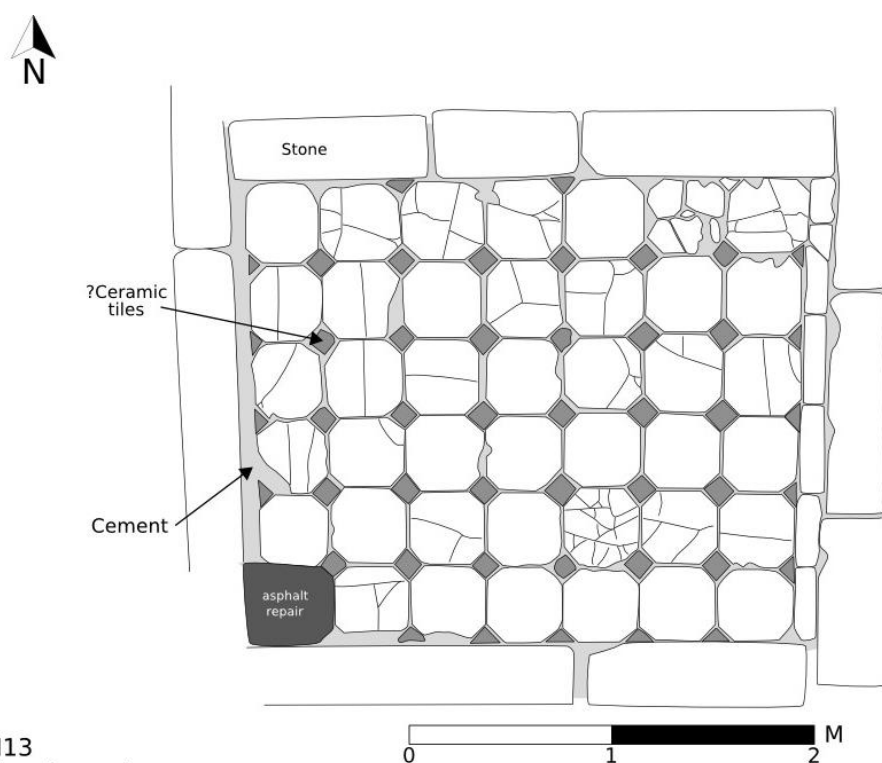
Fig. 53:

A damaged decorative stone and tile surface forming the top of a set of steps up onto the terrace south of the hall from the south was replaced during the 2013 – 15 works and was recorded and its elements evaluated. The surface comprised 41 (originally 42) small, octagonal (square with truncated corner) stone slabs with lozengiform hard fired unglazed black ceramic tile inserts between them, an edging on the east of six small stone blocks and one of three larger ones on the north (Fig. 53).

FXH13  
Tile/Stone Pavement  
South Terrace, Forty Hall

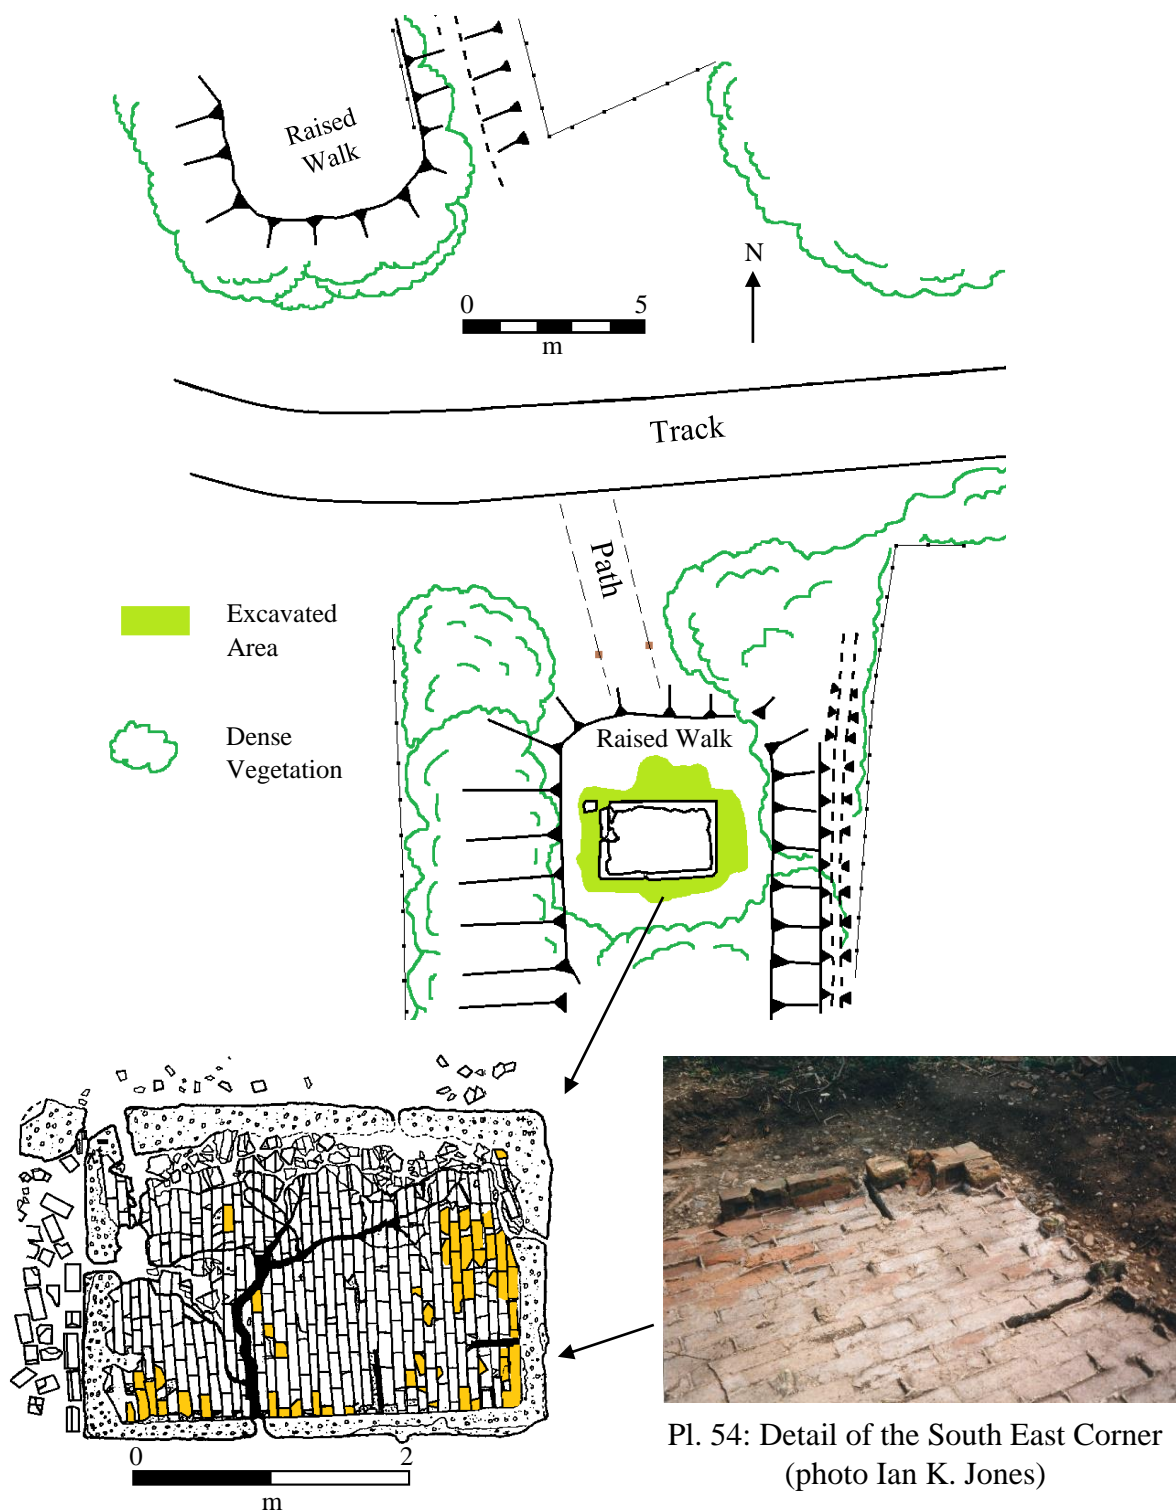
Fig. 58: The West Summerhouse and its Setting

<sup>115</sup> The surveys, held in the EAS archive, were by Jon Tanner and form the basis of Fig. 58; Fig. 59 draws on both surveys by Jon Tanner and by Northamptonshire Archaeology in Prentice (2010b); the plan of the east summerhouse omits some irregularities due to the movement of some walls. The 1999 clearance and excavation work was not recorded or reported in the detail or manner that allows it to be as fully evaluated as one might like.

Excavation of the site of the west summerhouse (Fig. 58 and Pls 54 - 55) showed that whatever had stood here earlier had been replaced, almost certainly in the late nineteenth century, by a brick floored largely timber building. Covering an area of 3.2 x 2.3 m, it was represented by a rammed gravel platform (which could presumably have been pre-existing) edged with a 30 cm thick, 23 – 61 cm wide band of concrete. The gravel acted as the base for a c. 2.9 x 2.0 m mortared floor of edge set bricks, mostly removed but represented by impressions in the mortar, which also indicated the positions of timber base plates for uprights around three sides of the floor. Slots (Pl. 54) suggested the settings for a bench or seat within the north facing building which was accessed by a c. 1.2 m wide gravel path leading from it, through a gate represented by two timber posts, to the east west track.

That one of the base beam impressions carried a decorative moulding suggested the use of some salvaged materials and loose brick finds (be they from this structure or a predecessor) were thought to have been of a variety of dates, the structure (and or an earlier one) might have had glazed windows as window glass fragments were recovered and multiple peg tile fragments with one from a pantile might point to tiled roof(s) on the building represented and perhaps a predecessor. Two *in situ* bricks from the externally rendered edge of the floor were stamped BHP (Pl. 55 inset) and were products of the Bush Hill Park brickworks which began production in 1875 and must strongly suggest that the structure excavated belonged to Phase 7 or later.

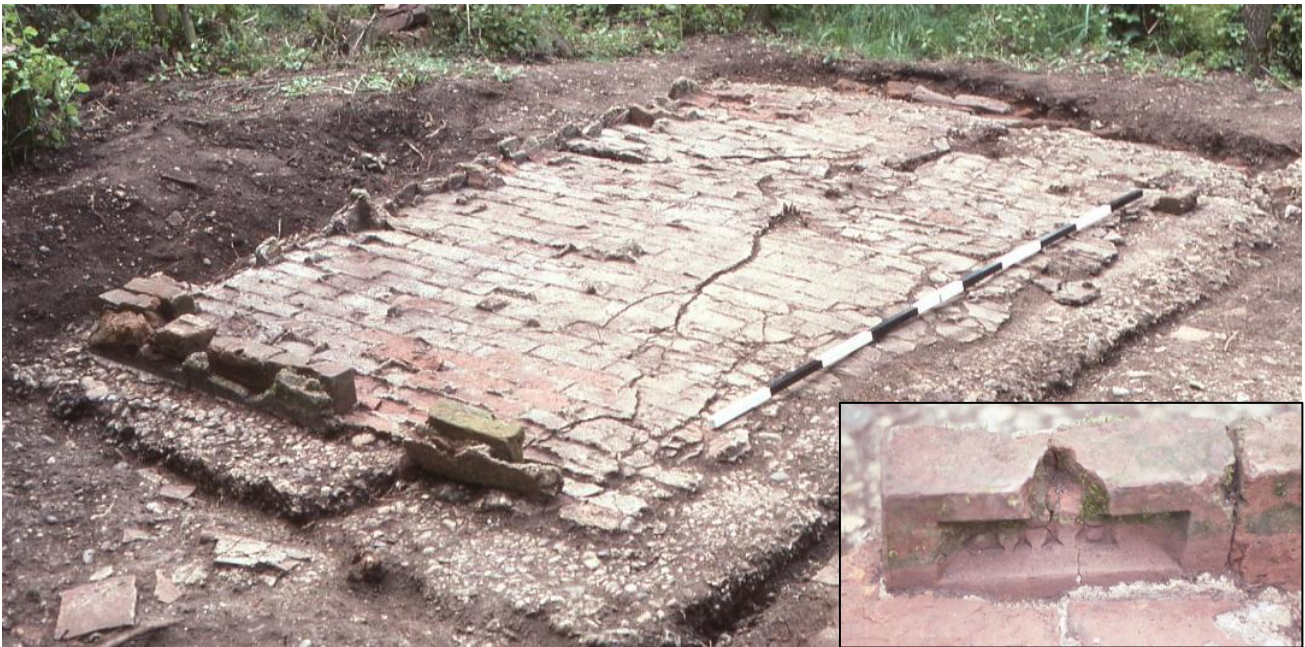
Pl. 55: The West Summerhouse Looking South West and Inset *in situ* Stamped Brick  
(photos Geoffrey Gillam (© Enfield Local Studies Library))

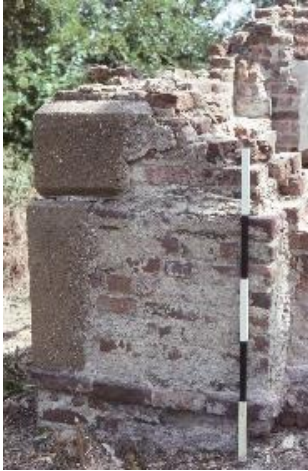
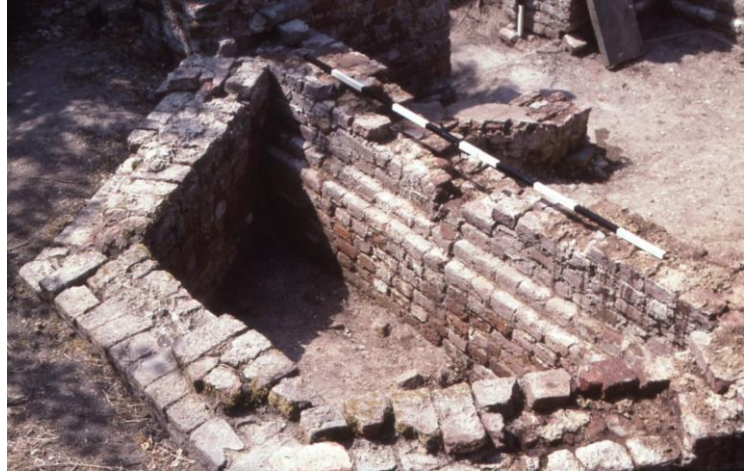
Pls 56 and 57: The North West Corner and (to Right) the East Bay of the East Summerhouse (photos Geoffrey Gillam (© Enfield Local Studies Library and Archive))

lime mortar and patched in places with Portland cement. An external chamfered rusticated finish (render), perhaps only on the thickened corners of the west face, as surviving is of cement (?replacing lime mortar) and on these thickened corners imitates ashlar masonry quoins (Pl. 56).

The bay (Pl. 57) is presumed to have featured large windows and, though nothing of it survives above floor level, has a thickened foundation (as has at least the south wall), but there is some divergence of opinion about whether it was an original feature or a modification to the structure, the former seeming more probable. Though it too had a void below floor level there was no communication between it and the (sub)basement, there being a north south sub-floor wall between the two, so that if it was used in any way it would have had to have been accessed by a trap door in the (lost) floor (which is probably unlikely).

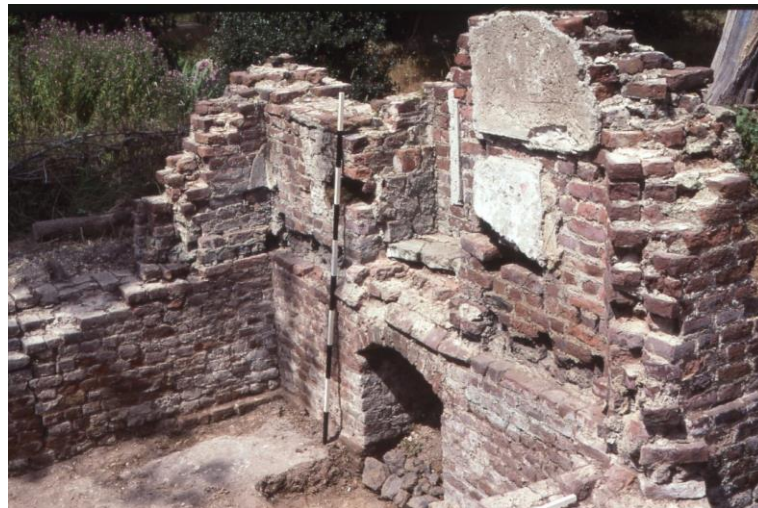
Pl. 58: The Interior of the East Summerhouse Looking North, Showing the (Sub)Basement Arched Support to the Partly Lost Fireplace Above (photo Geoffrey Gillam (© Enfield Local Studies Library))

The chimney on the north, the best preserved part of the summerhouse, served a partly surviving ground floor fireplace, originally 93 cm wide, supported at (sub)basement level by an arched recess built of edge set bricks (Pl. 58) with the remains of a second arch at right angles to support the fireplace's hearth slab. However, the hearth slab had clearly been replaced with a new limestone one, perhaps contemporaneously with the relining of the sides of the fireplace with edge lain bricks. Finds suggest that the fireplace, at some point, had a cast iron fireback and grate. Whether 30 cm square, 3.8 cm thick red clay tiles in demolition rubble were connected with the hearth or some other part of the structure is perhaps less clear (and the origin of some 12.5 cm square white glazed tiles more so).

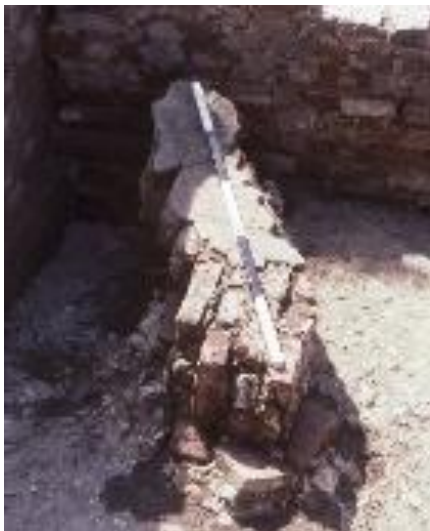
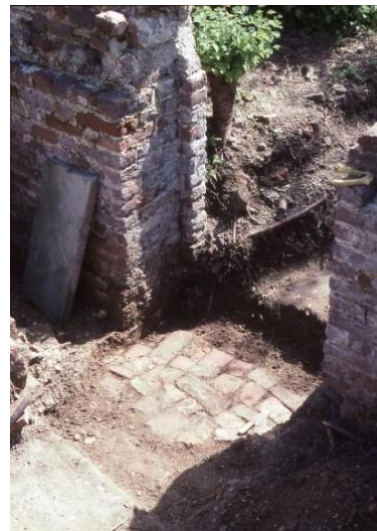
Pls 60 and 61: Fallen Brickwork in the Sub-basement of and (to Right) the Entrance to the East Summerhouse (photos Geoffrey Gillam (© Enfield Local Studies Library and Archive))

A section of fallen brickwork in the sub-basement (Pl. 60) suggests a roof with shallow pitched gables ?on the east and west and finds of a variety of oval or rectangular, angularly or rounded edged, Westmoreland (or Cornish) and Welsh slates and 25 x 15 x 1.2 cm peg (and ridge) tiles may imply two phases of roofing or two contrasting roofing finishes. Recovery of elements of a cast iron gutter and down pipe from a small trench at the north east corner of the building also probably suggest the upgrading of the roof drainage in the ?nineteenth century.

The (sub)basement was too constrained to have been used other than as a basic storage space and was accessed externally by a 86 cm wide doorway centrally in the south wall, surviving springing indicating that it was arched and had internal rebates for door posts,<sup>118</sup> though no floor surface is known beyond a 0.9 m square rough threshold of reused bricks (Pl. 61).

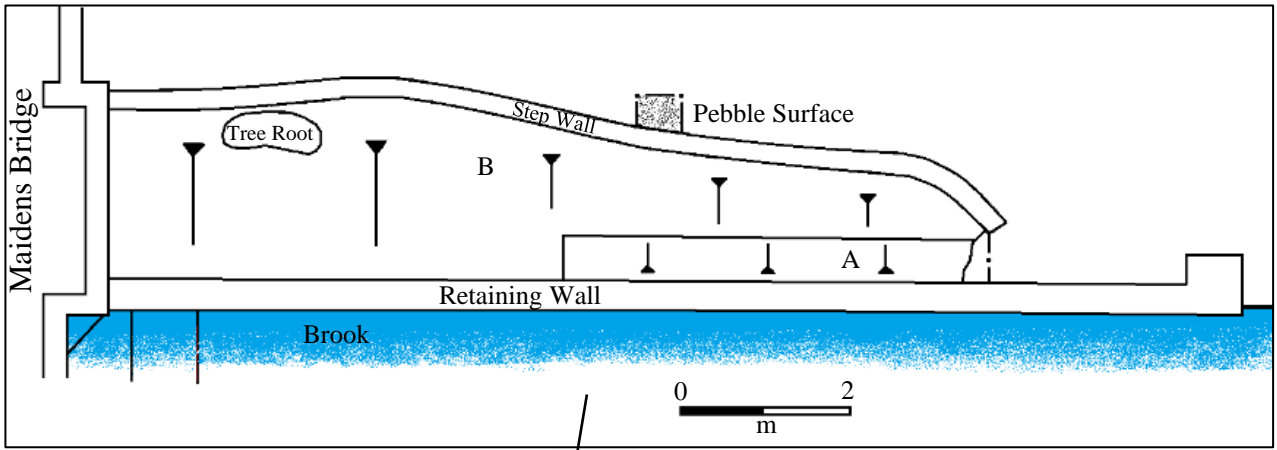
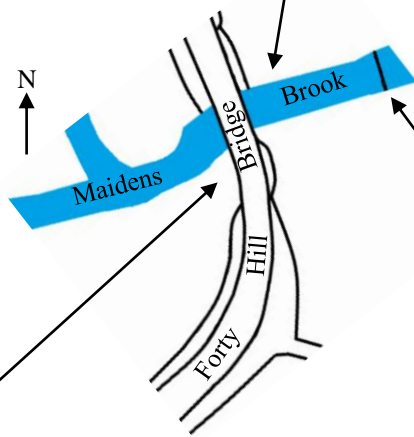
Fig. 62: Monitoring and Recording in the Vicinity of Maidens Bridge

The earlier (A on Fig. 62) appeared to be part of a one brick thick surface of orange/red unfrogged bricks, sloping up to the south and which likely formed part of the approach to the 1761 bridge. It had later been incorporated into a much more extensive brick surface (B on Fig. 62) presumably intended to stabilise the bank and provide an aesthetic flanking to the 1795 (or 1820s) bridge. It had extended for 20.85 m east of the current east side of Maidens Bridge, near the bridge been up to 4.43 m north south but narrowing as it ran east. It was bounded on the north by a rather sinuous 'step wall' or kerb, surviving to two courses above the level of the single brick thick surface and ending at the east end of that surface in a curve ?originally continued to the edge of the stream. The wall and surface were constructed of a mixture of bricks similar to those in the earlier surface and of red/grey, shallow frogged bricks, suggesting partial reuse of earlier bricks and of new ones, perhaps of the second or third quarters of the nineteenth century so that works to the bridge area even if not its full reconstruction in the 1820s seems to be likely.

However, traces of the likely approach to the 1761 bridge, a footbridge and adjuncts to the 1795 or 1820s bridge were recorded in 2008 when the brook's flow was pipe constrained to allow repair of a damaged later weir under and east of the bridge and other works in the vicinity were monitored. Though only limited recording of the footbridge (Fig. 62), before it was destroyed by a new concrete extension to the current weir, was possible, 12, clearly of originally 14, c. 12 cm square timber piles were seen forming two staggered north south lines, c. 1.87 m apart, the piles at 87 cm to 1.0 m intervals centre to centre. The more westerly line retained c. 5 cm thick timber boards between them on the west, and in some cases metal retaining plates on the east faces, while the more easterly line only appeared to have the timber boards between them, again on their west.

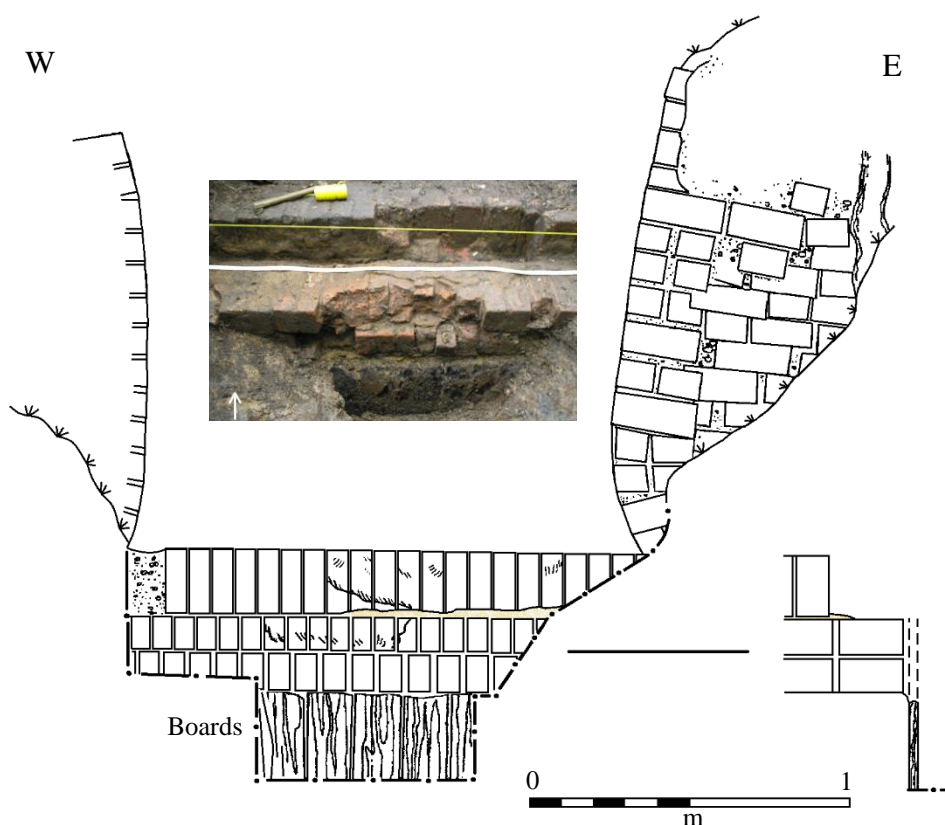
Fig. 72: Section at the South End of the Lined Channel

A small excavation across the south end of the channel showed that its floor was of three courses of bricks, the two lower mortared and edge lain along the orientation of the channel and the surface itself formed of unmortared end set bricks in staggered rows. The surface included five east west slots at 10 ft (3.05 m) centre to centre intervals, with a sixth one 6 ft (1.83 m) back into the culvert, one or two rows of edge set tiles (and elsewhere perhaps mortar fillets) used to achieve the precise spacing where the brick pattern did not allow for them (which might hint that they were later insertions). Two empty slots confirmed the presence of at least a second brick layer to the floor of the open channel elsewhere, while four of the slots retained 20 cm square timber beams set flush with the floor surface which might have acted when wet as expansion joints to compress the brick floor surface or have anchored wooden structure(s), perhaps to slow the water flow along the gully. The excavation also showed that at the south end of the channel the floor at least had been retained by 10 cm wide vertically set timber boards.

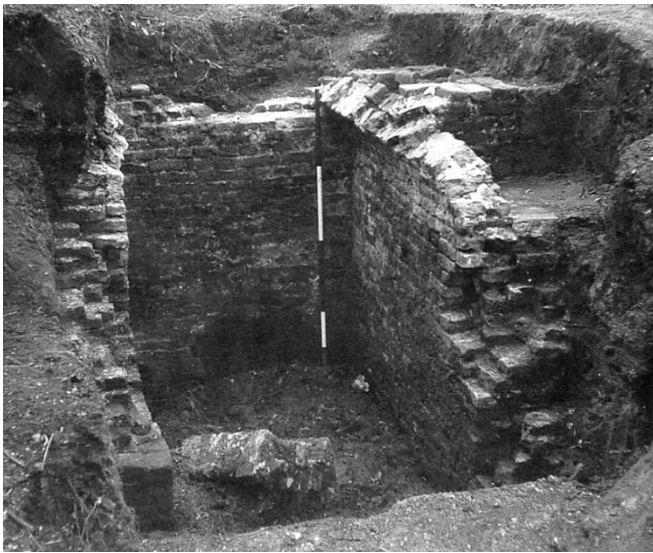
Pl. 75: The Boathouse Looking South  
(from Gillam 1997, Pl. 48)

As its base lay lower than the contemporary water level in the lake, and it was suggested at the time that this would have spoiled the ice, an identification as an ice house was rejected (though this argument is perhaps not conclusive) and it was suggested, partly on the basis of a (Parker-Bowles) family tradition, to be a boathouse. Indeed, local informants at the time of excavation recalled it as in use as a boathouse in the 1940s, providing housing for a small, clinker built rowing boat called the 'Daisy' which was secured by the staple.

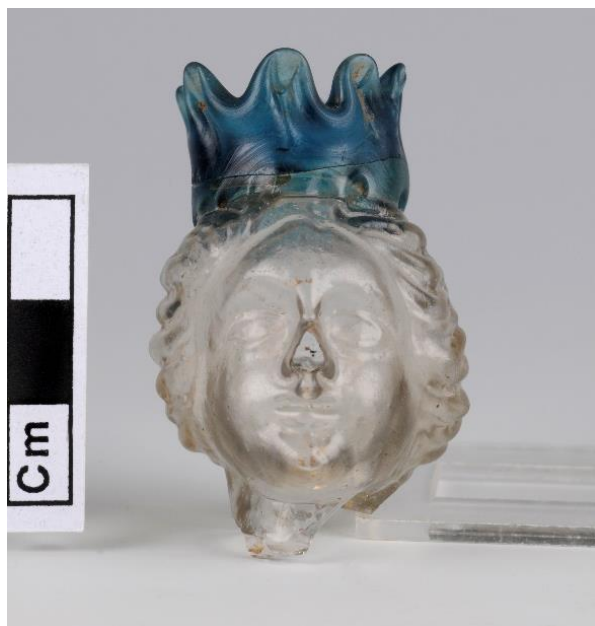
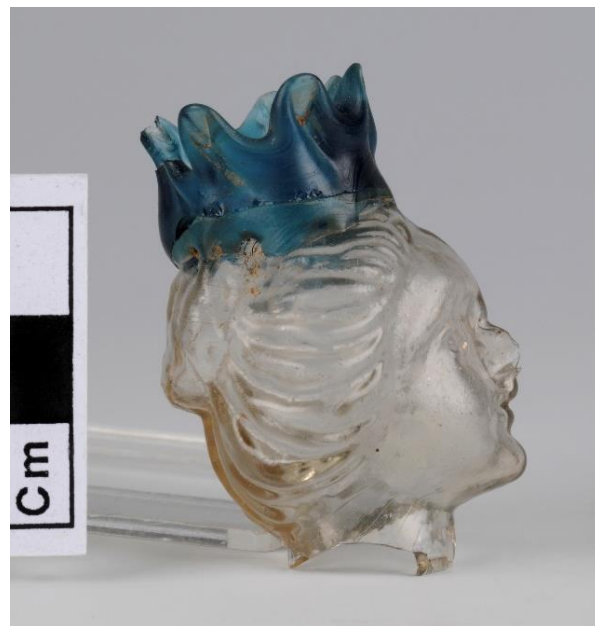
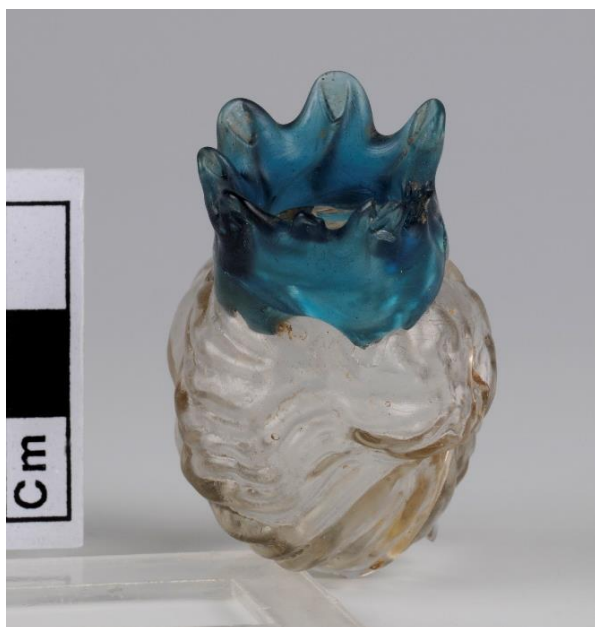
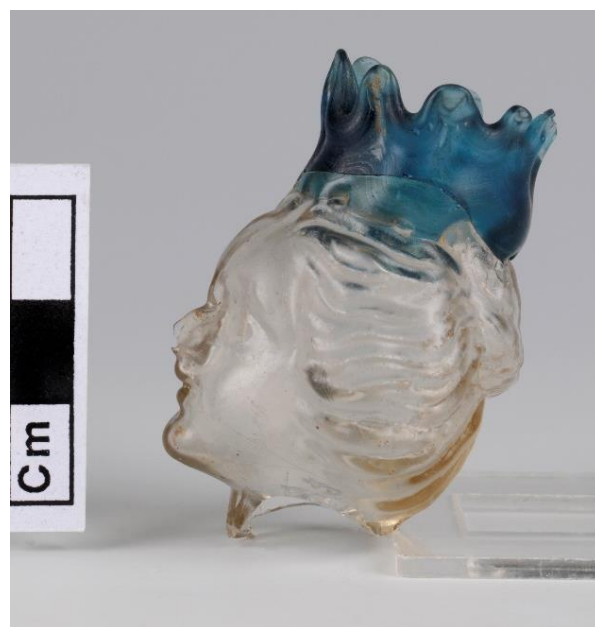
Pls 76 - 79: Crowned Female Head (photos Trevor Springett/LBE Museum Service  
(© Enfield Museum Service)

- \*3.1 Crowned female head, thought to be the upper part of a conical bird feeder or a decorative knob from a goblet-cover. The head is hollow, and is mould-blown from clear soda glass with an applied eight-pointed crown made from turquoise-blue glass. It is broken at the neck, but would almost certainly have terminated in a ruff before expanding into the rest of the vessel or lid.

The head is very similar to crowned female heads from decorative bird feeders (also known as bird fountains) in the Museum of London's Glass Reserve Collection, particularly A5102, A5103 and A1432. Other bird feeder heads were made in the form of men with tricorn hats (e.g. MoL Reserve Collection A13378 and A12126); these are more common and date to the eighteenth century (e.g. Shepherd nd, No. 235; Egan in Vince and Egan 1981, 170 - 1). An early eighteenth century English

The Forty Hall example is interesting because it is well-stratified in a mid- to late-seventeenth century context, and also particularly well moulded, made from high quality soda glass and (because of its date and quality) likely to be a Venetian import. It is also possible that it is not a bird feeder but (for example) a decorative knop from a vessel cover like the early eighteenth century English glass ceremonial goblet-cover. [124] (recovered in two precisely joining pieces, but tip of nose missing).

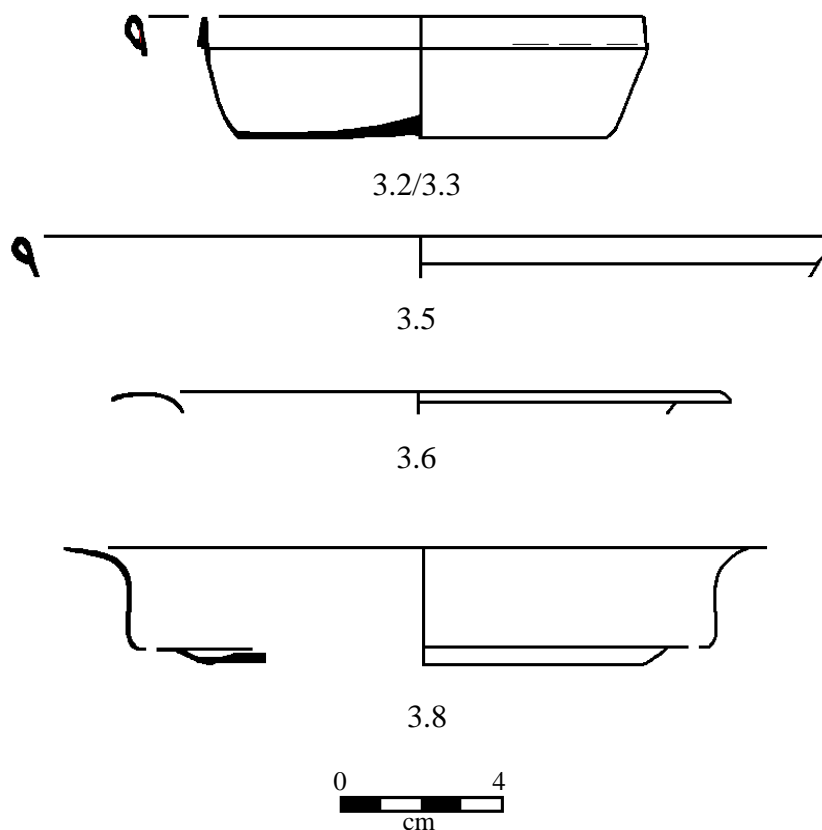
Fig. 84: Vessel Glass (1:2)

\*3.2 and 3.3 Two (?a pair) of freeblown shallow dishes (?possibly salts). Clear/*Cristallo* soda glass with a smoky grey cast and frequent small (in the base some larger) bubbles. Rims folded out and down giving a tubular rim in some sherds and just a thickening in others (?differentiating the two vessels), then horizontally creased internally, and externally part way down the rim, the external crease absent on some sherds where the rim is narrower. Sides slightly flaring above thickened flat bases with central 1 cm diameter pointil marks (one base pitted). Rim Di. 11 cm; Height 3 cm; Base Di. 9 cm. Probably Venetian. Complete wall profile, 5 other rim sherds, most of two separate bases with further body sherds and chips (total 20) mainly from [120] with smaller fragments [124] and [120]/[124] Second Sieving; probably matching sherd [S] and chips Trample Over [123] and [S].
