# **The Archaeology of Forty Hall and its Estate**

Martin J. Dearne

Published 2025 by the Enfield Archaeological Society  
Copyright © Martin J. Dearne and the Enfield Archaeological Society 2025  
ISBN 978-0-9501877-4-7  
Designed by Martin J. Dearne and Printed by the Enfield Council Design and Print  
Service

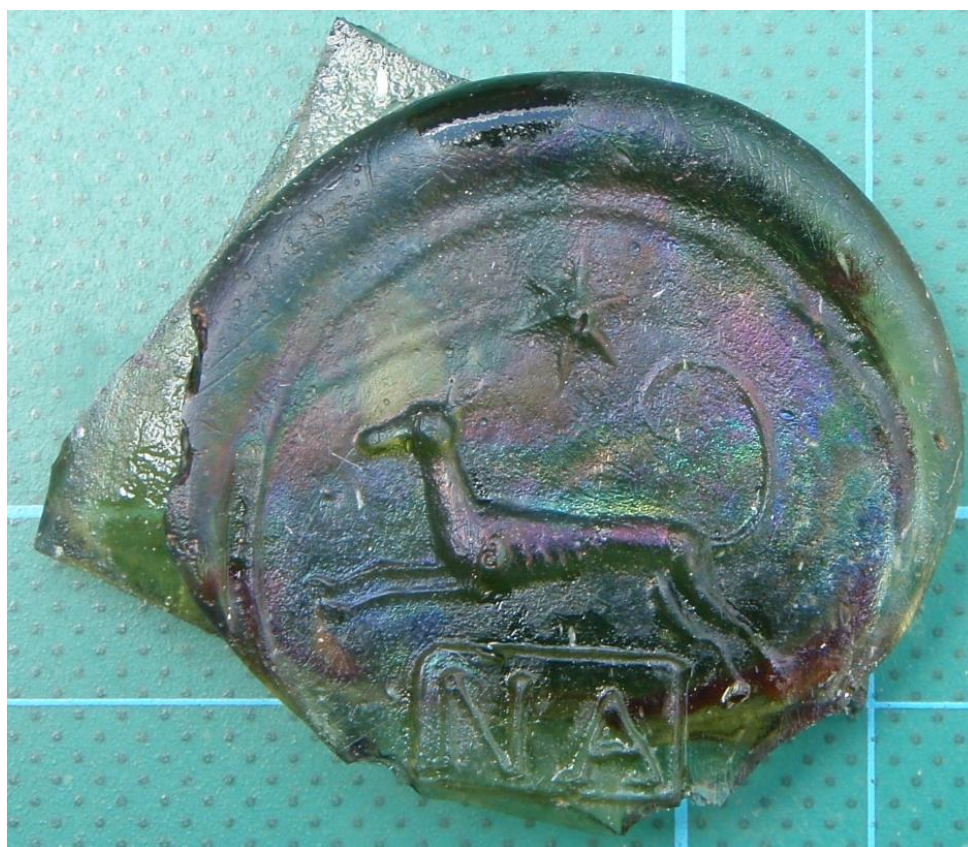
Pl. 80: Wine Bottle Seal 4.5

- 4.3 Base. Form uncertain. Low kick. Kick Height c. 7 mm; kick W. 44 mm. [124].
- 4.4 Base. Form uncertain. Kick Height 13 mm; kick W. ?60 mm. [120].
- \*4.5 Virtually complete applied seal from a bottle in bubbly green rather than olive green glass (plus matching body sherd). Seal diameter 4 cm. Raised rectangle carrying ‘NA’ below running greyhound and six pointed star from a single matrix. The initials do not obviously relate to anyone known to have been associated with the hall and the NA probably relates to the proprietor of a tavern which one might speculate was called the greyhound (or even the dog star). [124].

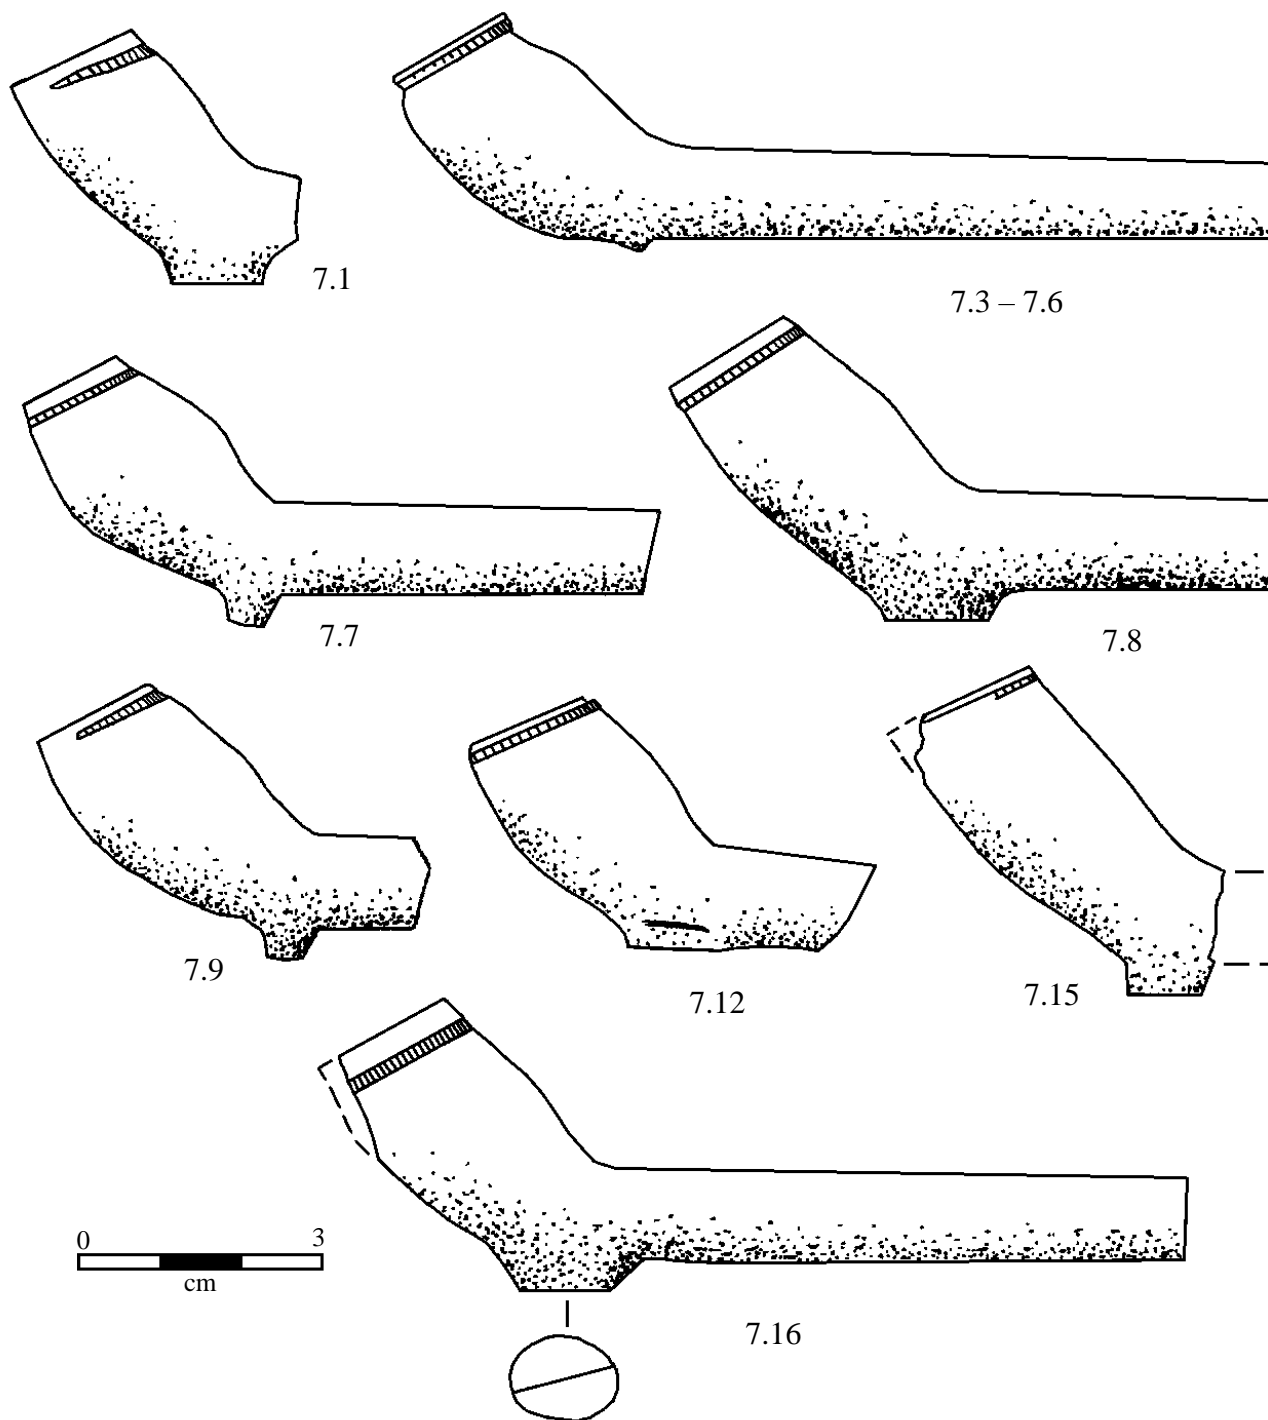
Fig. 85: Clay Pipe Bowls (1:1)

- \*7.1 Milled rim. Atkinson and Oswald (1969) Type 18 variant as Atkinson (2005) No. 16 (c. 1650 – 60), but quite small bowl. [124].
- 7.2 Plain rim. Incomplete. Atkinson and Oswald (1969) Type 9 (c. 1660). [124].
- \*7.3 – 7.6 Milled rims. All identical. Atkinson and Oswald (1969) Type 9 (c. 1660), but very small spurs. [124].

- \*7.7 Milled rim. Atkinson and Oswald (1969) Type 15 (c. 1660 – 80). [124].
- \*7.8 Milled rim. Atkinson and Oswald (1969) Type 18 variant as Atkinson (2005) No. 16 (c. 1650 – 60). [120]

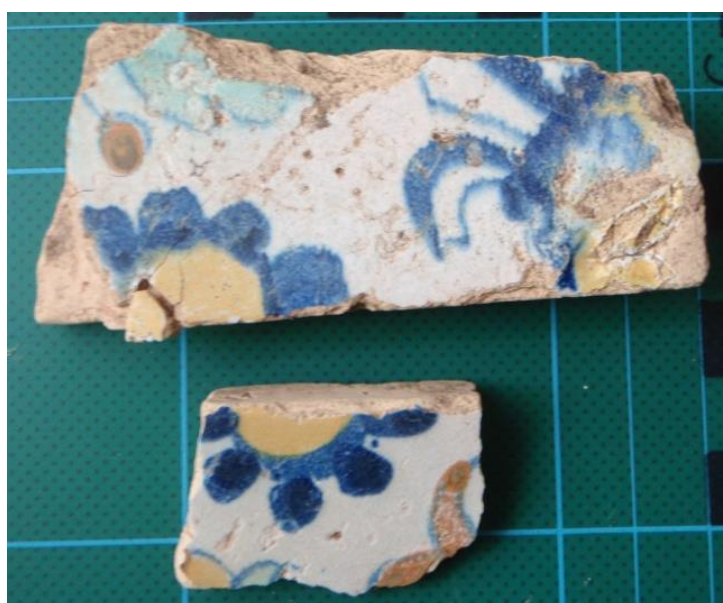
Pl. 81: Tin Glazed Floor Tiles 8.1 and (Below) 8.2

- \*8.1 Corner. Pickleherring Design 8 or 9/Rotherhithe Design 15 (bunch of grapes or pomegranate with *fleur-de-lis* corners) (cf. Tyler *et al* 2008, 54 and Fig. 75; 88 and Fig. 141). Closely similar to published Pickleherring fragments of Design 8 (grapes with flanking leaves) and perhaps specifically Style 2 of that design. [124].
- \*8.2 Edge. Ditto, but perhaps more likely Pickleherring Design 9. [120]/[124].

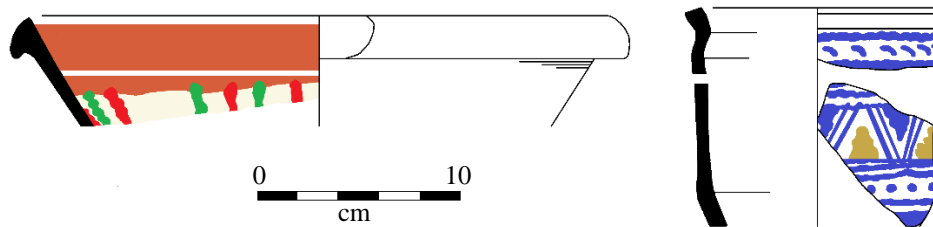
Fig. 86: Selected Finds 1 and 2 (1:4)

\*2 Rim and body, three sherds, all unabraded and probably from the same TGW 'drug' jar. Tin-glazed earthenware with a good white glaze. Ext. polychrome decoration including dark blue horizontal, mainly slightly wavy, lines on/below carination and below rim, thicker line on shoulder and rows of horizontal oblique dashes/dots above and below line bounded zone with chevron pattern of alternating triangles infilled in blue and diffused brown (yellow). Rim Di. 13 cm; Estimated Ht. c. 13 cm. Orton's (1988, 327) Group D, dated to the second half of the seventeenth century and parallelable in Tyler *et al* (2008, 78, Fig. 116).

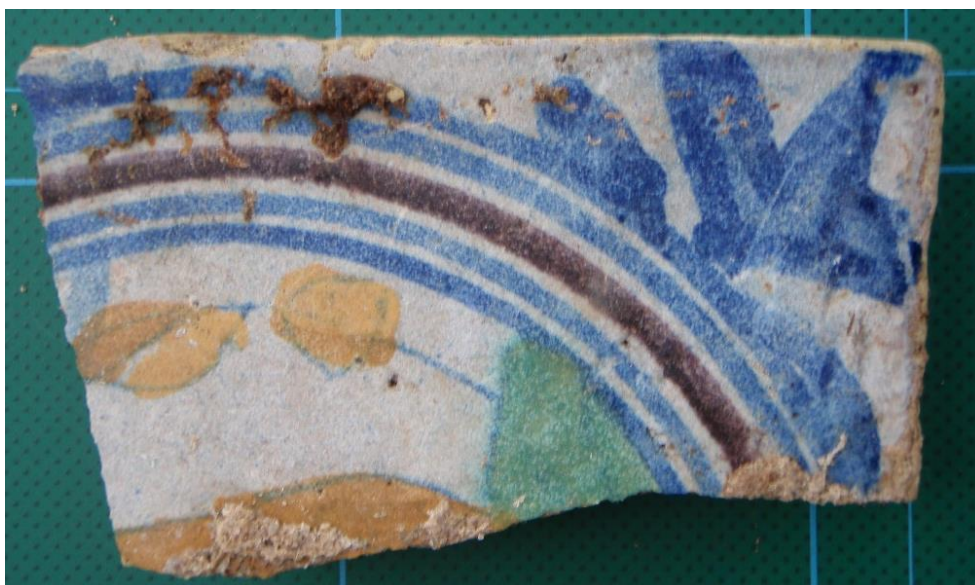
Pl. 82: Selected Find 3

\*3 Two fragments (one illustrated) of tin glazed, polychrome, delftware floor tile. Ian M. Betts kindly writes: the tile measures 19 mm in thickness with a reconstructed length of 144 mm with bevelled edges. The tile is in the medallion style with corner foliage designs and a circular central border of five concentric rings, the central ring being purplish brown in colour with the outer two in a blue colour. The central design appears to be of an animal rendered in yellow standing on green grass next to a plant with yellow foliage and a sky background of white and blue. No corner nail holes were visible indicating the tile is more likely an English copy of a Dutch design. The tile probably originated from the Aldgate pottery in London with a date range of 1570 to 1600. Mortar adhering to some of the broken edges and face suggests the tile has been reused.

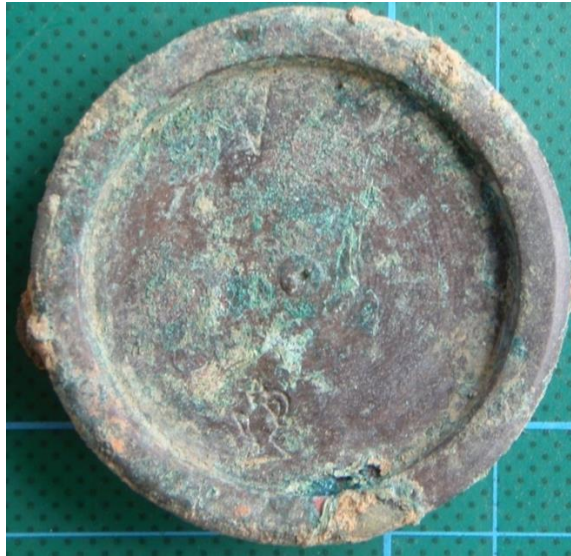
Pl. 83: Selected Find 4

\*4 Ae circular weight, Di. 4.7 cm, Max. Th. 5.8 cm, Weight 55.9 gms. Upper face with raised border, slightly recessed ring around chuck mark and concentric turning marks. Lower face with concentric mould marks and extensive multi-directional file marks. Strongly registered ewer stamp on upper face, but very weakly registered 'A', probably from crowned I/sword/A stamp of the reign of James I (authentication mark of the London Founders Company). Two ounce avoirdupois (standard 56.8 gms), ?but a little under weight even allowing for corrosion. A virtually identical example from Southwark (Egan 2005, 163 No. 832) came from a context of c. 1630 – 50.

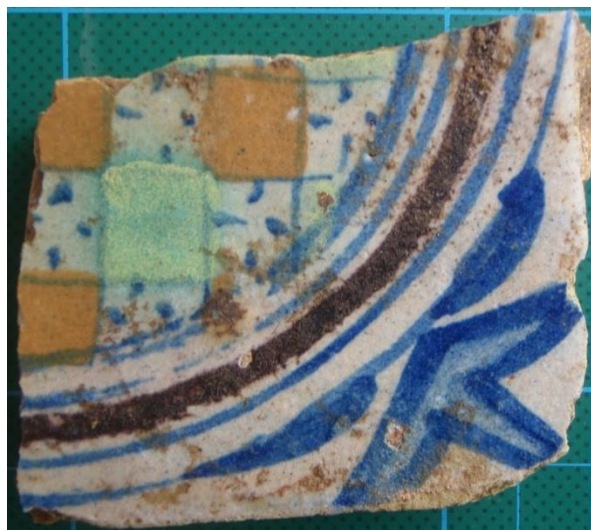
Pl. 85: Selected Find 5

\*5 Corner (6.8 x 6.0; Th. 2.0 cm) of a tin glazed, polychrome, delftware floor tile. Medallion tile of Tyler *et al* (2008, 54 and Fig. 76) Pickleherring design 14 Style 1, green, brown and blue-dashed chequerboard, here within a blue and brownish multiple medallion with blue (?very stylised *fleur-de-lys*) corner motifs. The medallion colours almost certainly indicate that it is a Pickleherring product (pers. comm. Ian M. Betts) and so c. 1618 – c. 1650; it is therefore likely to have belonged to one of the original floors of the hall.

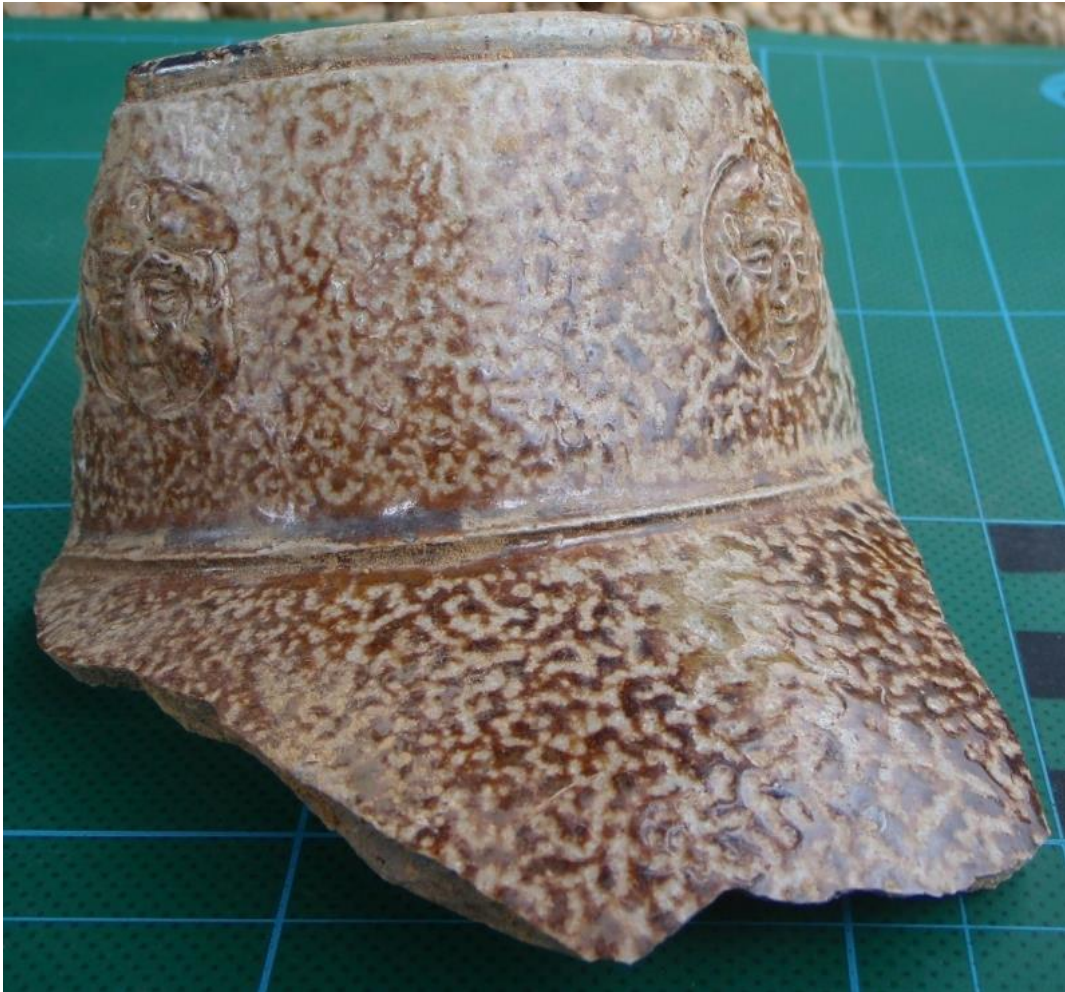
Pl. 84: Selected Find 6

\*6 Rim/body/handle (3, join), globular FREC jug. Cordon at junction of body and neck, cylindrical straight-sided neck with two surviving small ?identical ?grotesque masks and simple thinned rim (similar to an example in the Museum of London and another with beardman masks came from the 1629 *Batavia* wreck (Green 1989, 124, BAT 2809-20455)). c. 1600 – 1650.
